**Draft Biological Technical Report for the
East Valley Parkway and Midway Drive Drainage Improvement Project,
City of Escondido, California**

APPENDIX E
Photo Document

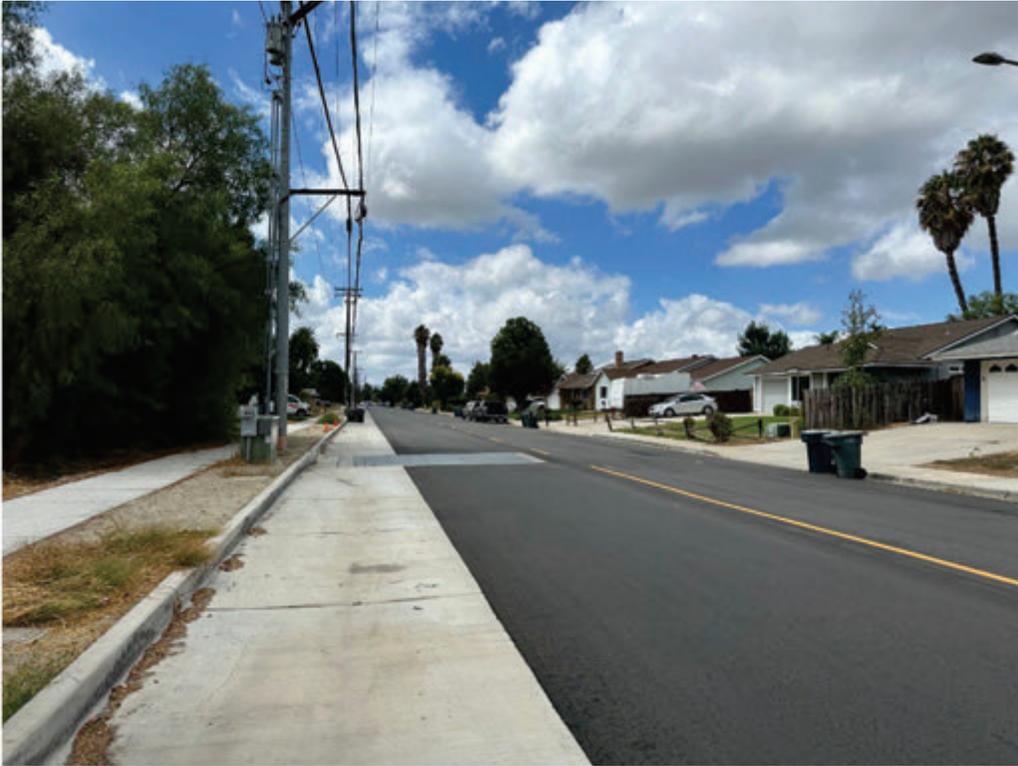
Photo 1: Representative photo of developed land: Southwest-facing view of E. Lincoln Road, southwest of El Norte Parkway.

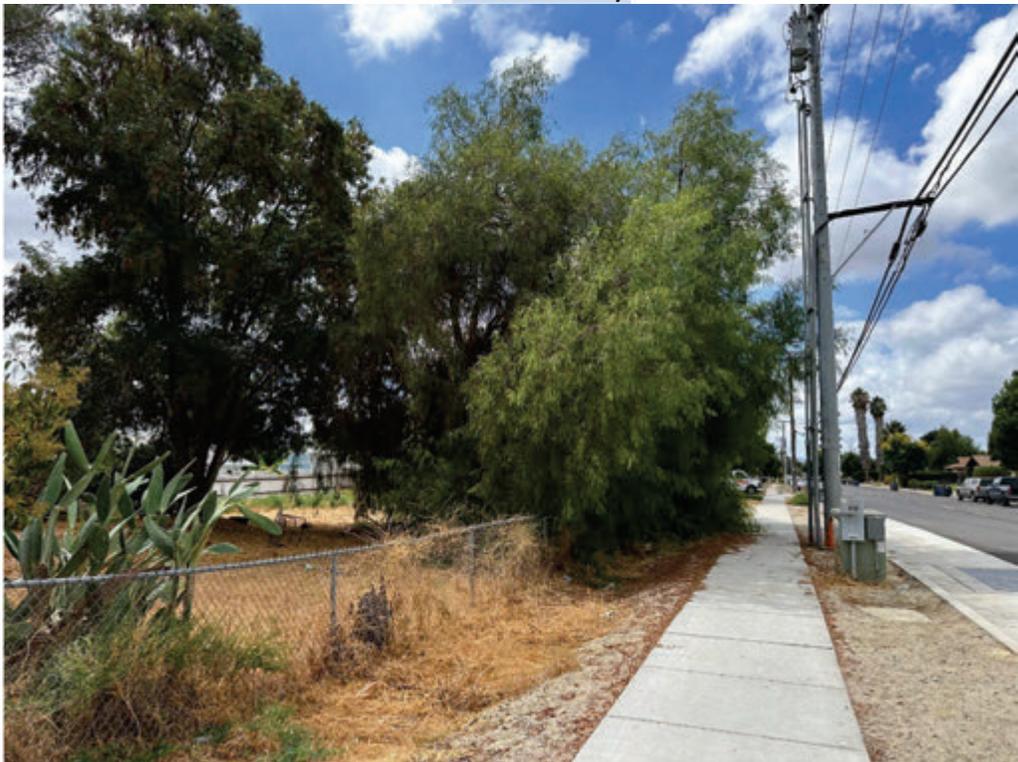
Photo 2: Representative photo of landscaping/ornamental: Northeast corner of E. Lincoln Road and Nightingale Place.

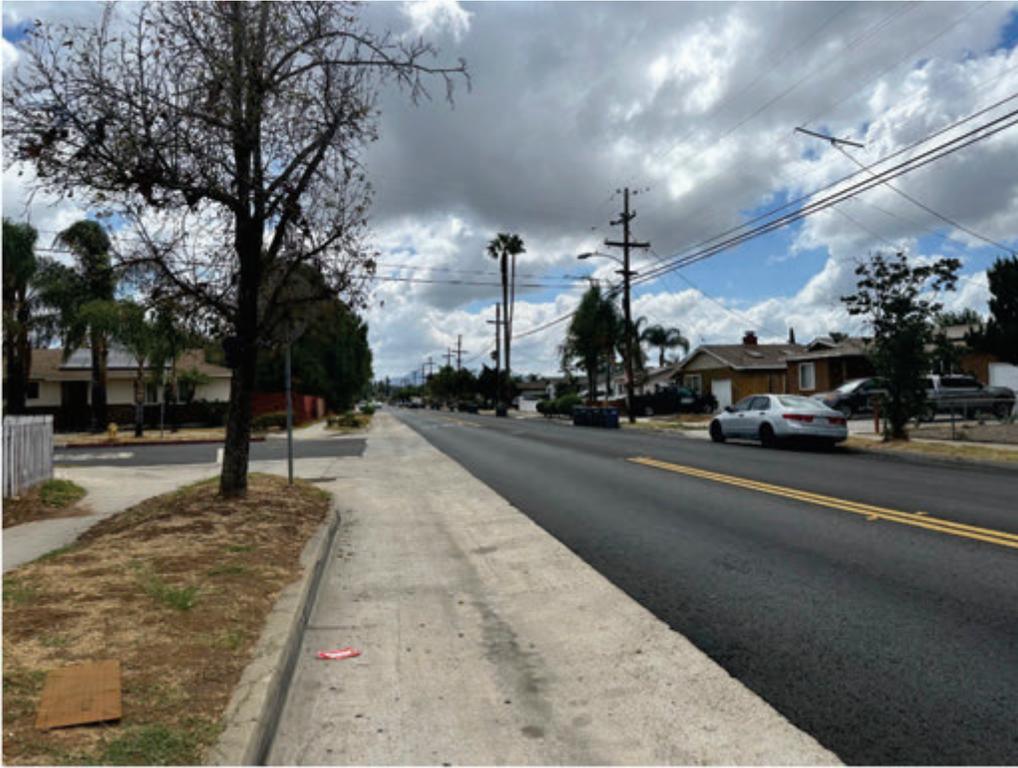
Photo 3: Representative photo of developed land: South-facing view of N. Midway Drive and E. Lincoln Avenue.

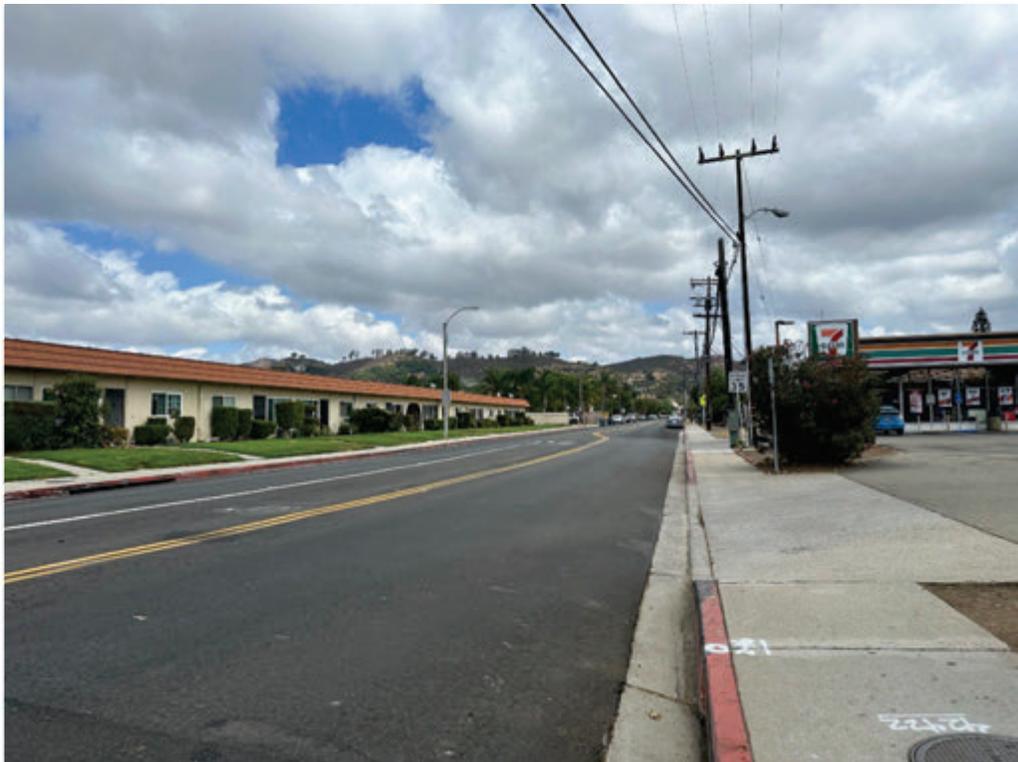
Photo 4: Representative photo of developed land: East-facing view of E. Mission Avenue and N. Midway Drive.

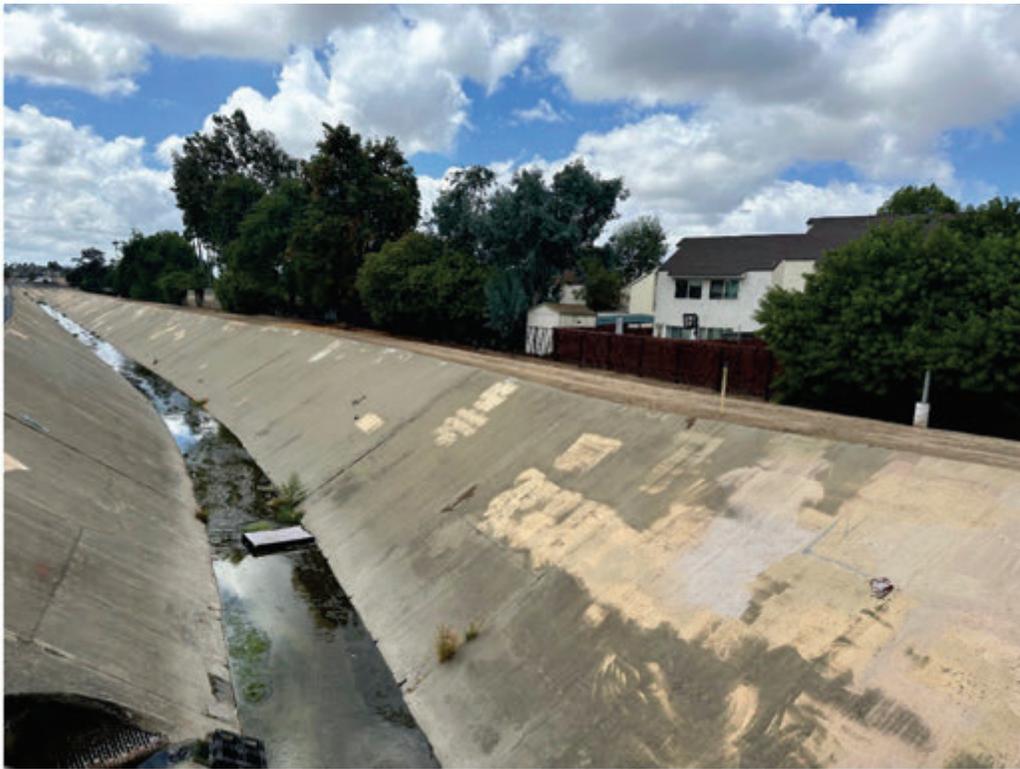
Photo 5: Representative photo of concrete-lined channel: East-facing view of Escondido Creek, south of Washington Avenue.

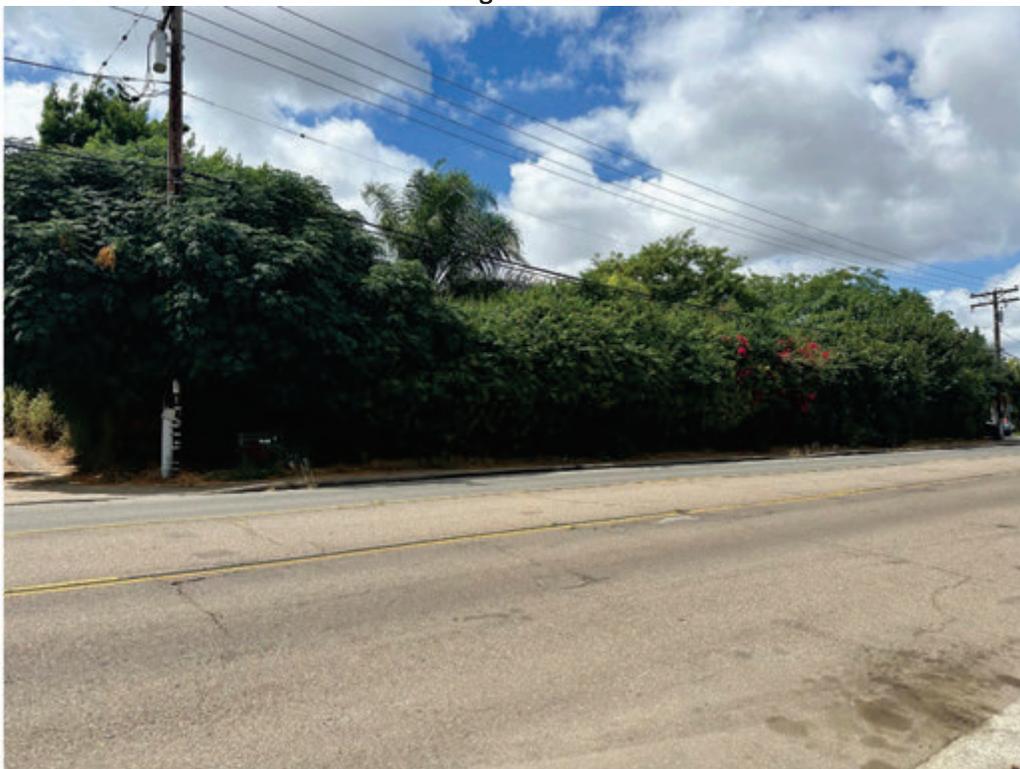
Photo 6: Representative photo of landscaping/ornamental: West-facing view on N. Midway Drive, south of E. Grand Avenue.

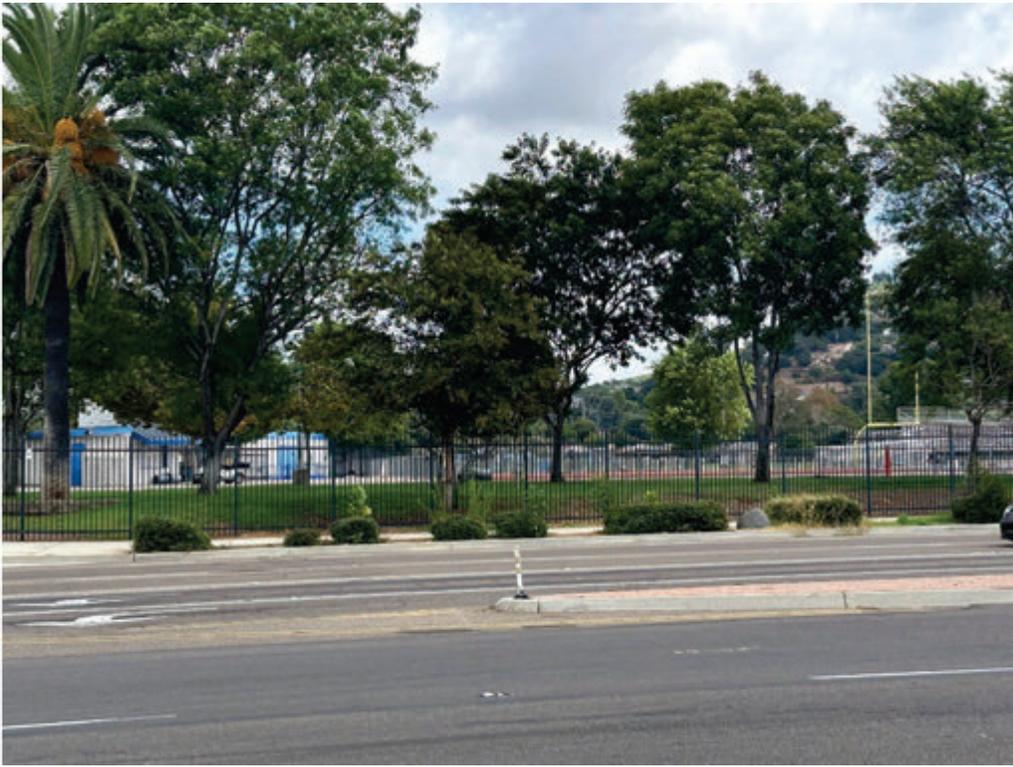
Photo 7: Representative photo of landscaping/ornamental: East-facing view on Bear Valley Parkway and S. Midway Drive.

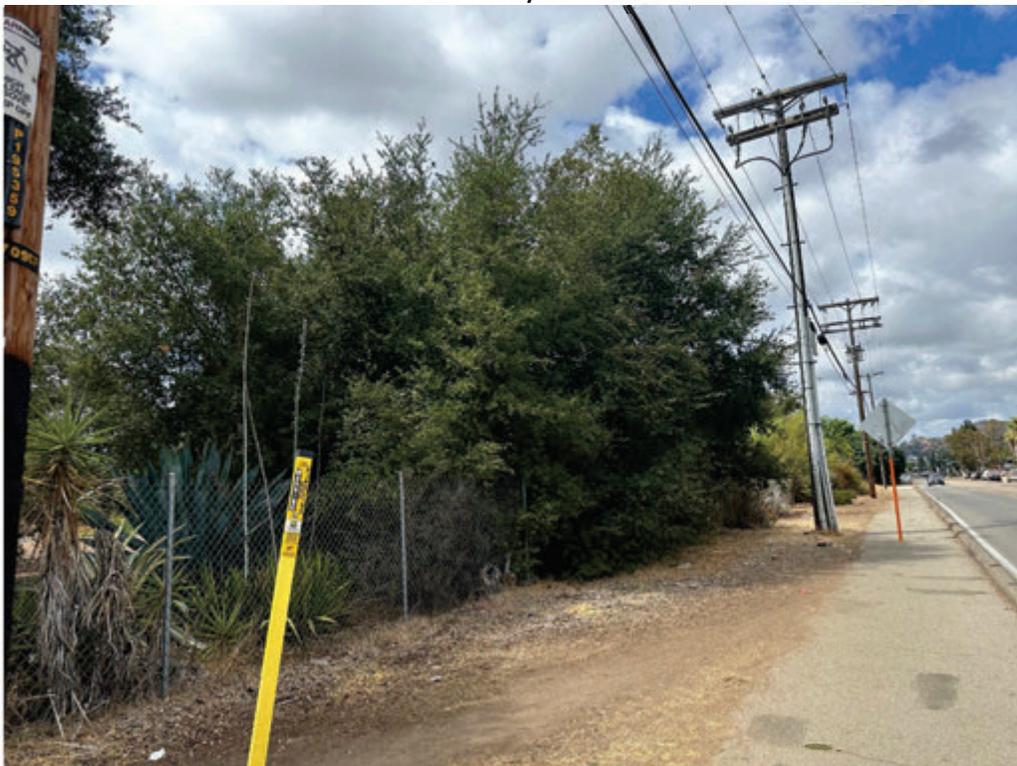
Photo 8: Representative photo of coast live oak woodland: North-facing view on N. Midway Drive, north of Oak Hill Drive.

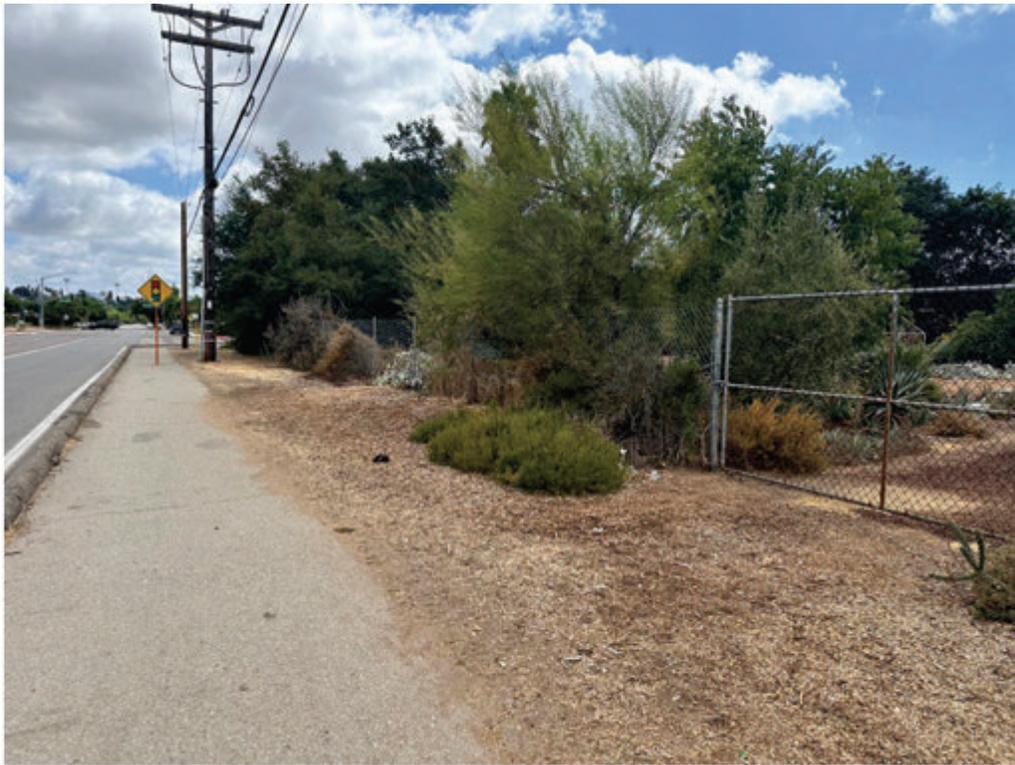
Photo 9: Representative photo of landscaping/ornamental: South-facing view on N. Midway Drive, north of mapped coast live oak woodland habitat, south of E. Grand Drive.

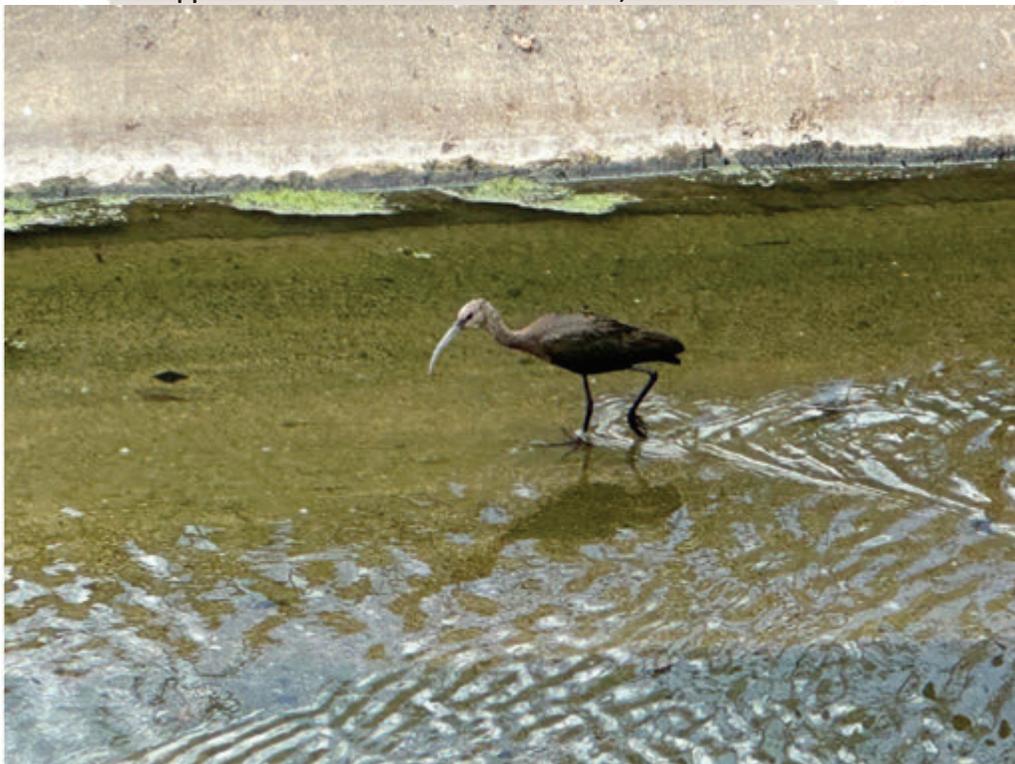
Photo 10: White-faced ibis wading in the concrete-lined channel of Escondido Creek at N. Rose Street.

<i>Plegadis chihi</i> White-faced ibis	WL (nesting colony), MHCP	Found in shallow areas of freshwater marshes and wet grass.	Observed onsite in concrete-lined Escondido Creek under Rose Street crossing. Suitable foraging habitat is present within Escondido Creek but no suitable nesting habitat occurs onsite. This species nests in colonies and the small patch of freshwater marsh onsite is not suitable for a nesting colony.
<i>Poliopitila californica californica</i> Coastal California gnatcatcher	FT, SSC, MHCP	Coastal sage scrub, coastal sage scrub-chaparral mix, coastal sage scrub-grassland ecotone, riparian in late summer	Not observed onsite. No potential to occur due to lack of suitable habitat onsite.
<i>Rallus obsoletus levipes</i> Light-footed Ridgway's rail	FE, SE, CFP	Found in salt marshes traversed by tidal sloughs, where cordgrass and pickleweed are the dominant vegetation.	Not observed onsite. No potential to occur due to lack of suitable habitat onsite.

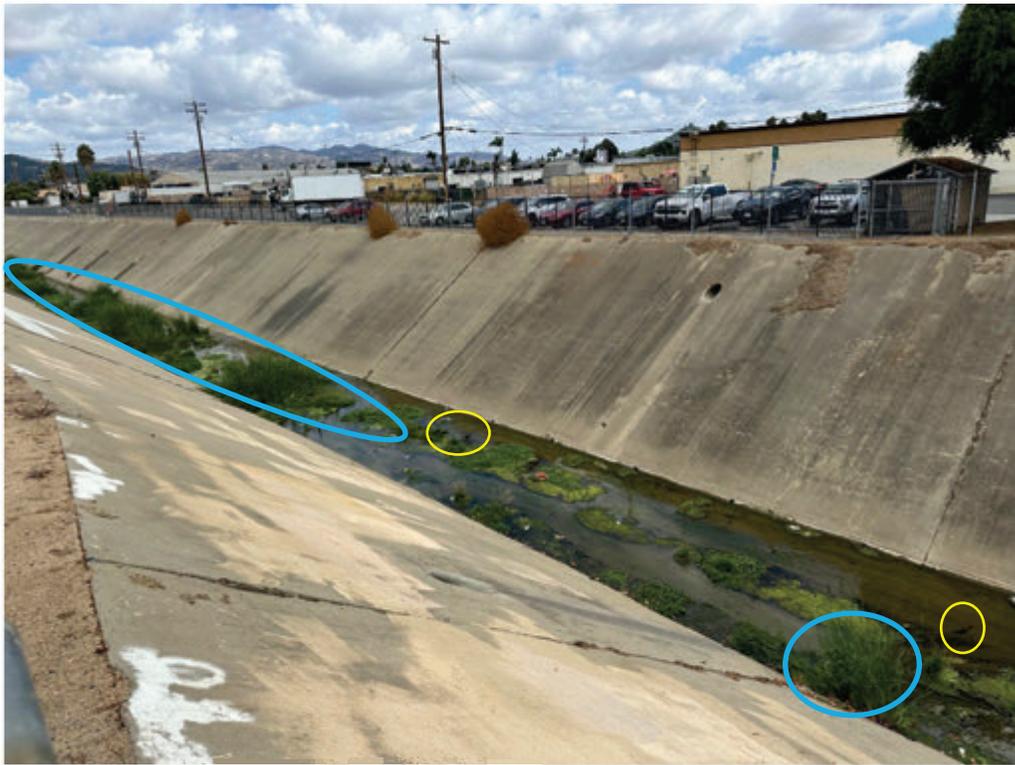
Photo 11: Representative photo of freshwater marsh (circled in blue) in Escondido Creek at N. Rose Street. White-faced ibis are circled in yellow.

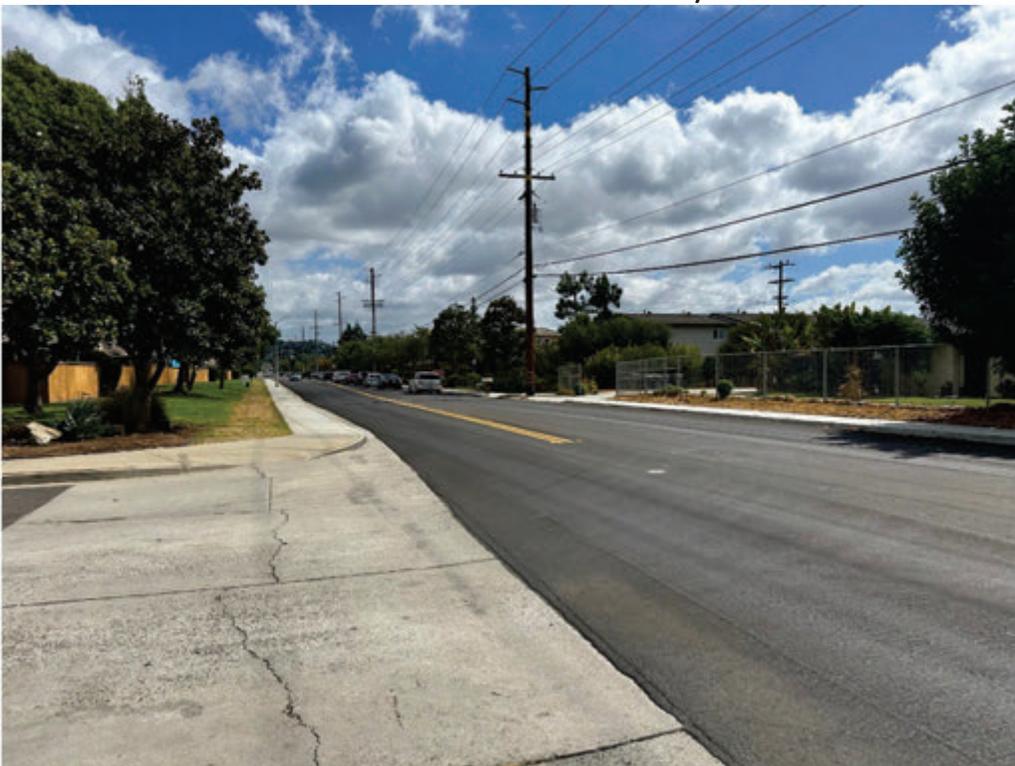
Photo 12: Representative photo of developed land and landscaping/ornamental: South-facing view of N. Citrus Avenue at Prescott Glen.

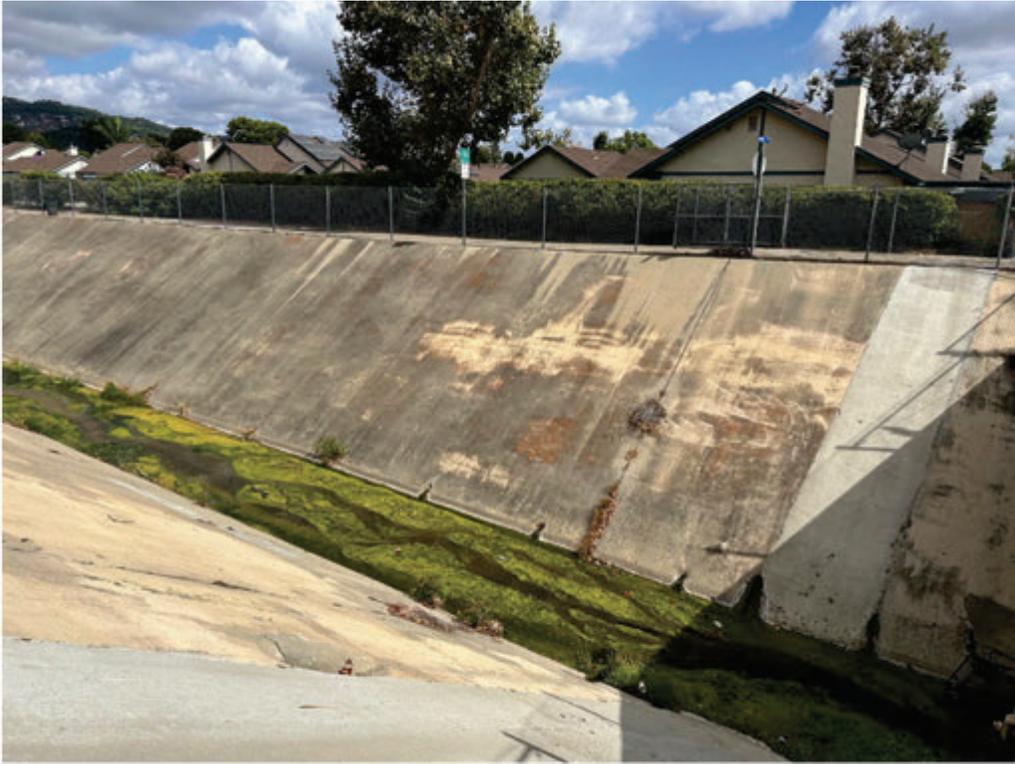
Photo 13: Representative photo of concrete-lined channel: East-facing view of Escondido Creek at N. Citrus Avenue.

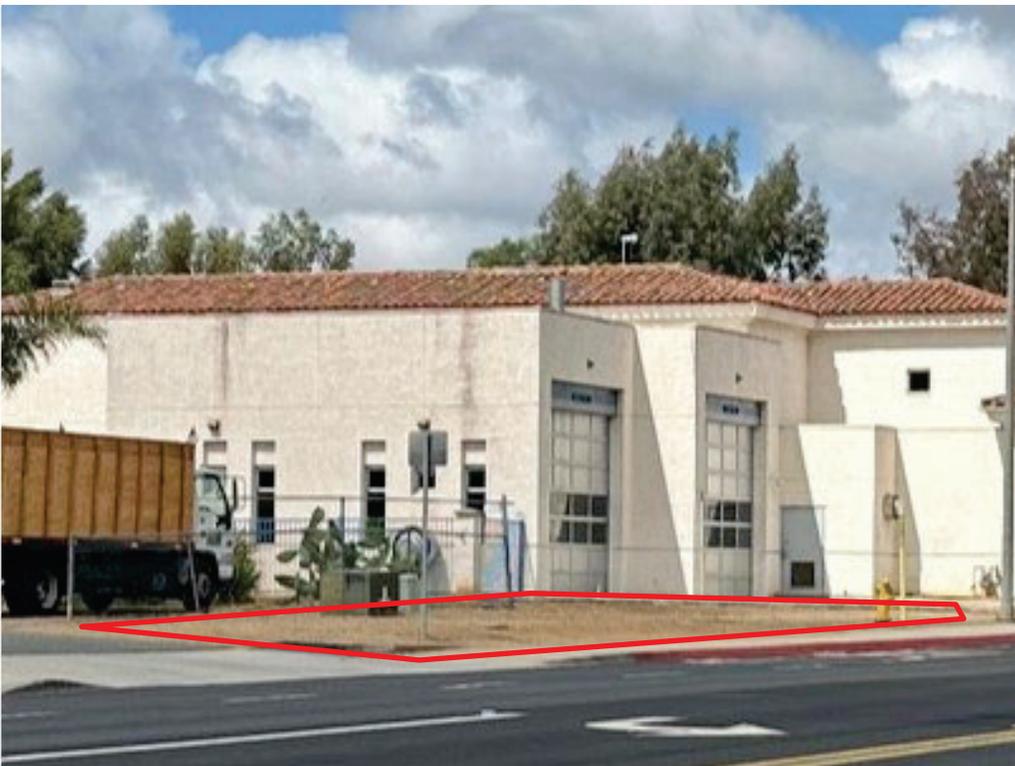
Photo 14: Representative photo of bare ground: Northwest-facing view on N. Midway Drive, north of E. Valley Parkway.

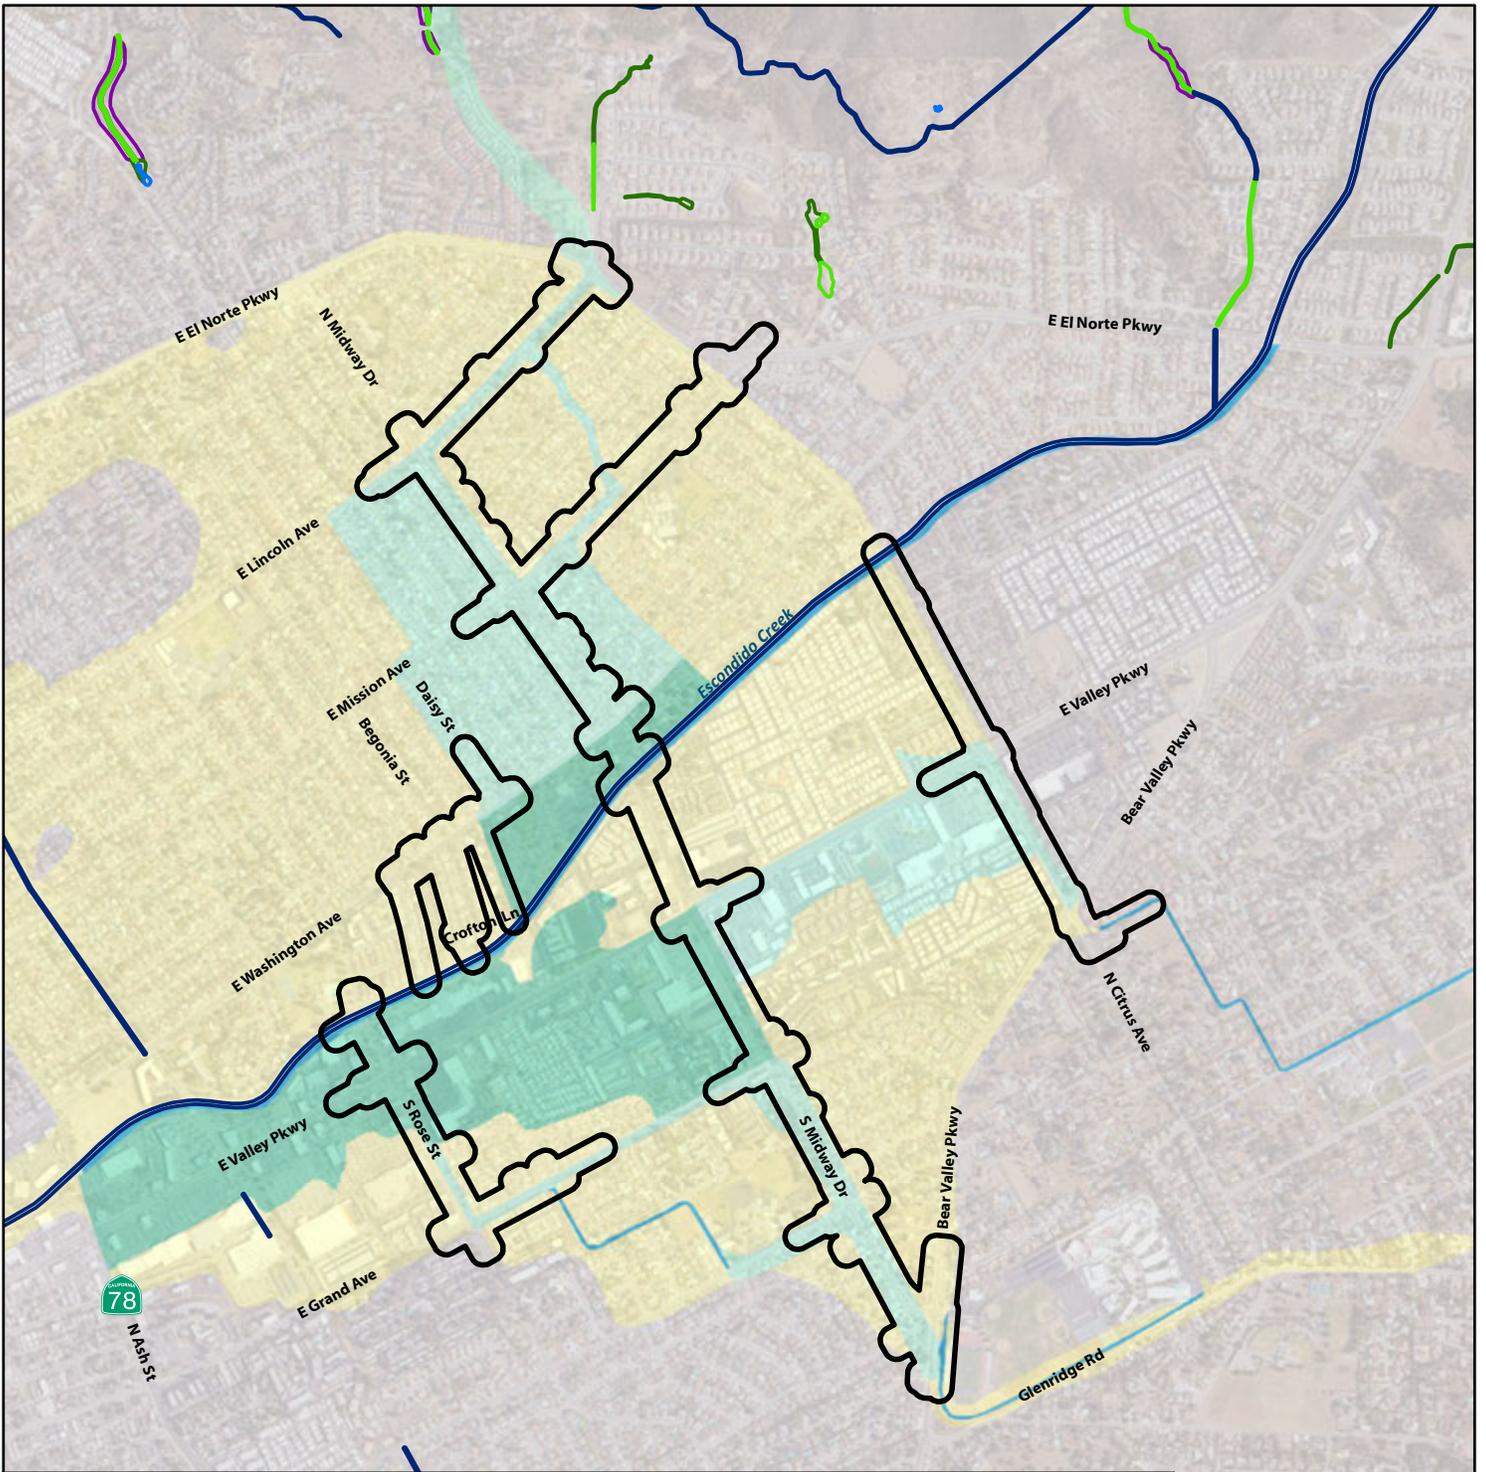
Figure 3

Survey Area	FEMA Flood Zones
National Wetlands Inventory (NWI)	A
Freshwater Emergent Wetland	AH
Freshwater Forested/Shrub Wetland	AO
Freshwater Pond	X, 0.2 PCT ANNUAL CHANCE FLOOD HAZARD
Riverine	X, AREA OF MINIMAL FLOOD HAZARD
Forested/Shrub Riparian

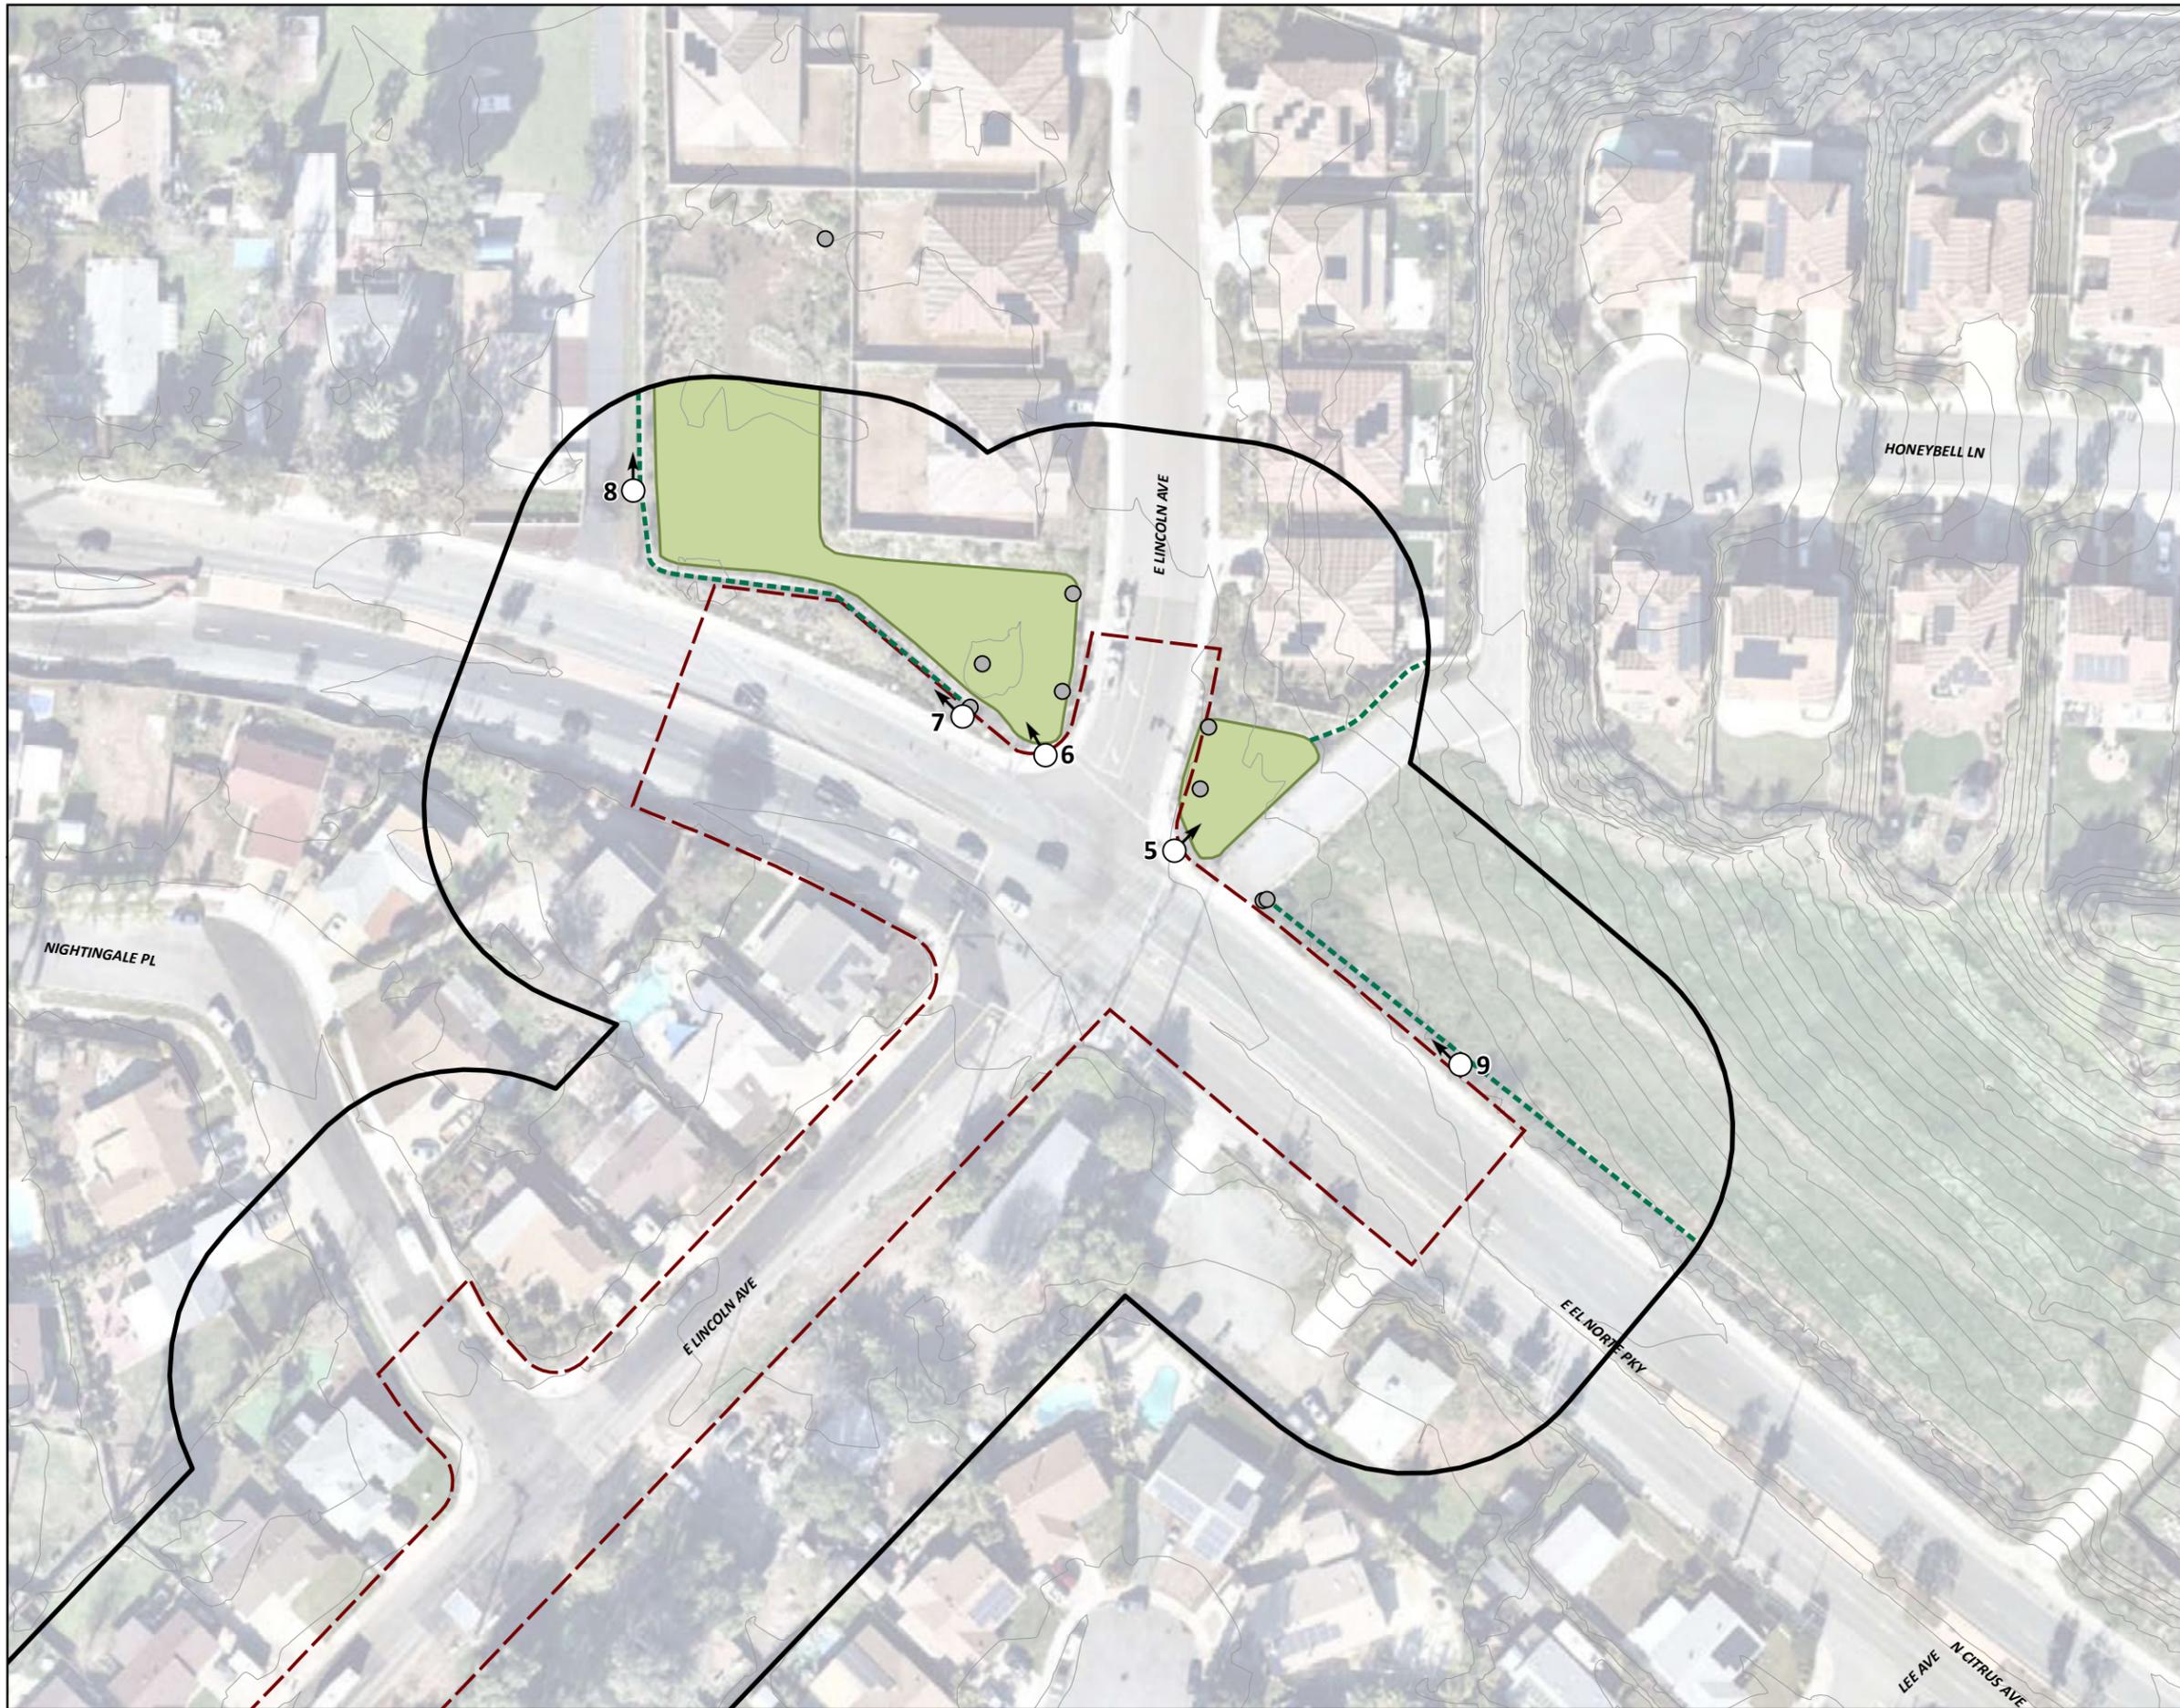
Figure 6 - Page 1 of 7
Aquatic Resources

- Survey Area
- Project Impacts
- Photo Location
- Culvert
- Topographic Contour (2-foot Interval)
- Non-Jurisdictional Features**
- Brow Ditch
- Detention Basin/Bio swale

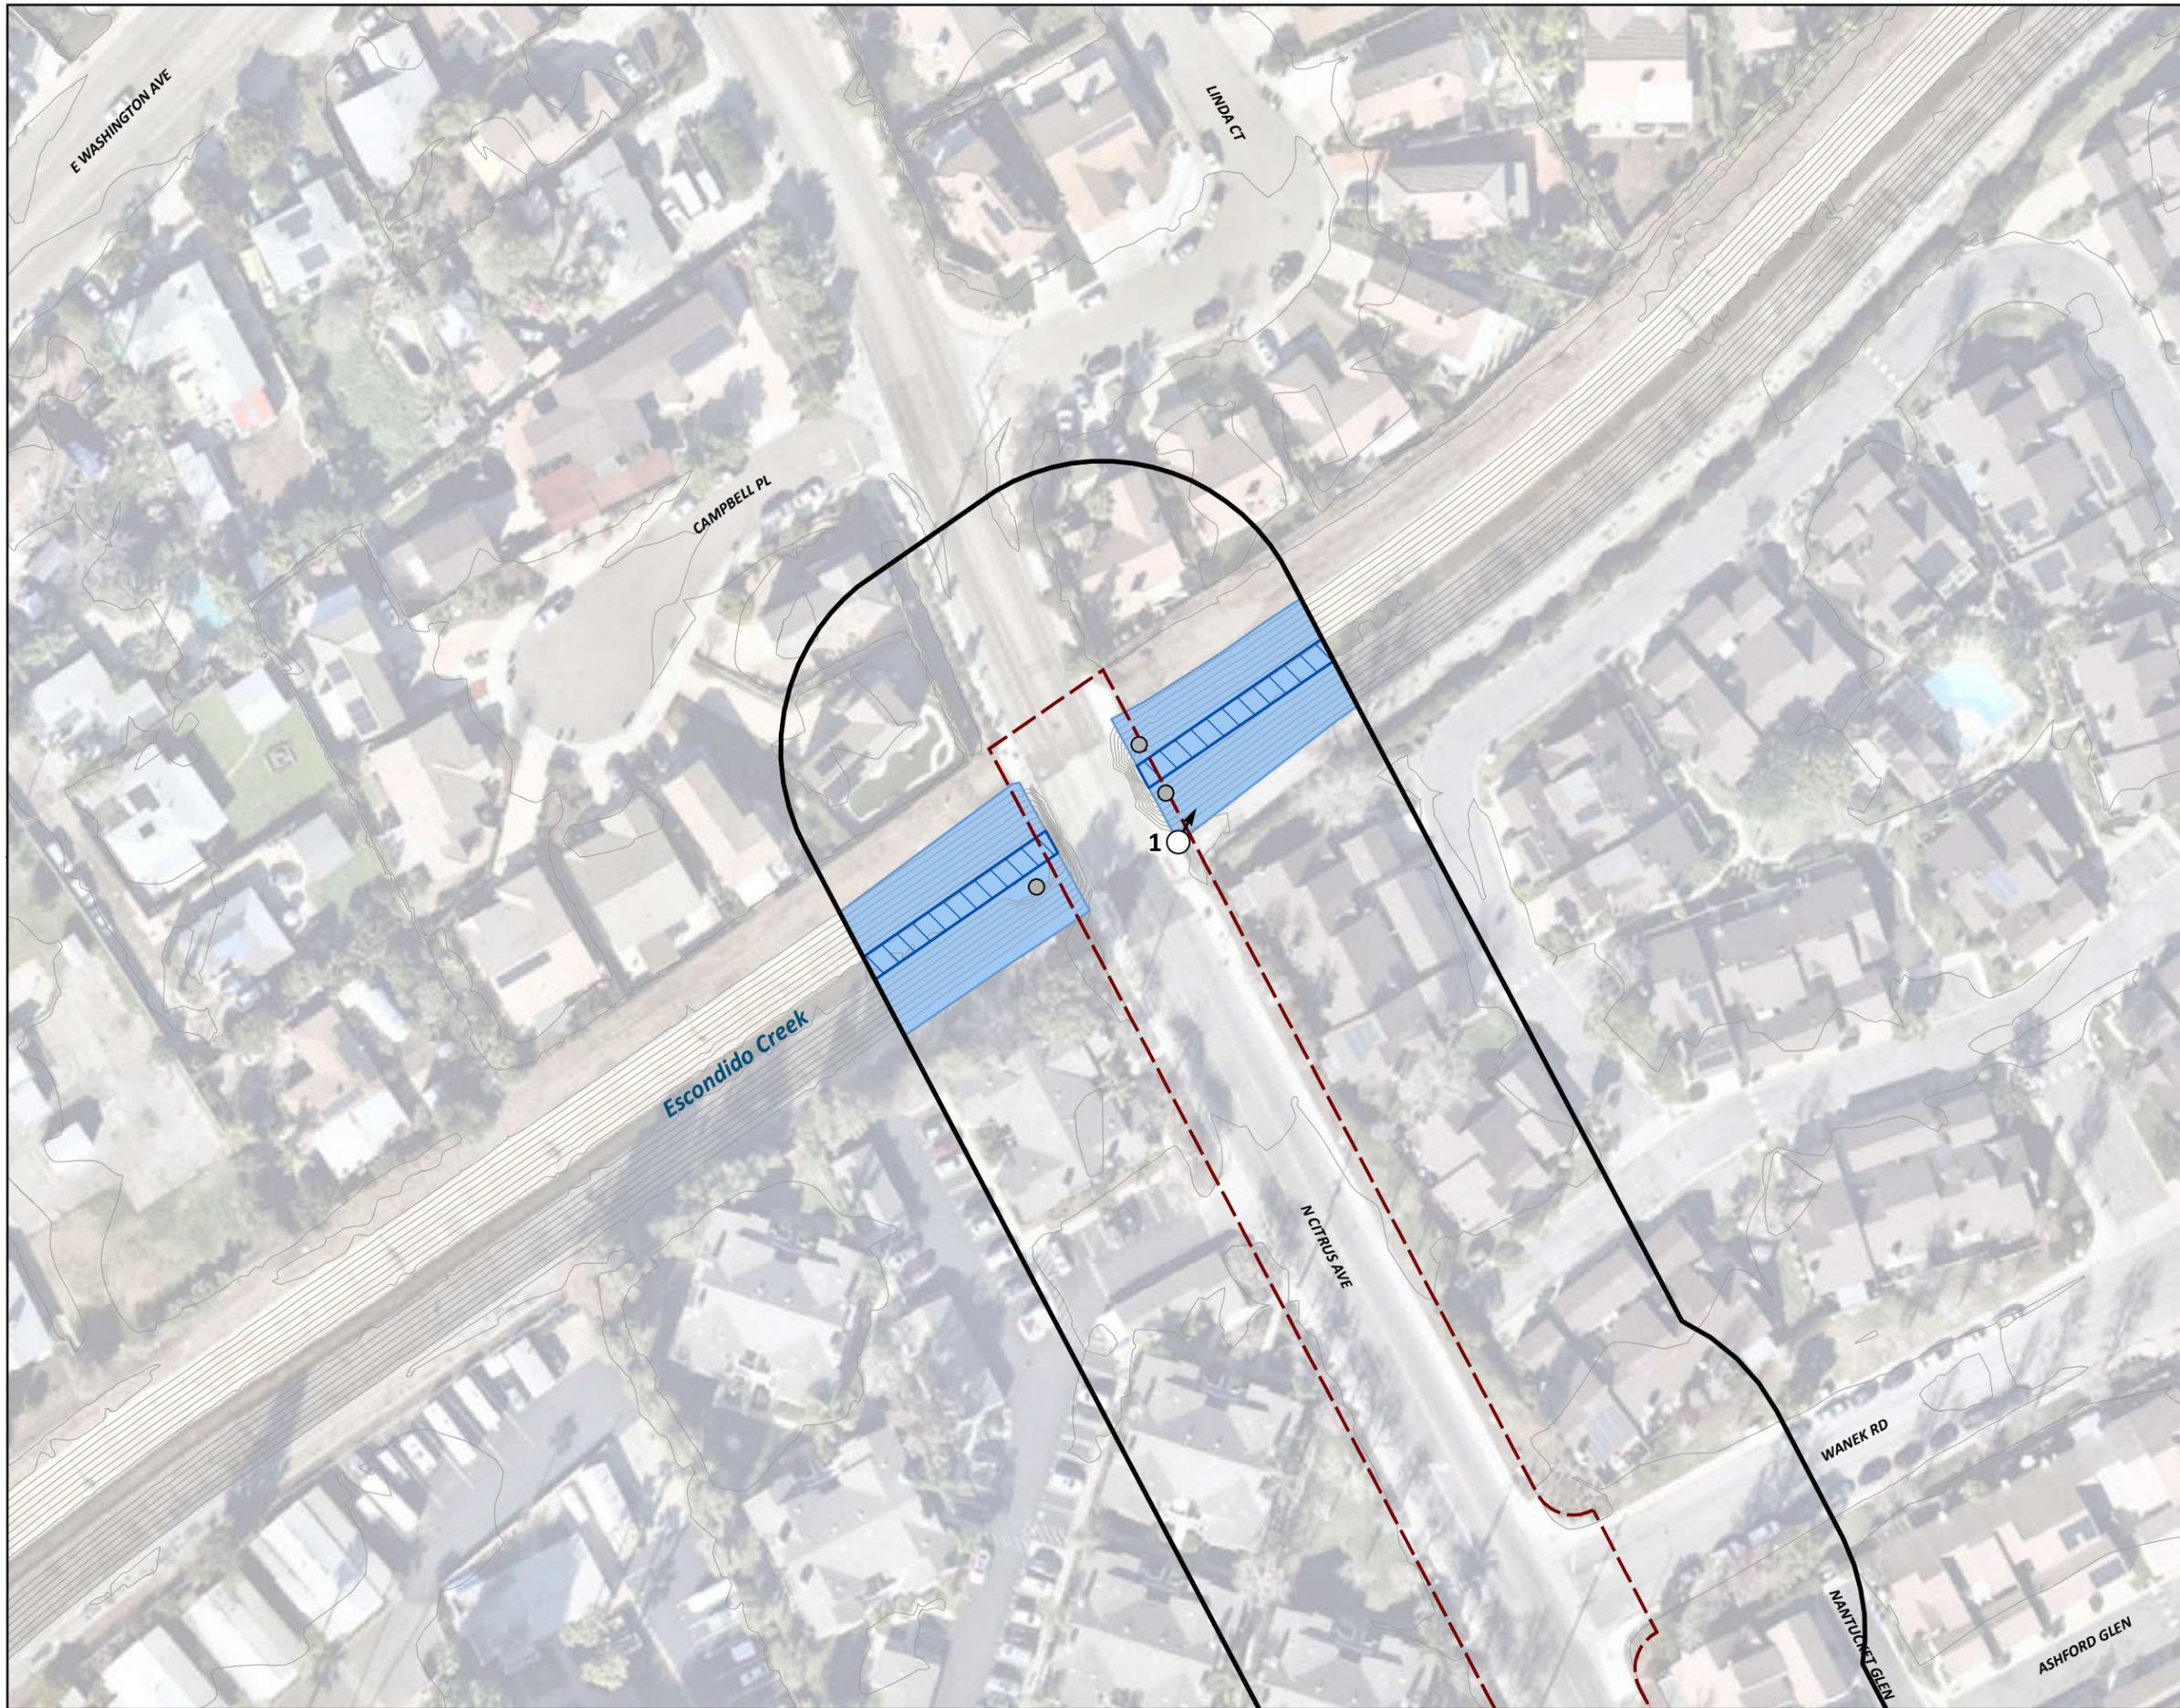
Figure 6 - Page 2 of 7
Aquatic Resources

- Survey Area
- Project Impacts
- Photo Location
- Culvert
- Topographic Contour (2-foot Interval)
- Corps/RWQCB Aquatic Resources**
- Non-wetland Waters
- CDFW Streambed**
- Concrete-lined Channel
