**Draft Biological Technical Report for the
East Valley Parkway and Midway Drive Drainage Improvement Project,
City of Escondido, California**

APPENDIX E
Photo Document

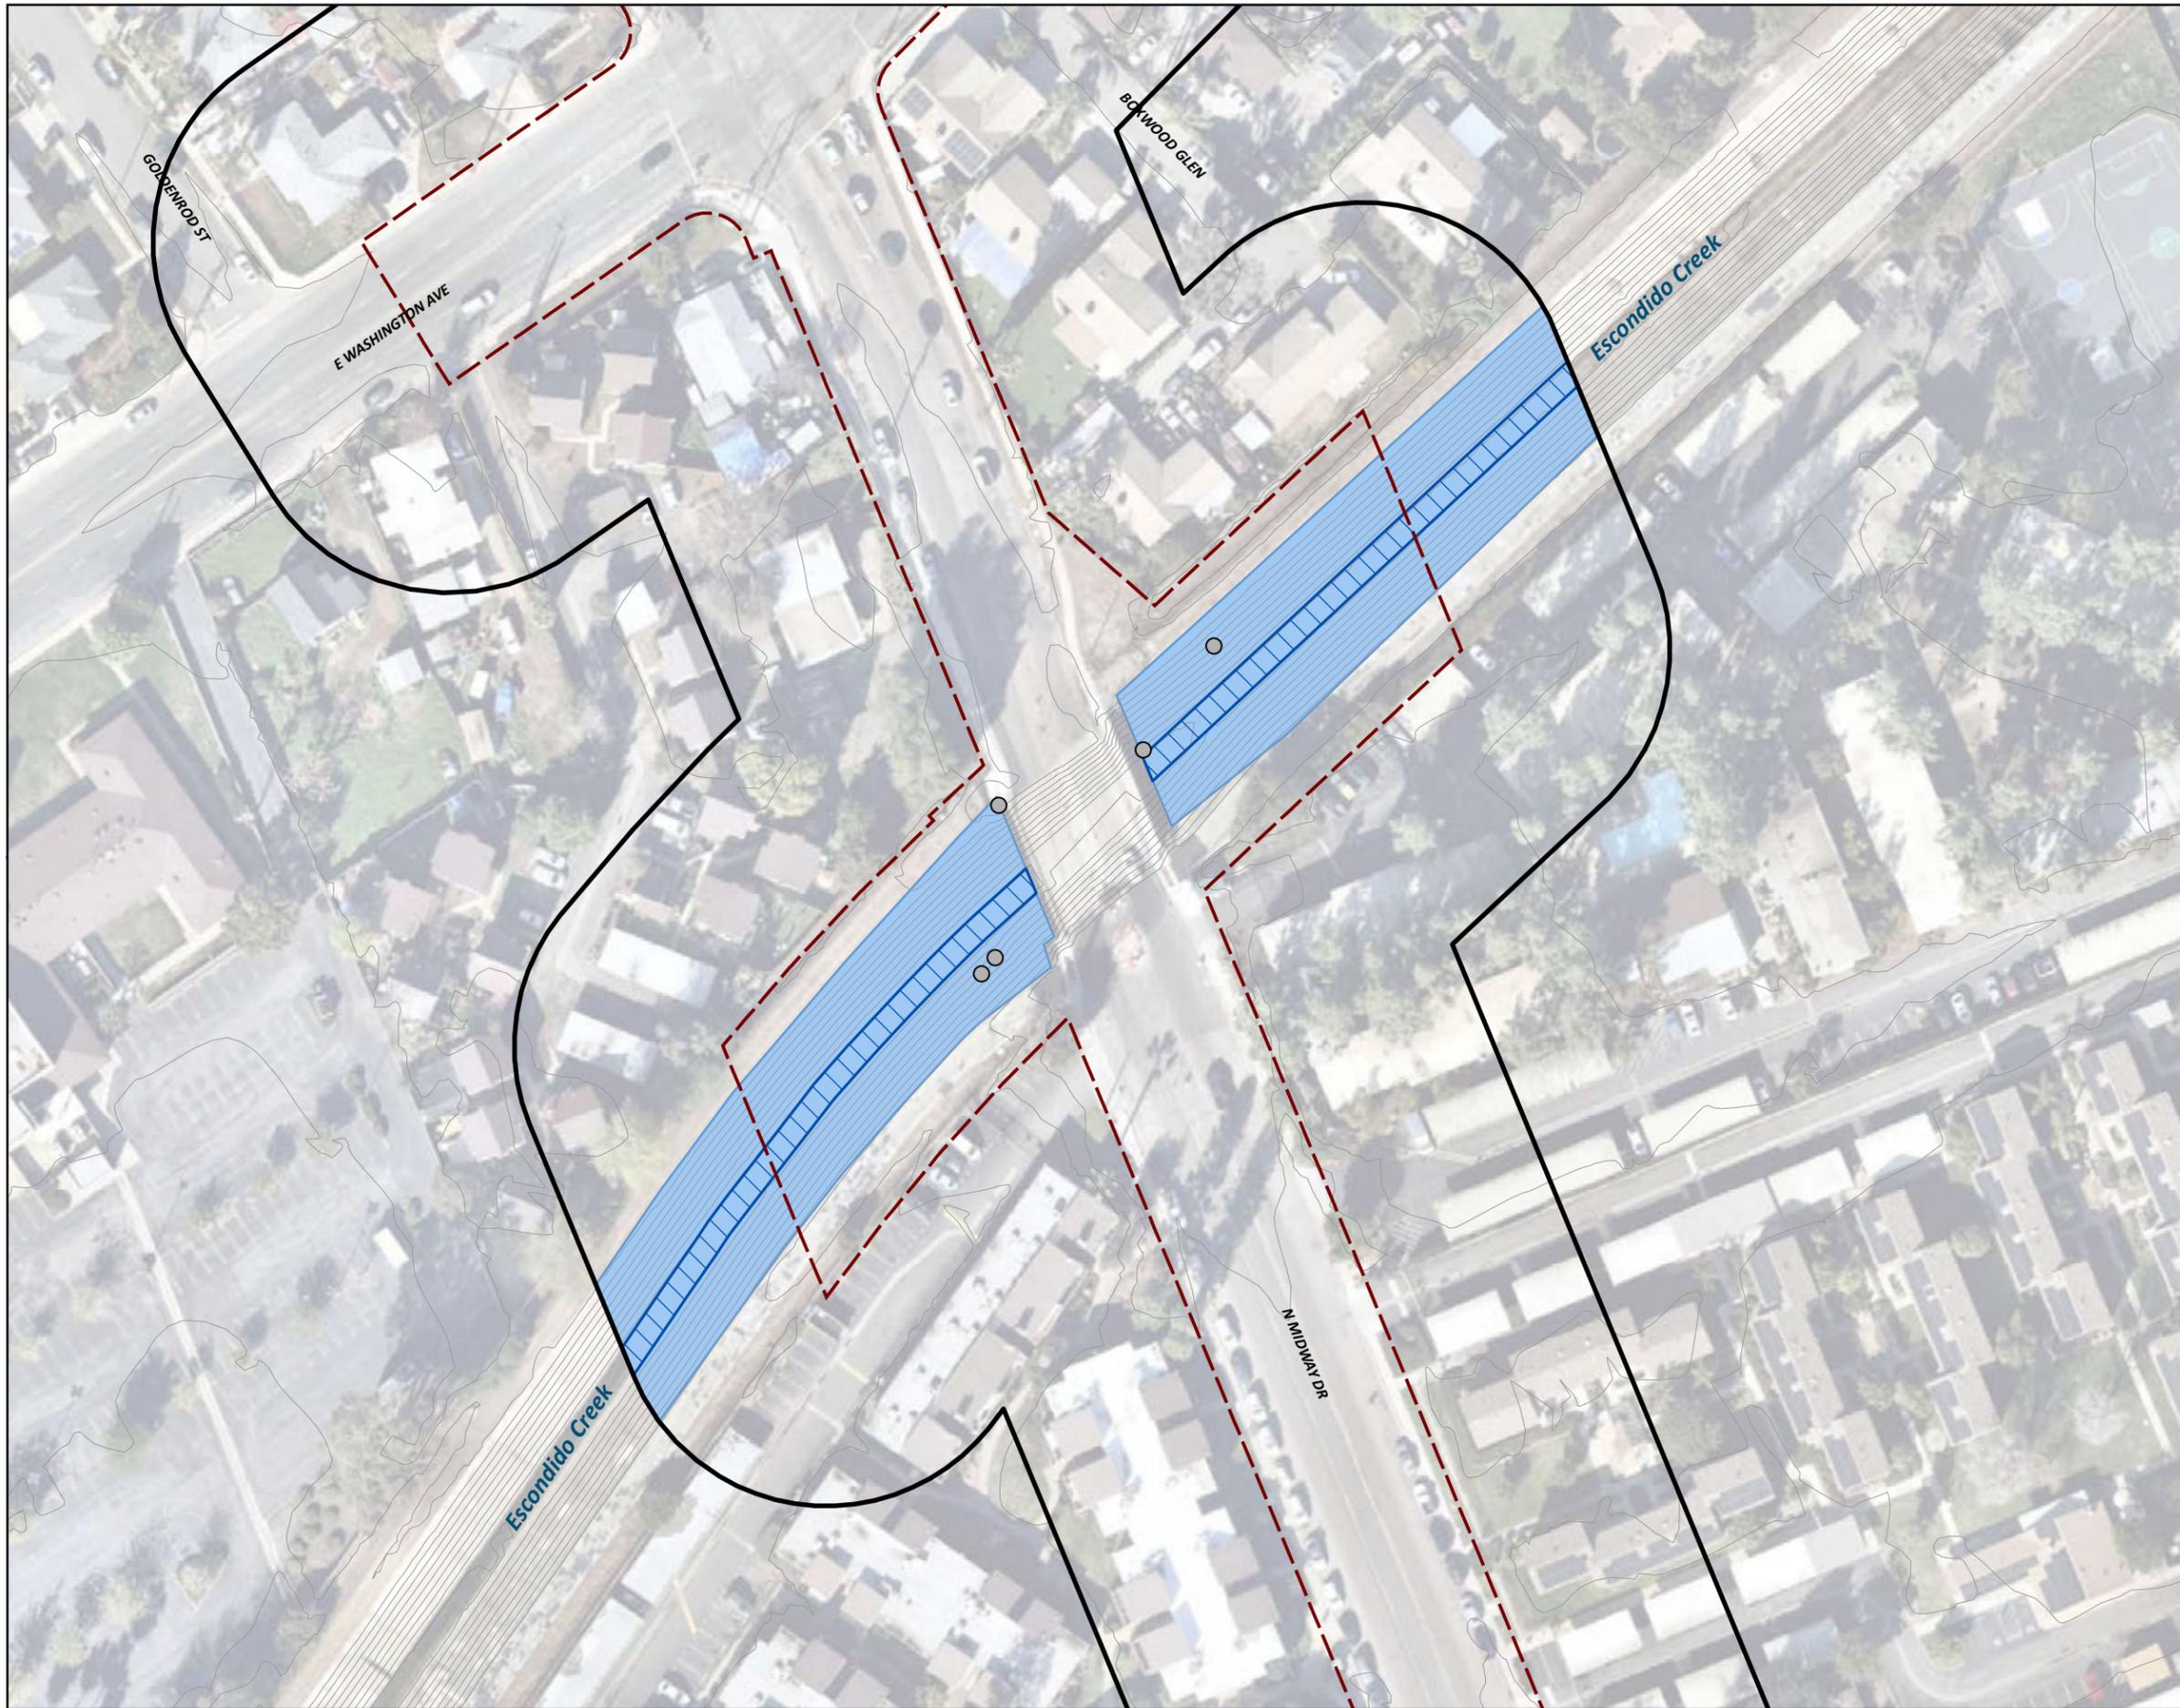
Figure 6 - Page 3 of 7
Aquatic Resources

- Survey Area
- Project Impacts
- Culvert
- Topographic Contour (2-foot Interval)
- Corps/RWQCB Aquatic Resources**
- Non-wetland Waters
- CDFW Streambed**
- Concrete-lined Channel

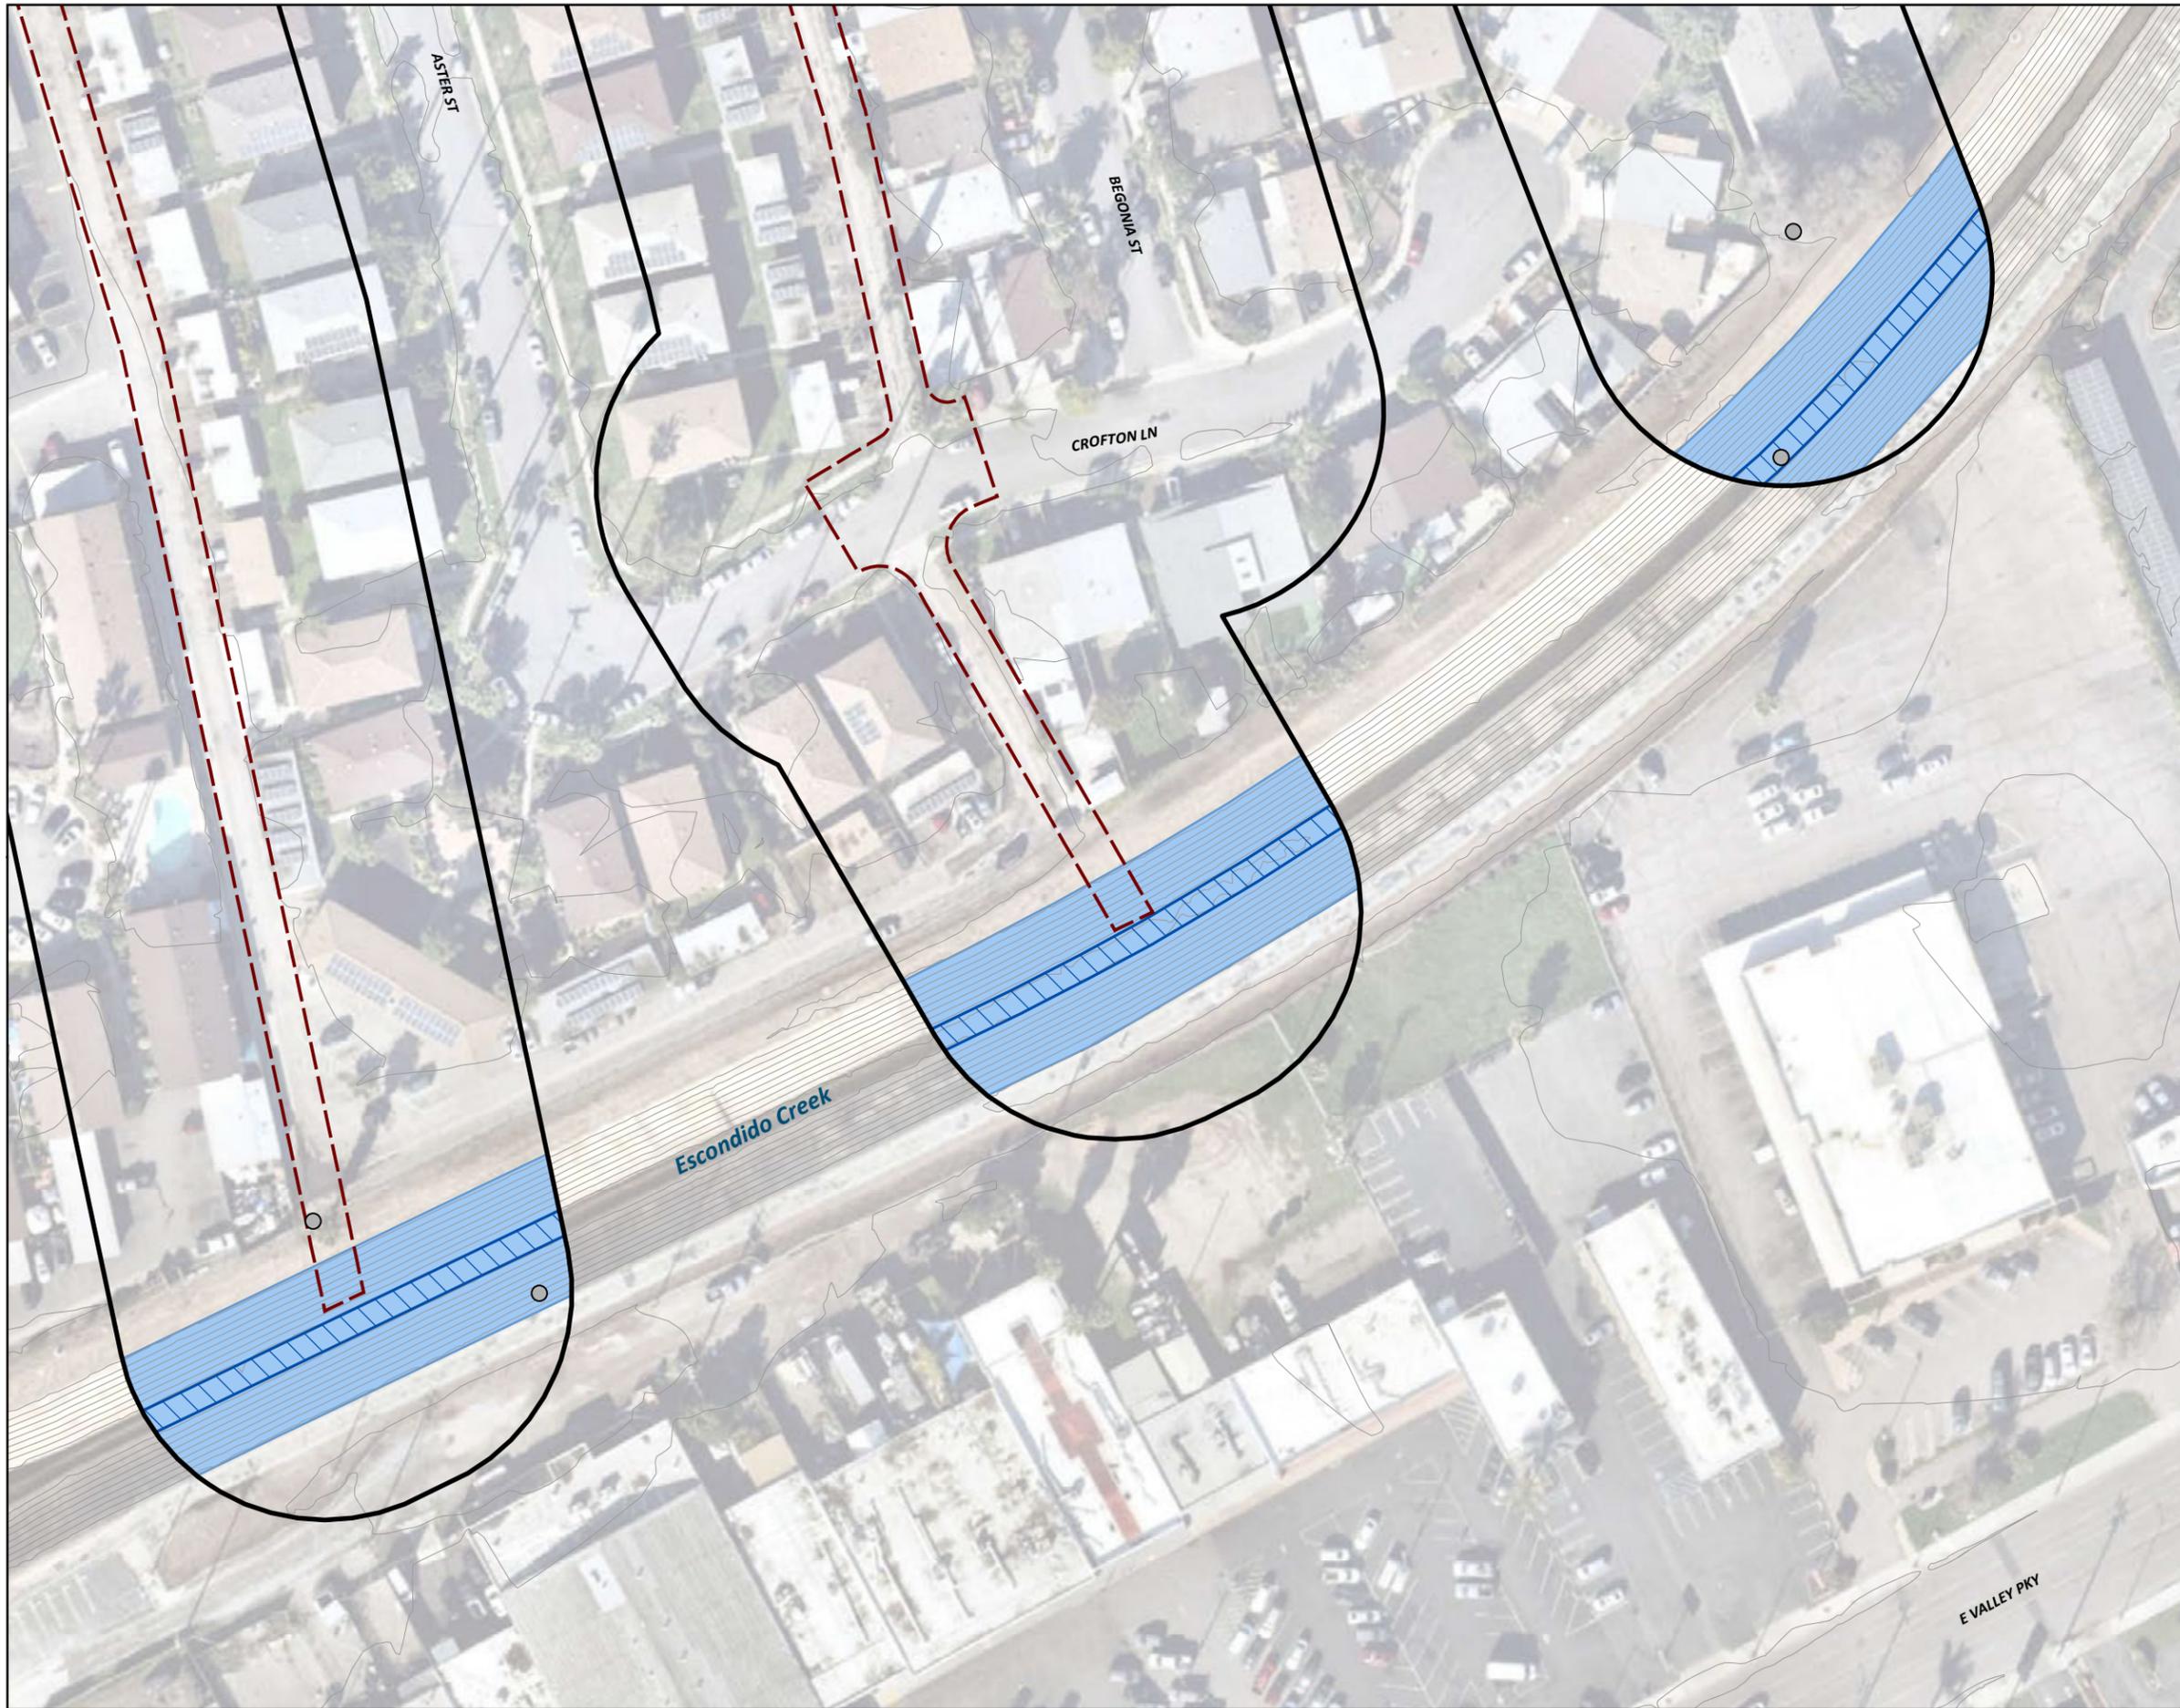
Figure 6 - Page 4 of 7
Aquatic Resources

- Survey Area
- Project Impacts
- Culvert
- Topographic Contour (2-foot Interval)
- Corps/RWQCB Aquatic Resources**
- Non-wetland Waters
- CDFW Streambed**
- Concrete-lined Channel

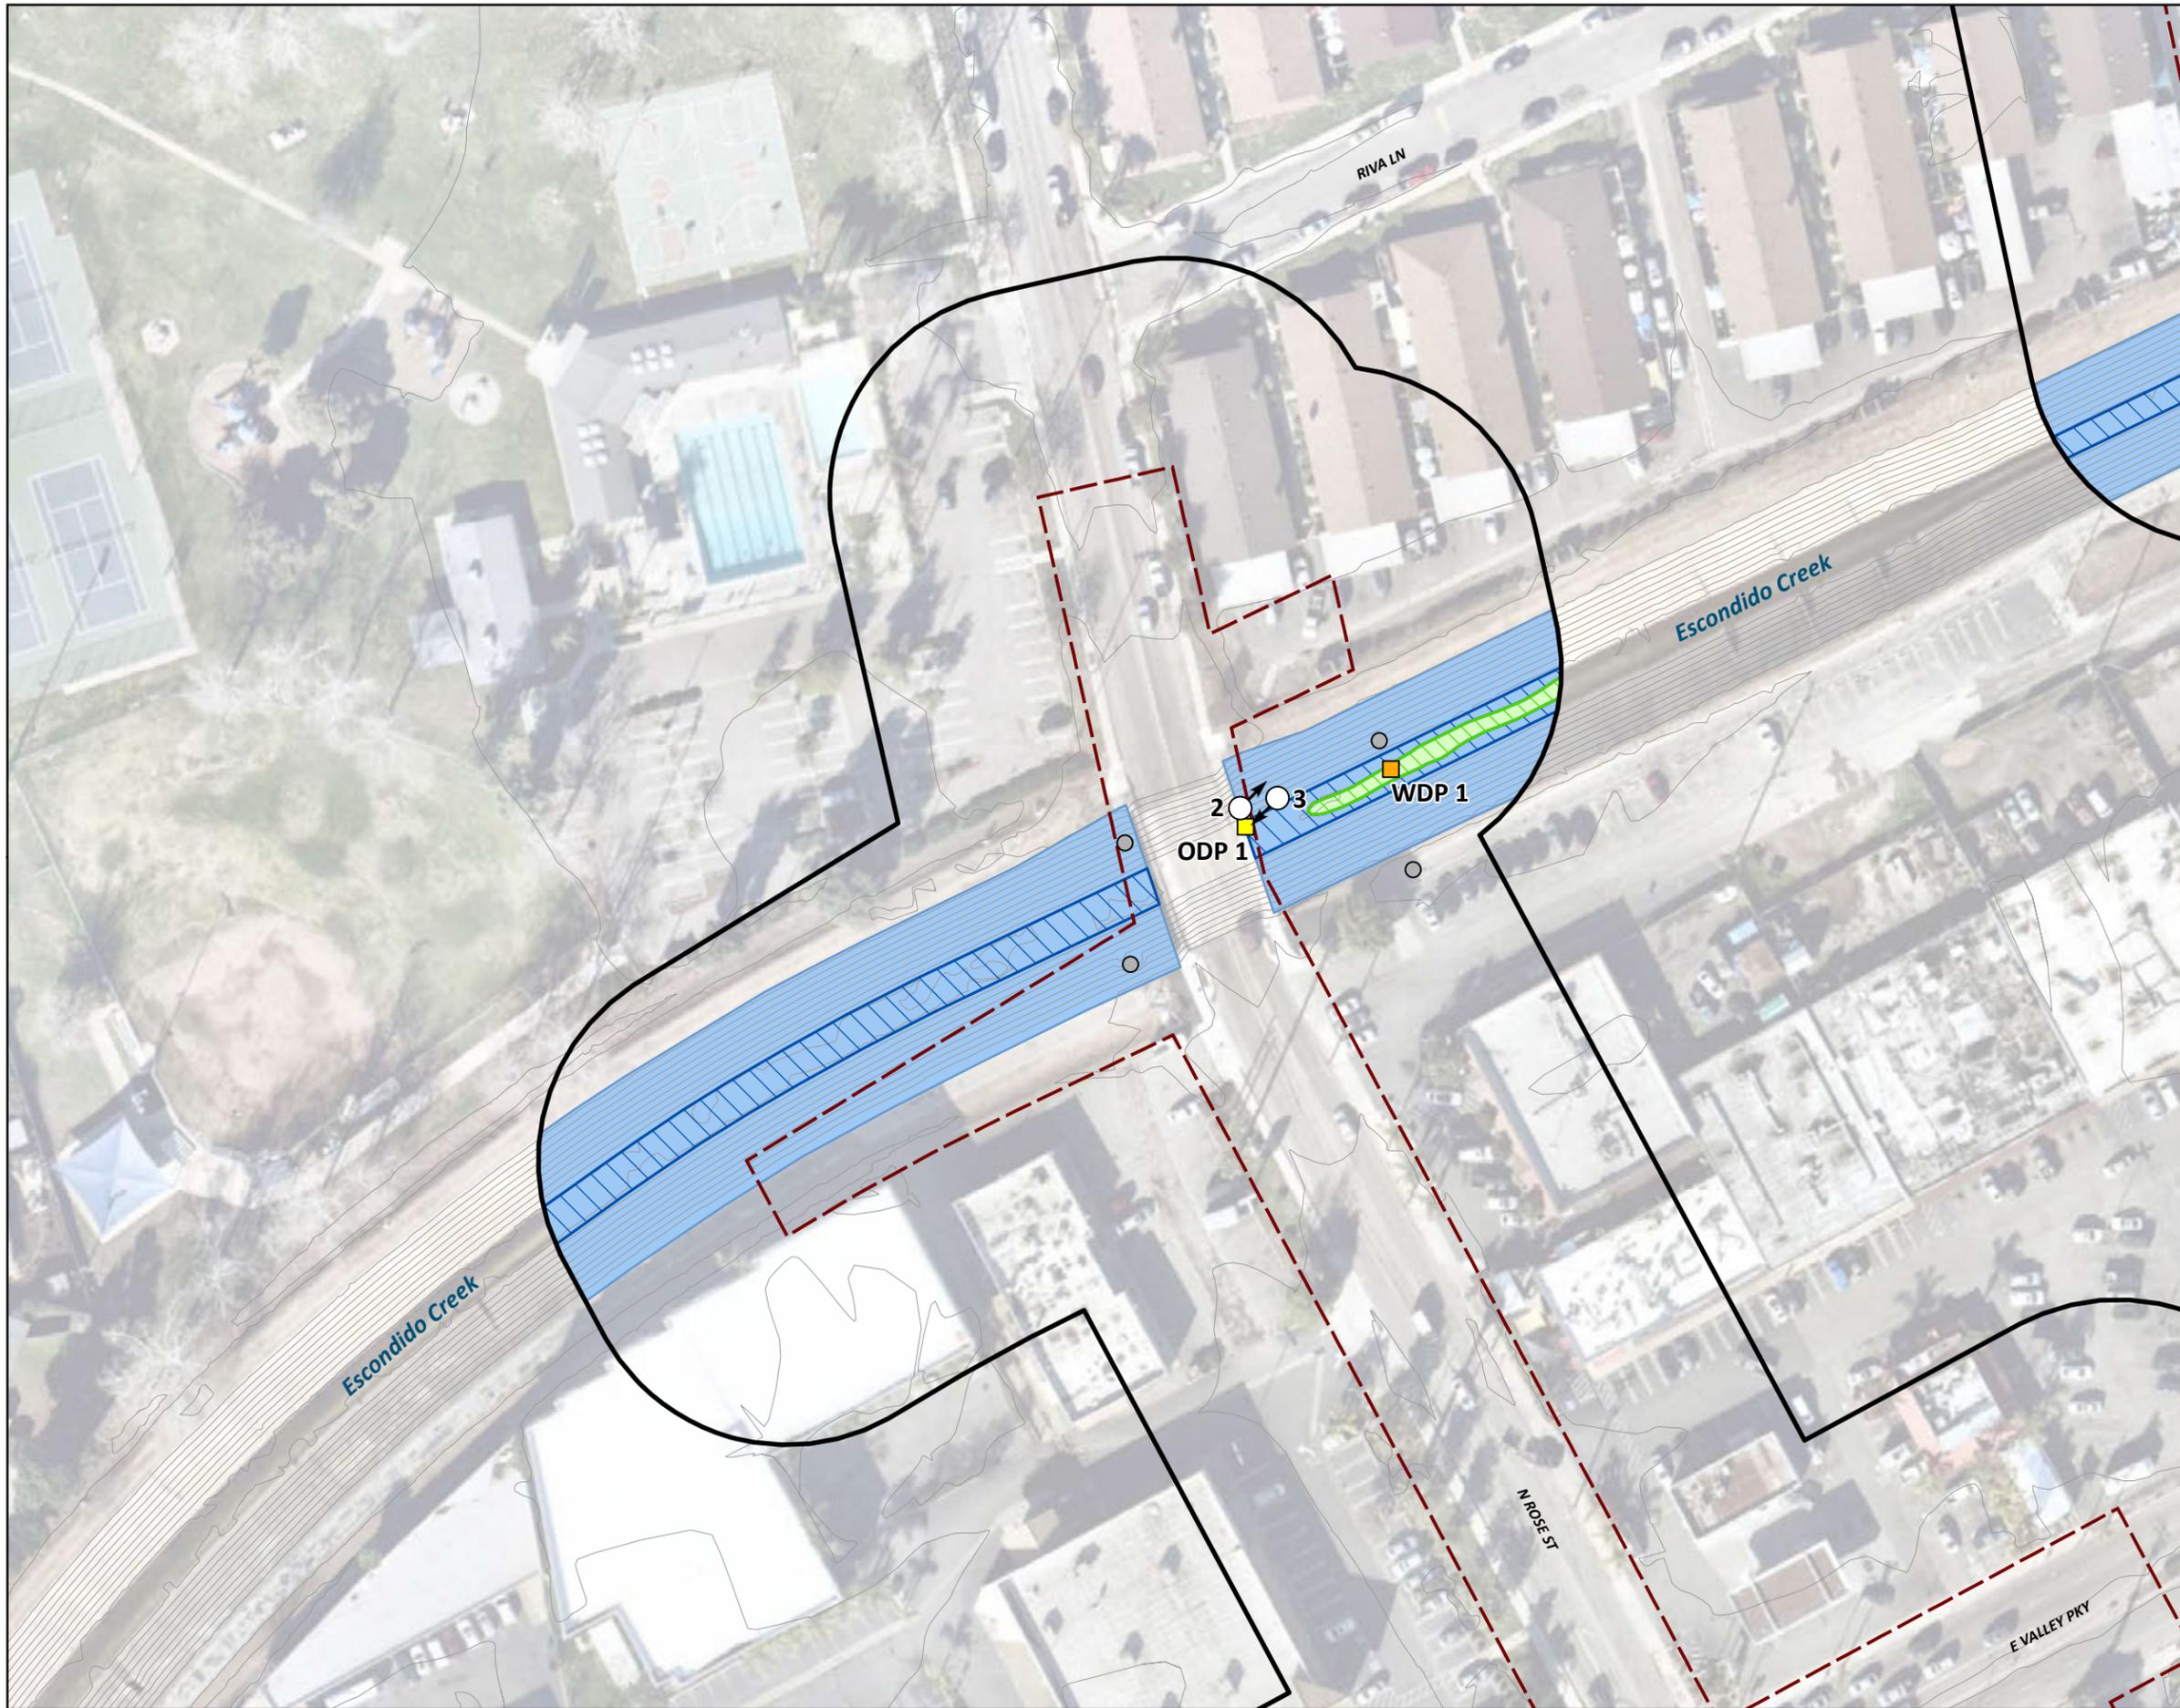
Figure 6 - Page 5 of 7
Aquatic Resources

- Survey Area
- Project Impacts
- Photo Location
- OHWM Datasheet Point (ODP)
- Wetland Data Form Point (WDP)
- Culvert
- Topographic Contour (2-foot Interval)
- Corps/RWQCB Aquatic Resources**
- Non-Wetland Waters - Federal Wetland (Three parameter wetland within OHWM)
- Non-wetland Waters
- CDFW Streambed**
- Freshwater Marsh
- Concrete-lined Channel

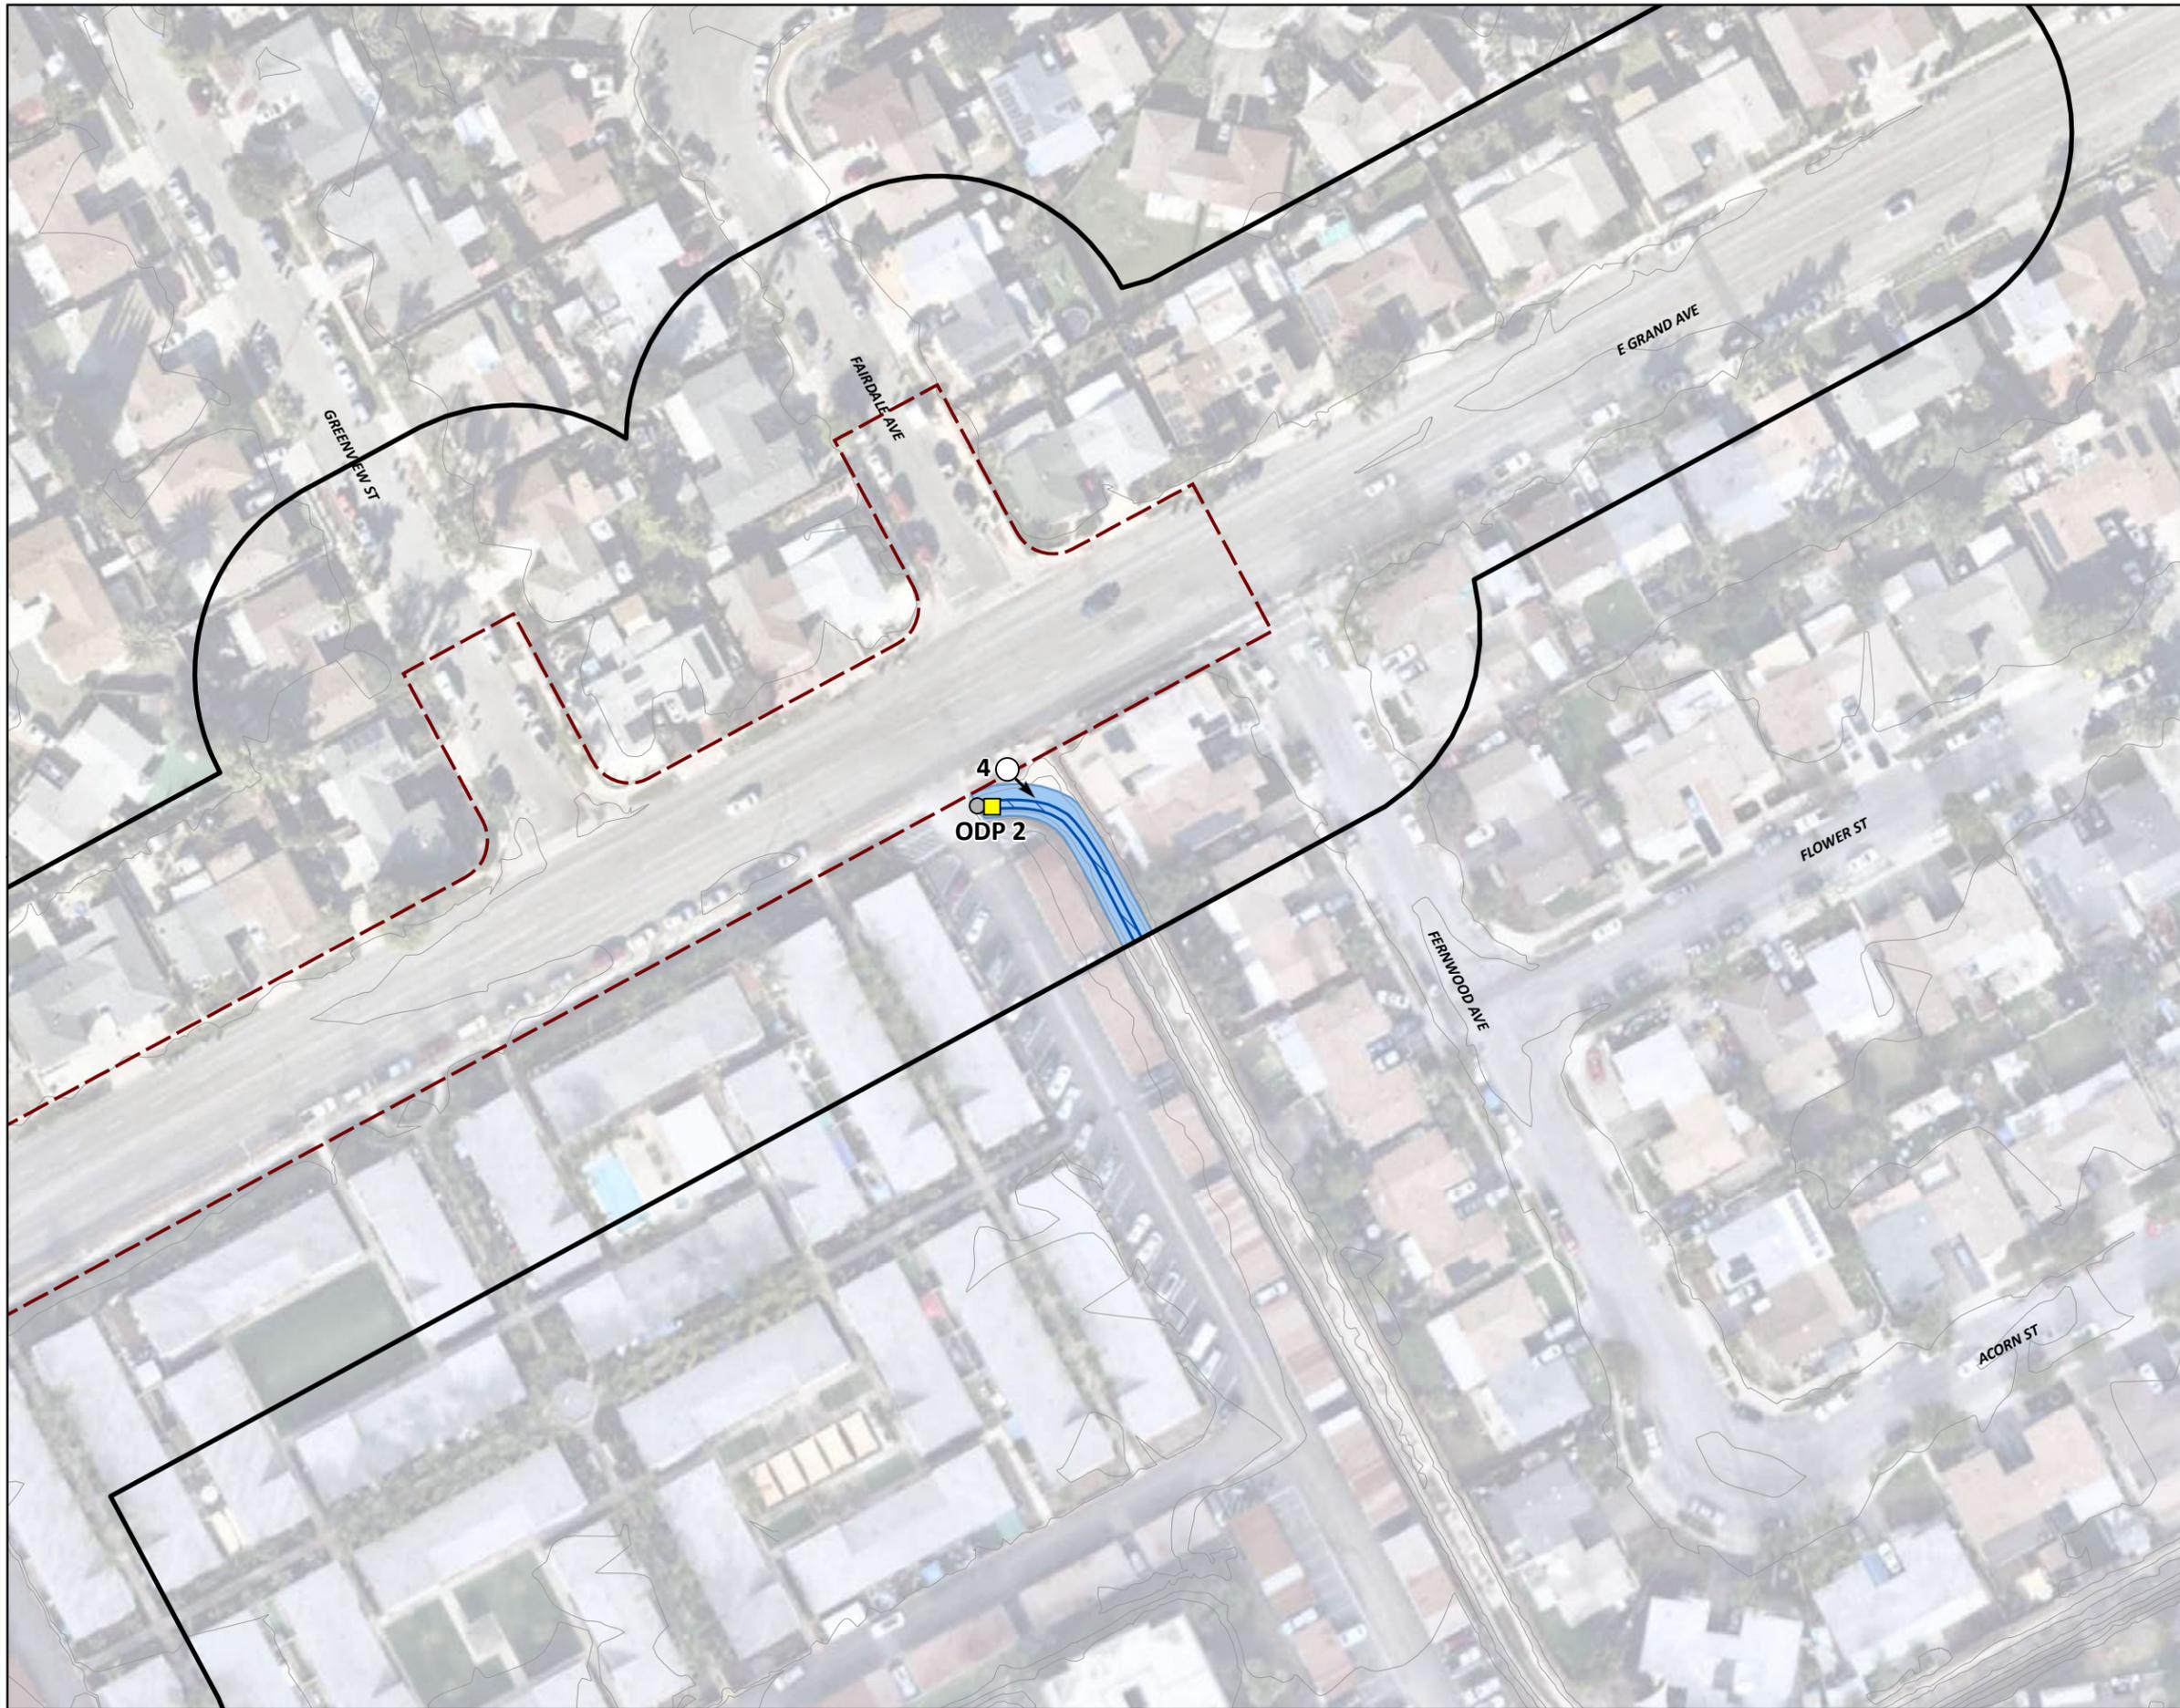
Figure 6 - Page 6 of 7
Aquatic Resources

- Survey Area
- Project Impacts
- Photo Location
- OHWM Datasheet Point (ODP)
- Culvert
- Topographic Contour (2-foot Interval)
- Corps/RWQCB Aquatic Resources**
- Non-wetland Waters
- CDFW Streambed**
- Concrete-lined Channel

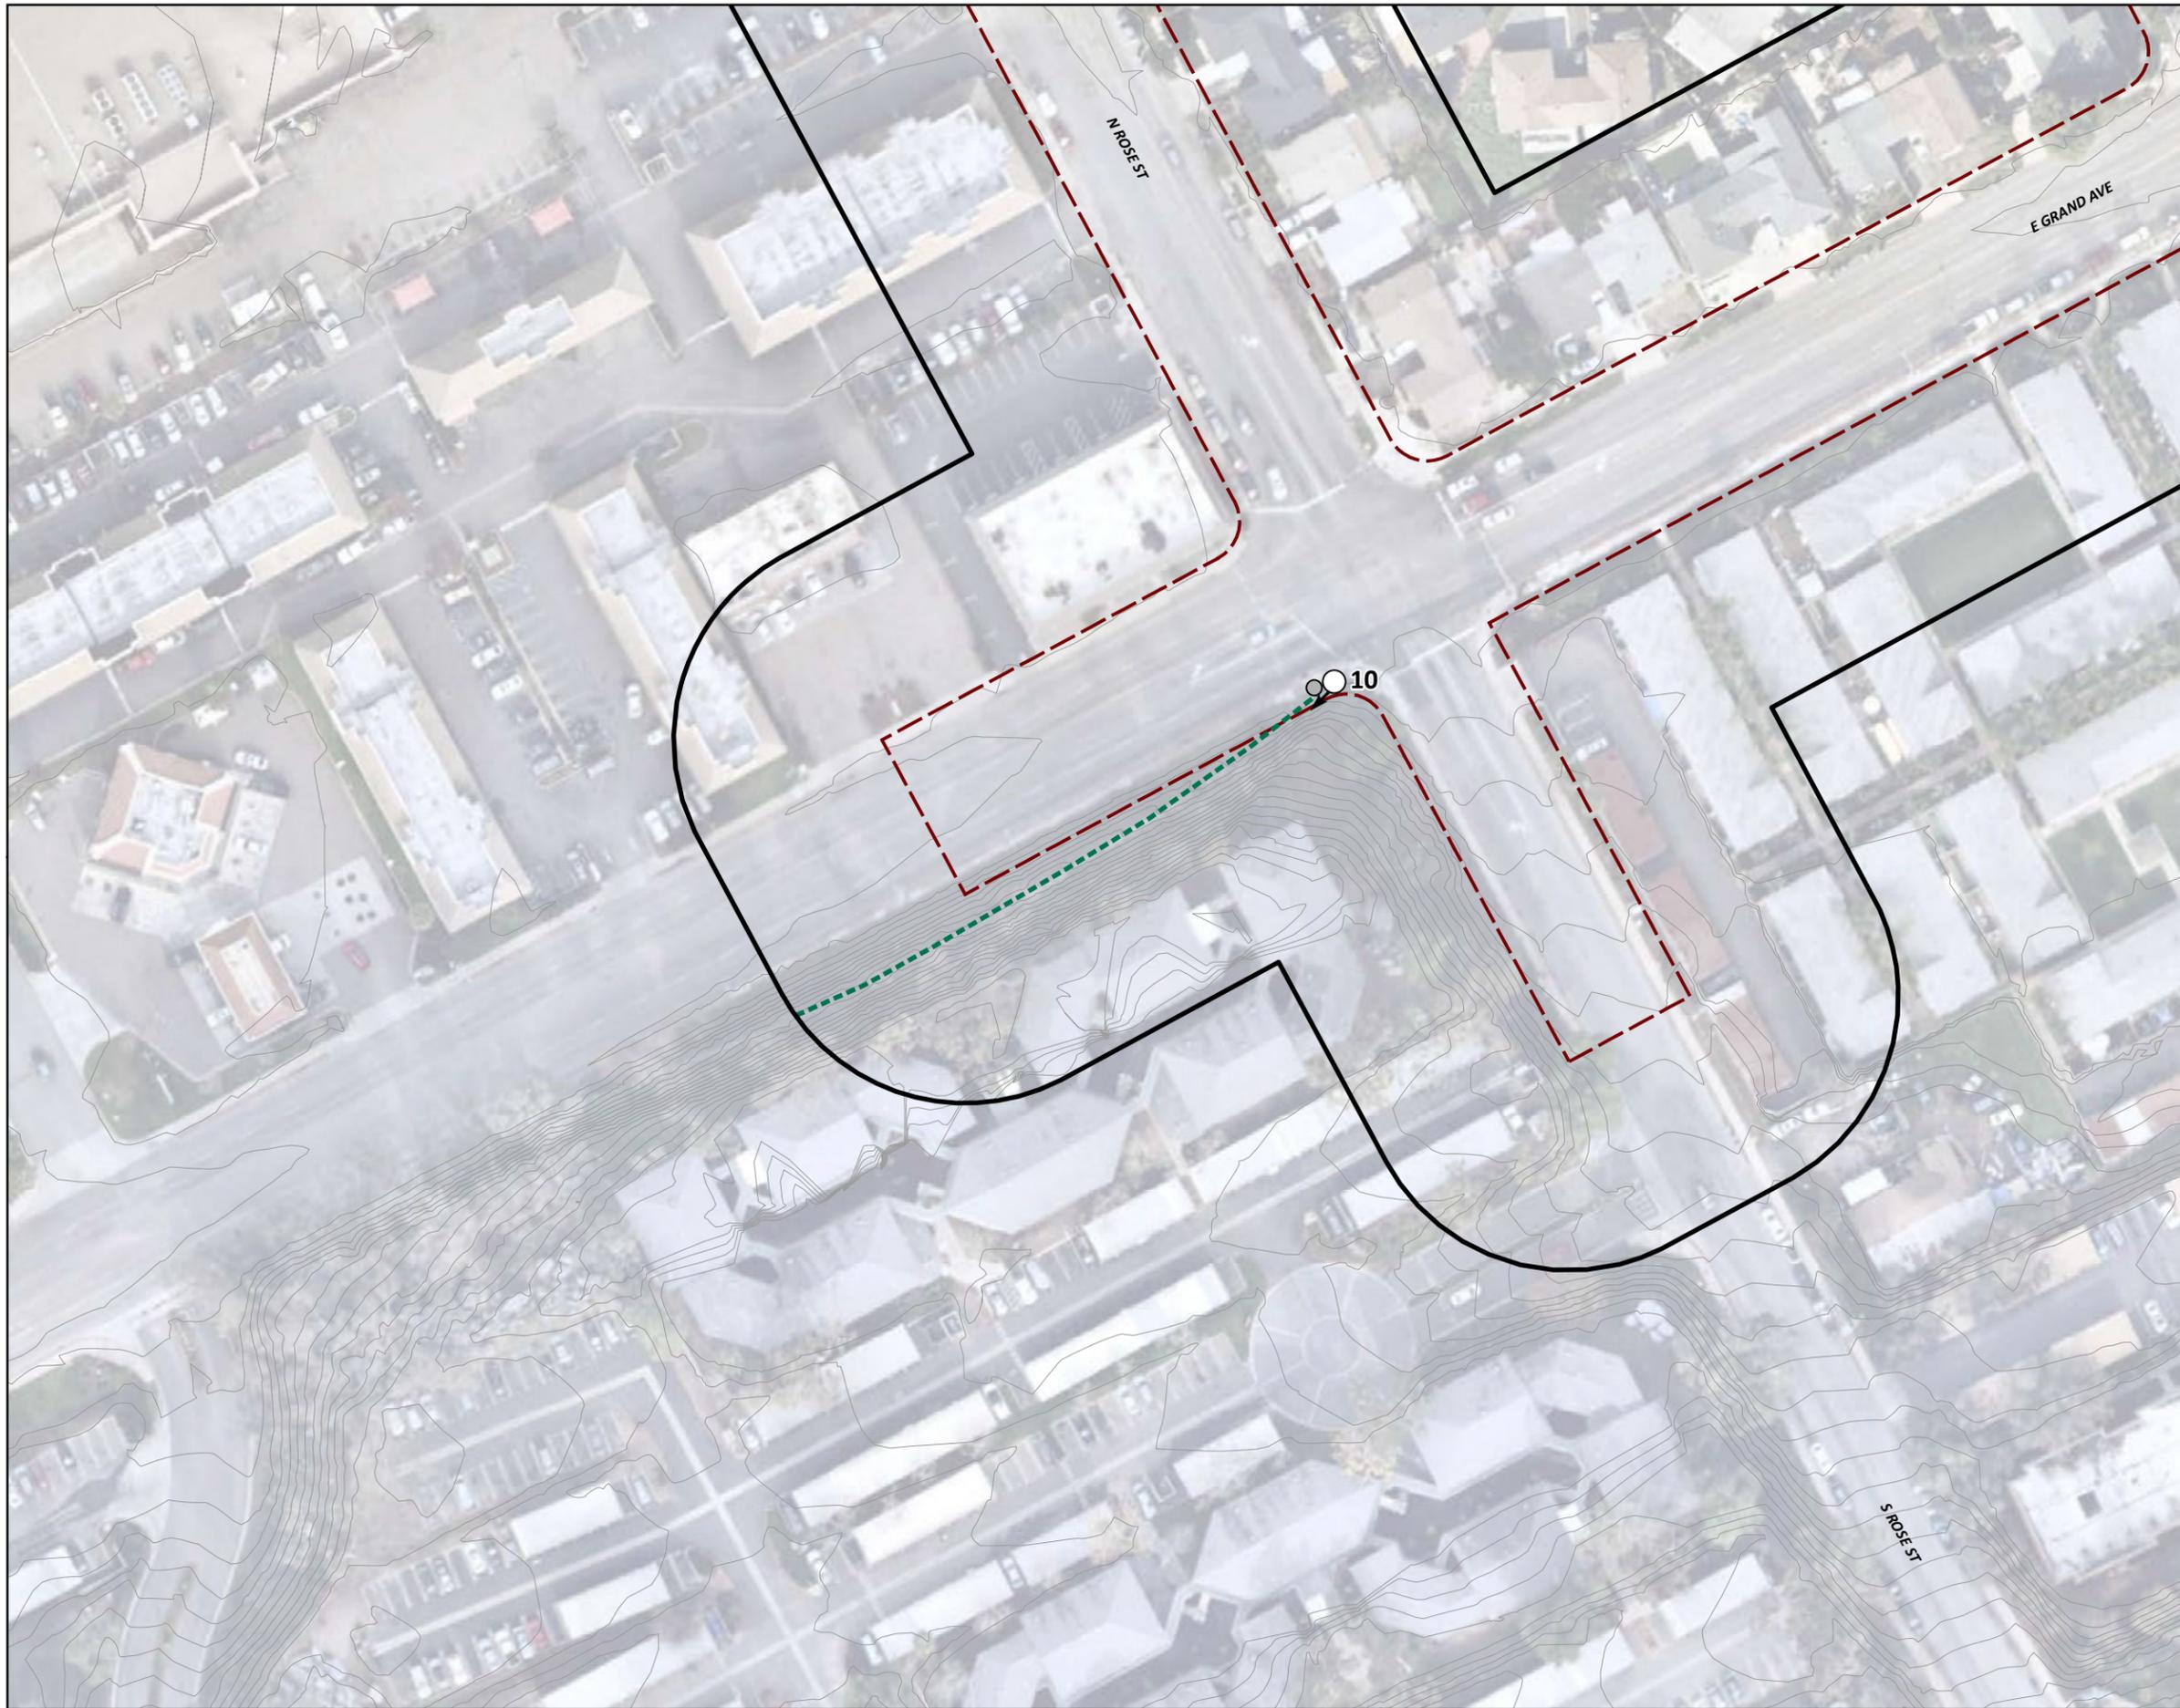
Figure 6 - Page 7 of 7

- Survey Area
 - Project Impacts
 - Photo Location
 - Culvert
 - Topographic Contour (2-foot Interval)
- Non-Jurisdictional Features**
- Brow Ditch

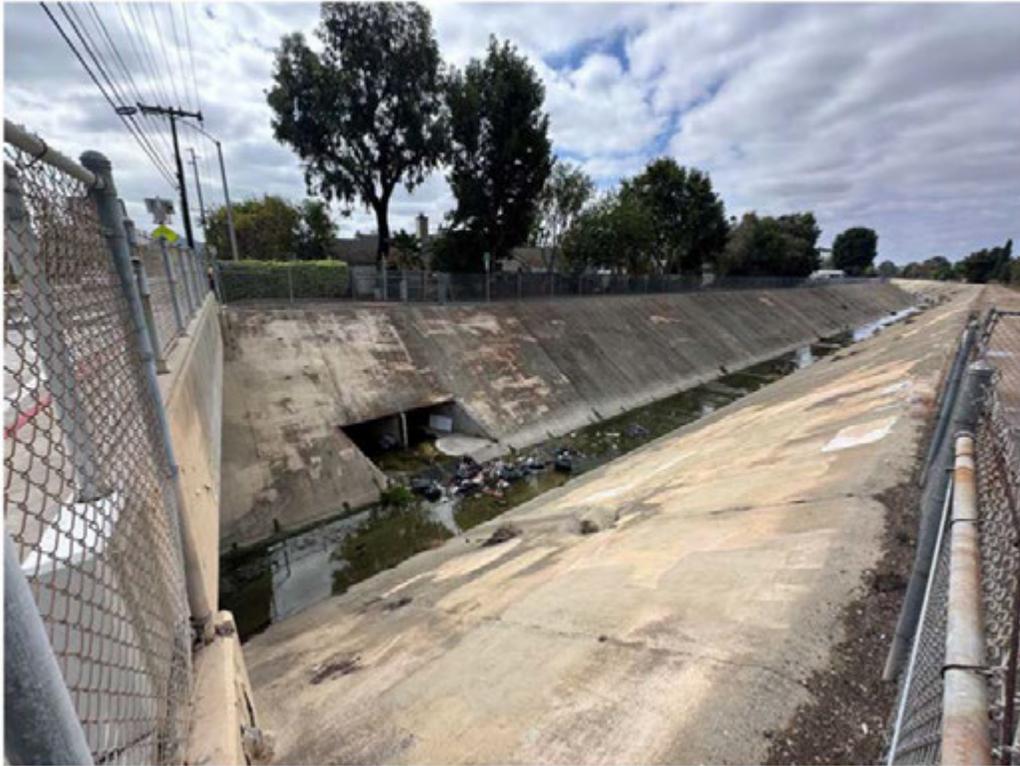
Photo 1: View facing northeast across the Escondido Creek channel at the North Citrus Avenue crossing. Escondido Creek is a concrete-lined channel at this location that conveys perennial surface flows. Culvert outlets are visible at center.

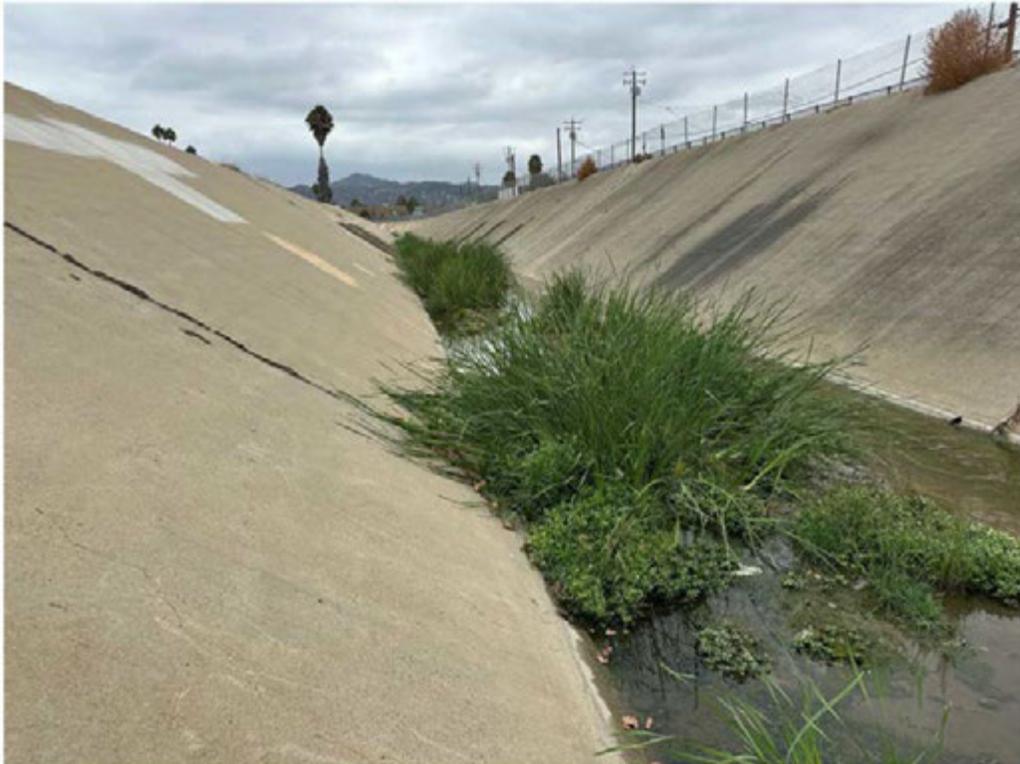
Photo 2: View facing east/upstream along the Escondido Creek channel at the North Rose Street crossing. Sediment deposits have allowed emergent freshwater marsh vegetation to persist. This is also the location of WDP-1.

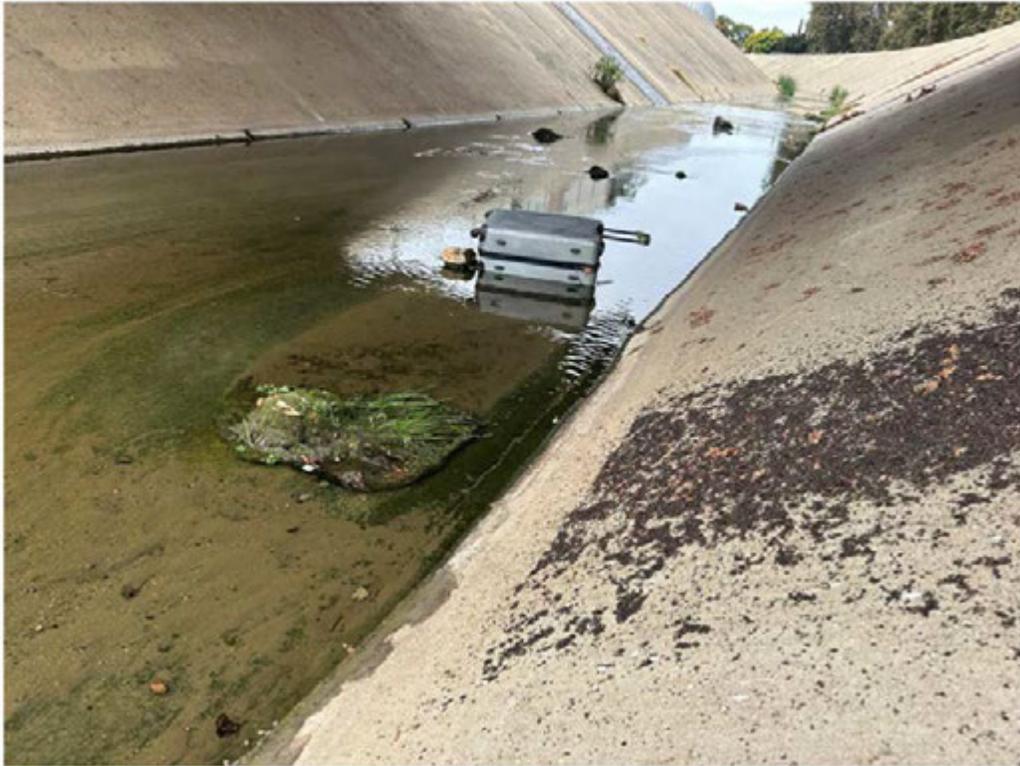
Photo 3: View facing southwest along the Escondido Creek channel showing debris (rodent scat) washed away and therefore indicating the location of the OHWM at location ODP-1. Water staining along the channel banks is also visible.

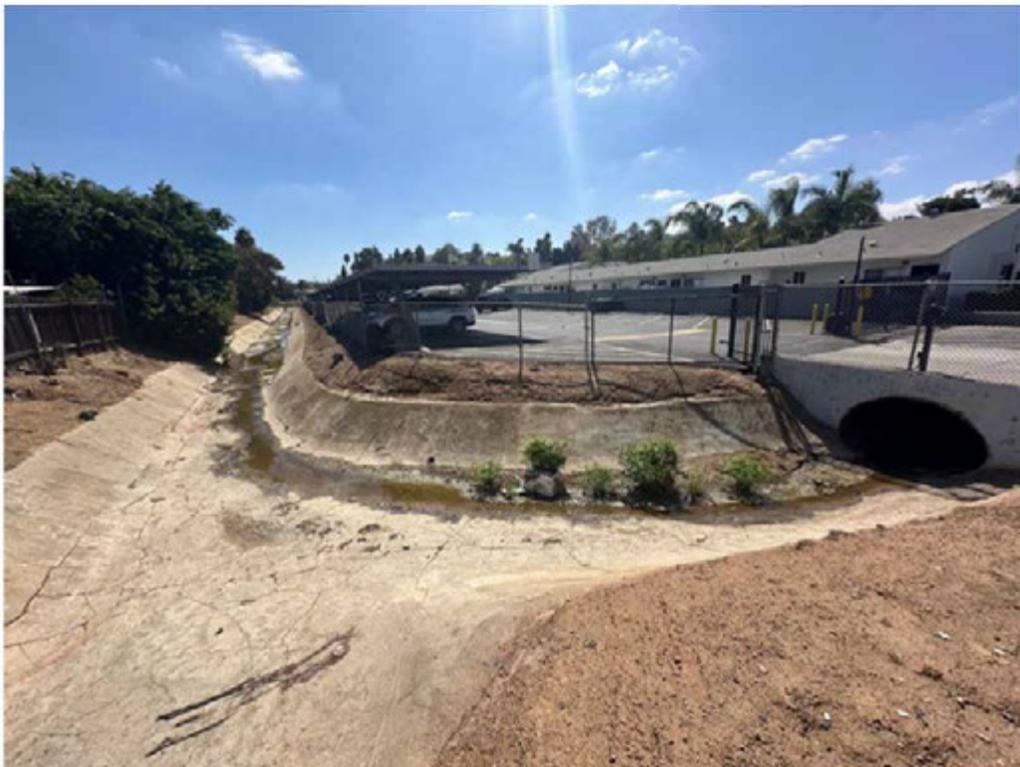
Photo 4: View facing south along the tributary channel at East Grand Avenue and location of ODP-2. This concrete-lined channel also supports intermittent flows and some hydrophytic vegetation (umbrella sedge) colonizing a sediment deposit.

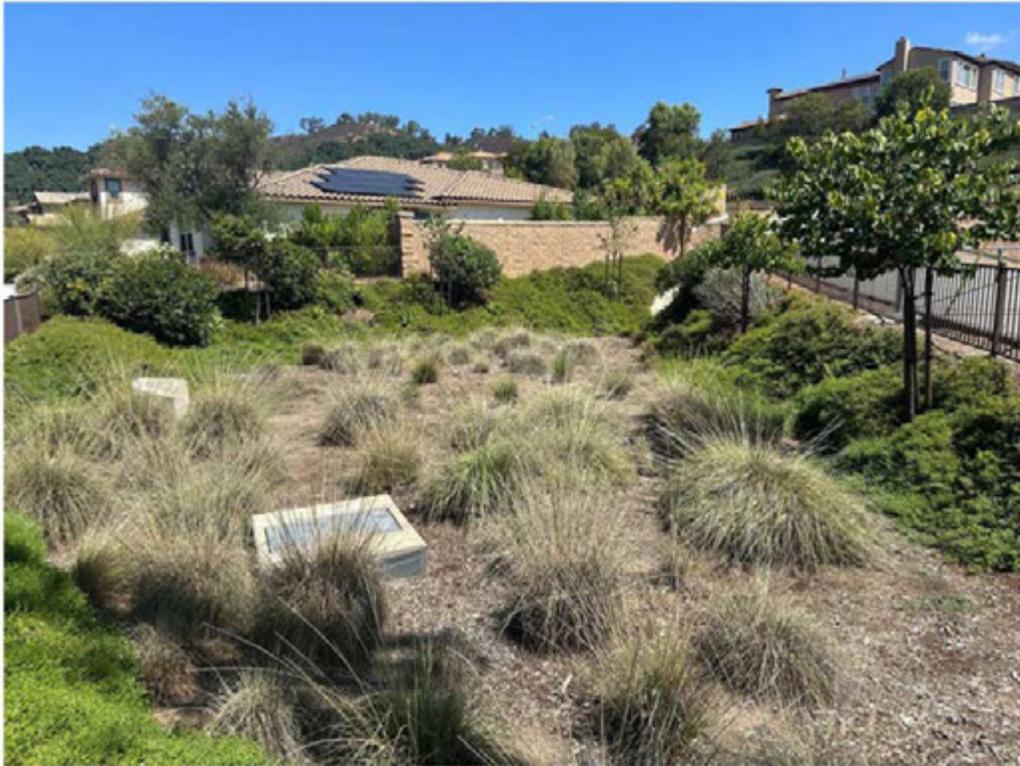
Photo 5: View facing northeast at detention basin/bio-swale located on the northeast side of intersection of El Norte Parkway and East Lincoln Avenue. Basin is landscaped with ornamentals and planted natives. A concrete brow ditch is just visible entering the basin at right.
