**Draft Biological Technical Report for the
East Valley Parkway and Midway Drive Drainage Improvement Project,
City of Escondido, California**

APPENDIX E
Photo Document

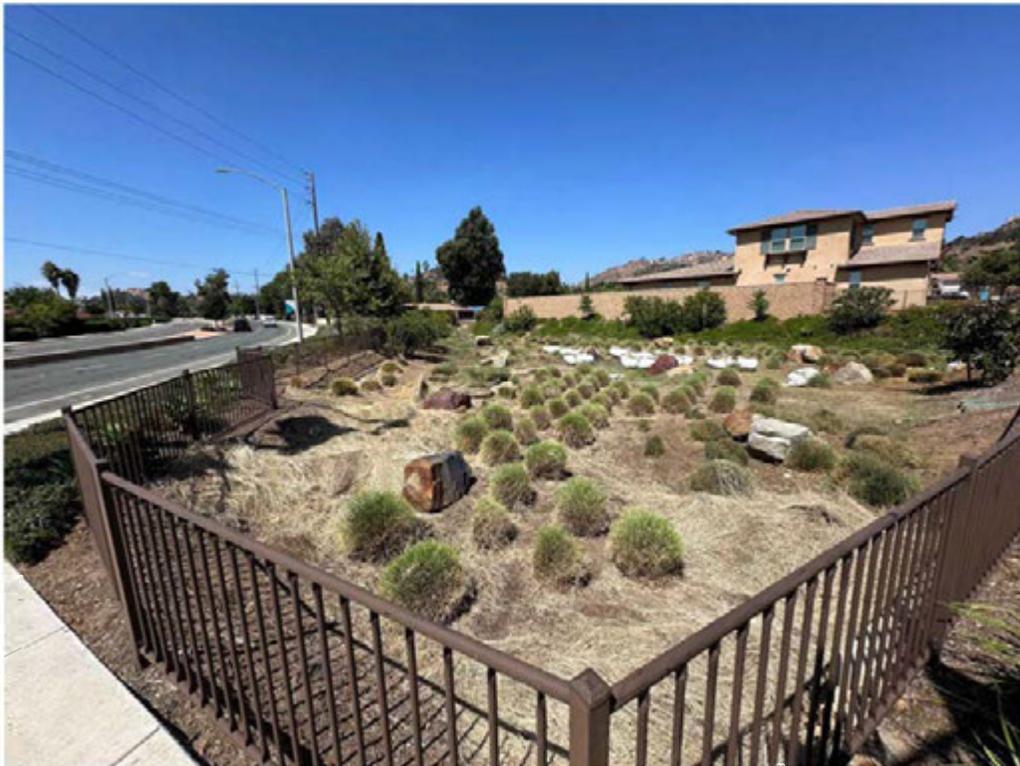
Photo 6: View facing west at second larger detention basin/bio-swale located on the northwest side of intersection of El Norte Parkway and East Lincoln Avenue. Basins is maintained and similarly landscaped as the other basin.

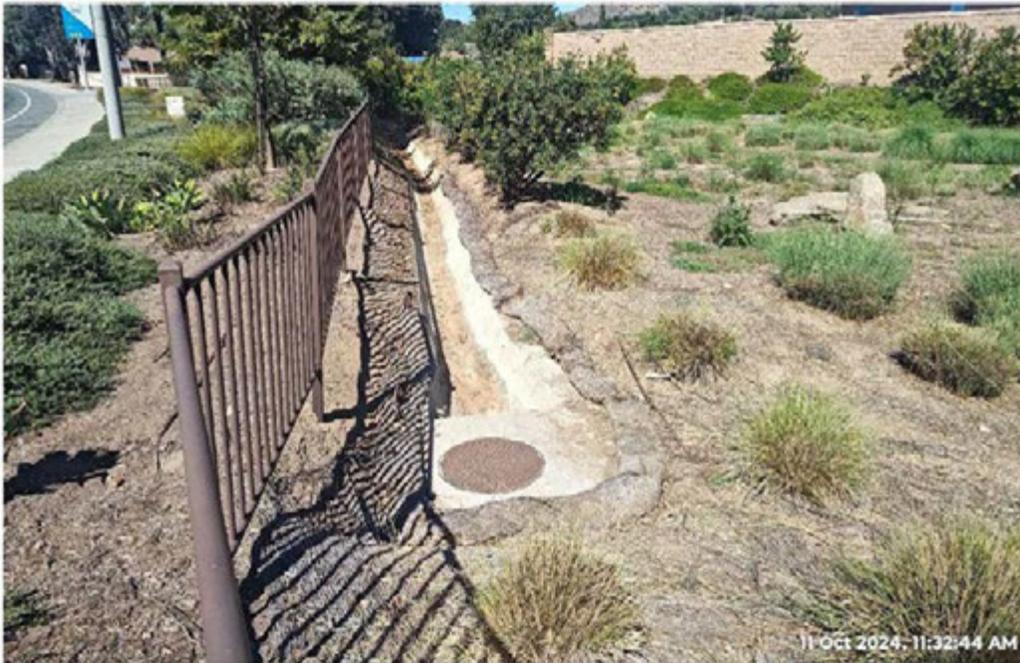
Photo 7: View facing northwest at concrete brow ditch entering a storm drain next to the large detention basin.

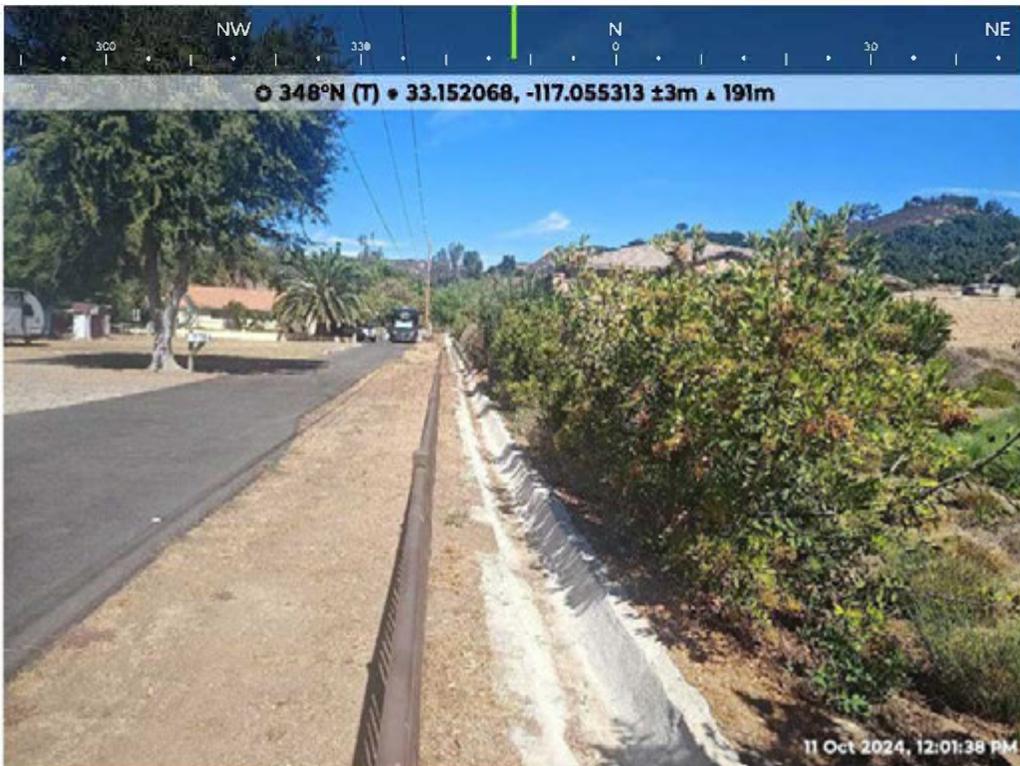
Photo 8: View facing north of concrete-lined brow ditch west of the large detention basin/bioswale.

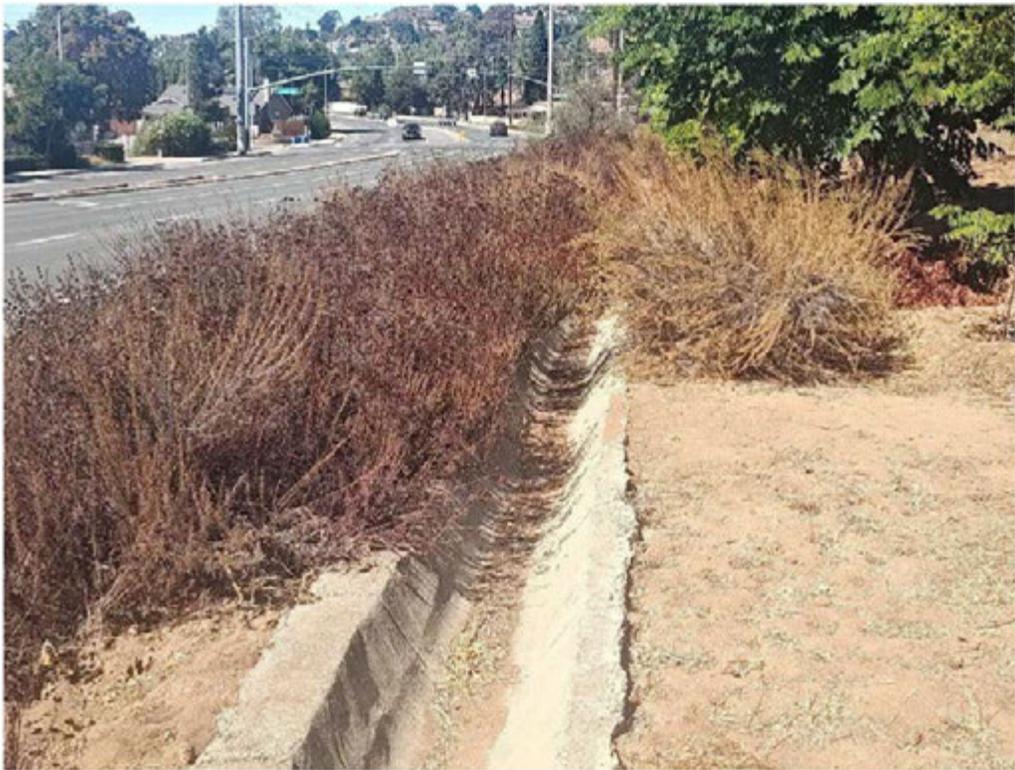
Photo 9: View facing northwest of concrete brow ditch located along edge of undeveloped lot and El Norte Parkway.

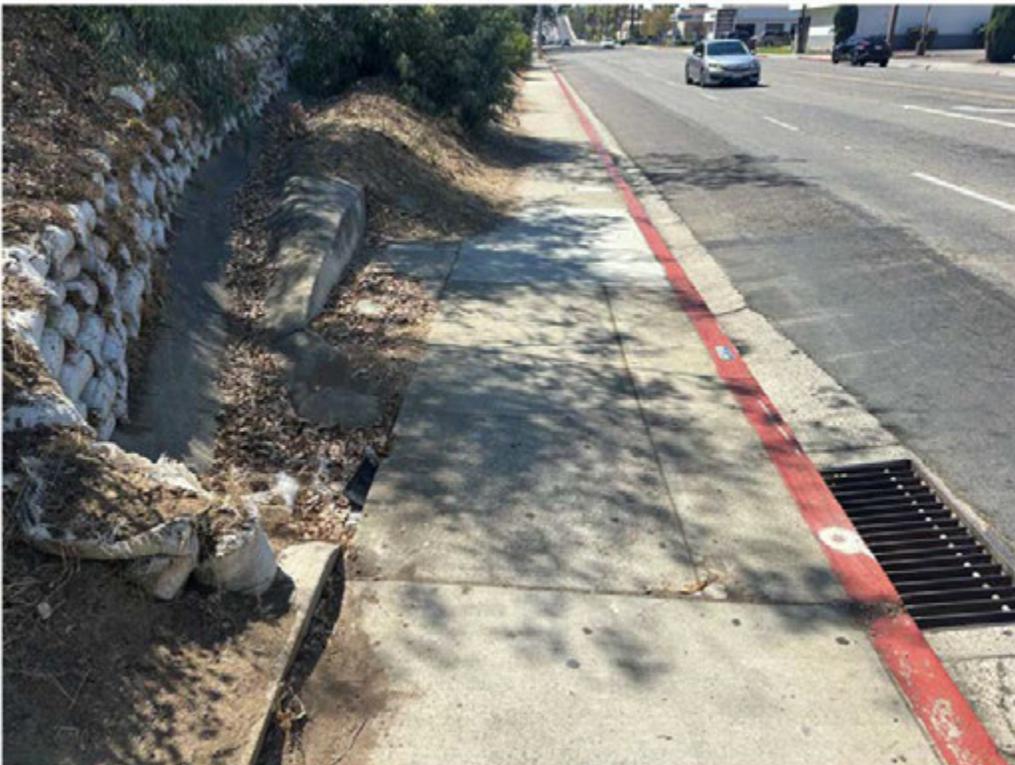
Photo 10: View facing southwest of concrete brow ditch (at left) entering culvert along East Grand Avenue.

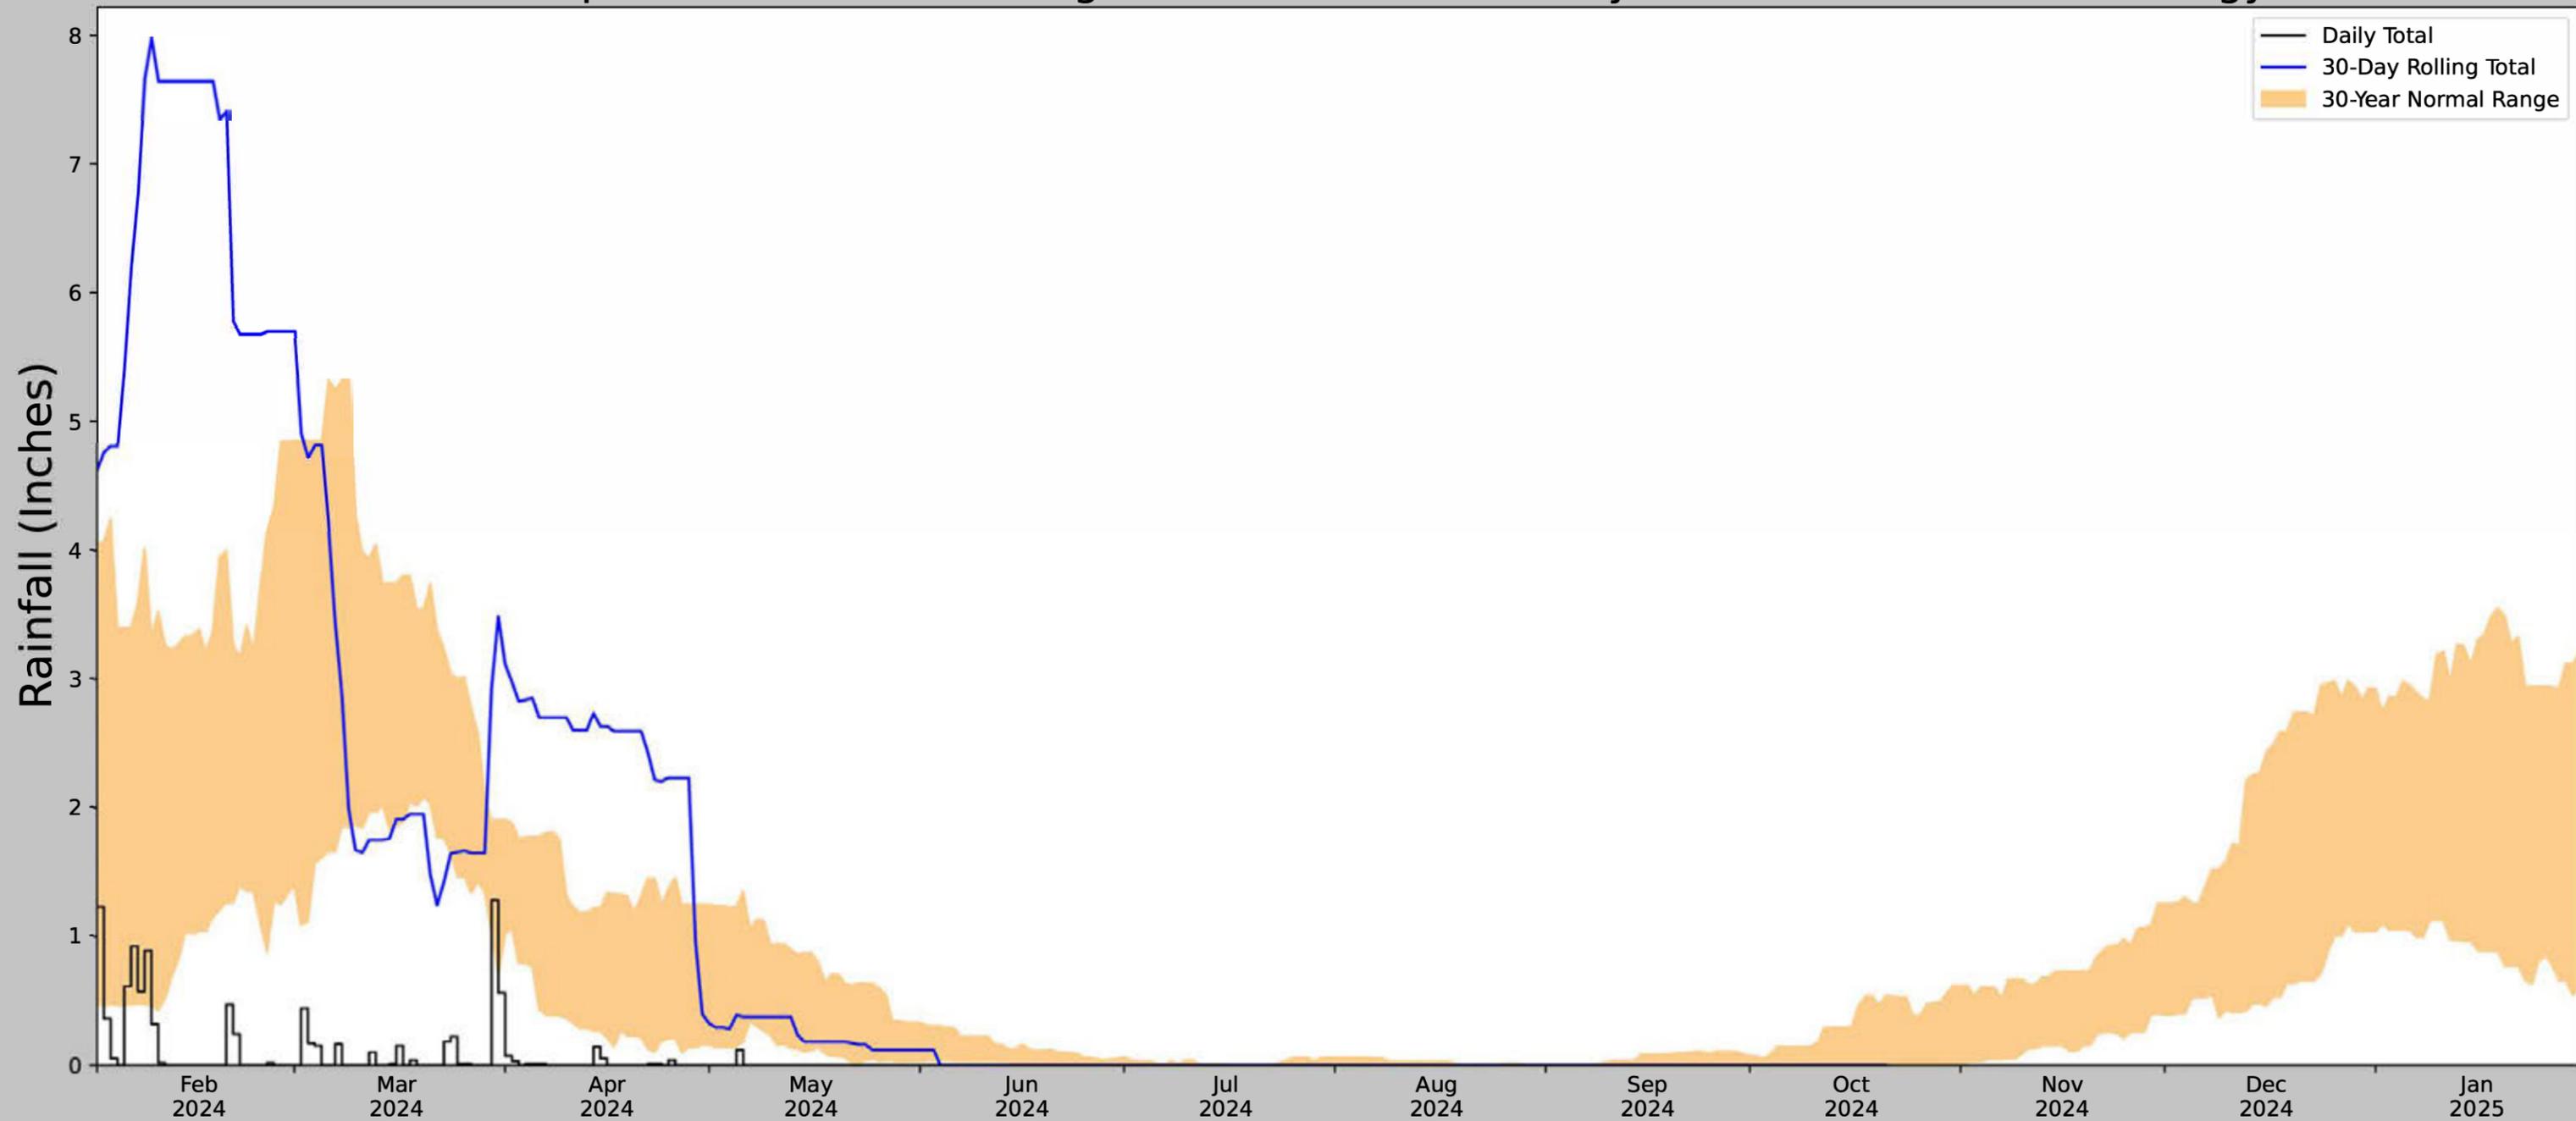
Coordinates	33.14048, -117.053393
Observation Date	2024-09-18
Elevation (ft)	673.869
Drought Index (PDSI)	Mild wetness (2024-08)
WebWIMP H ₂ O Balance	Dry Season

30 Days Ending	30 th %ile (in)	70 th %ile (in)	Observed (in)	Wetness Condition	Condition Value	Month Weight	Product
2024-09-18	0.0	0.079921	0.0	Normal	2	3	6
2024-08-19	0.0	0.005906	0.0	Normal	2	2	4
2024-07-20	0.0	0.003543	0.0	Normal	2	1	2
Result							Normal Conditions - 12

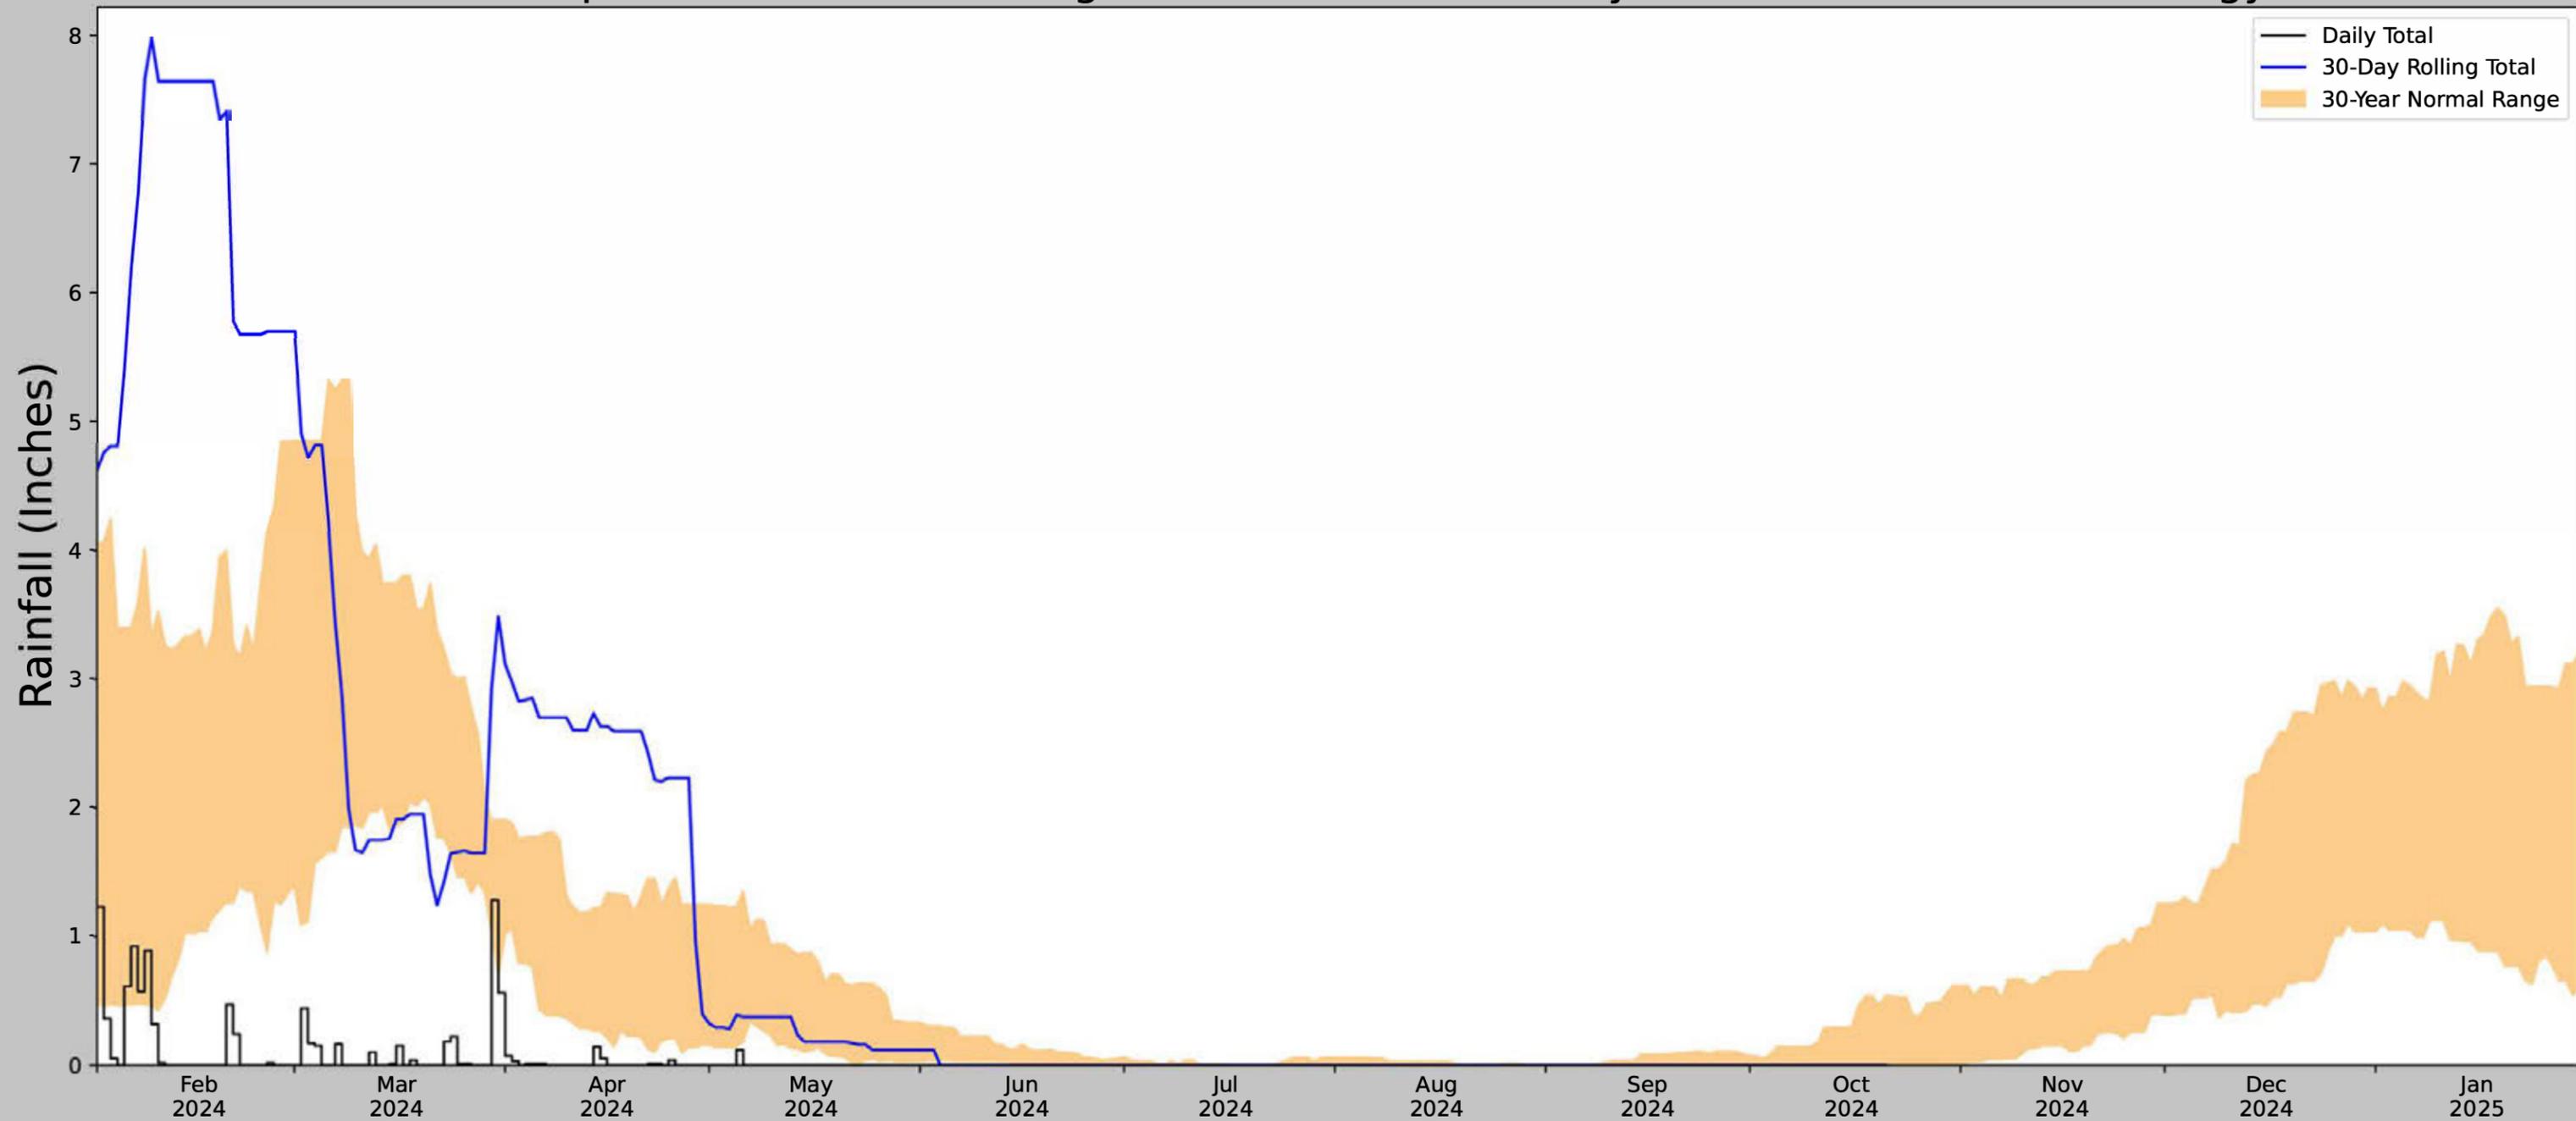
Coordinates	33.14155, -117.02338
Observation Date	2024-09-18
Elevation (ft)	673.869
Drought Index (PDSI)	Mild wetness (2024-08)
WebWIMP H ₂ O Balance	Dry Season

30 Days Ending	30 th %ile (in)	70 th %ile (in)	Observed (in)	Wetness Condition	Condition Value	Month Weight	Product
2024-09-18	0.0	0.079921	0.0	Normal	2	3	6
2024-08-19	0.0	0.005906	0.0	Normal	2	2	4
2024-07-20	0.0	0.003543	0.0	Normal	2	1	2
Result							Normal Conditions - 12

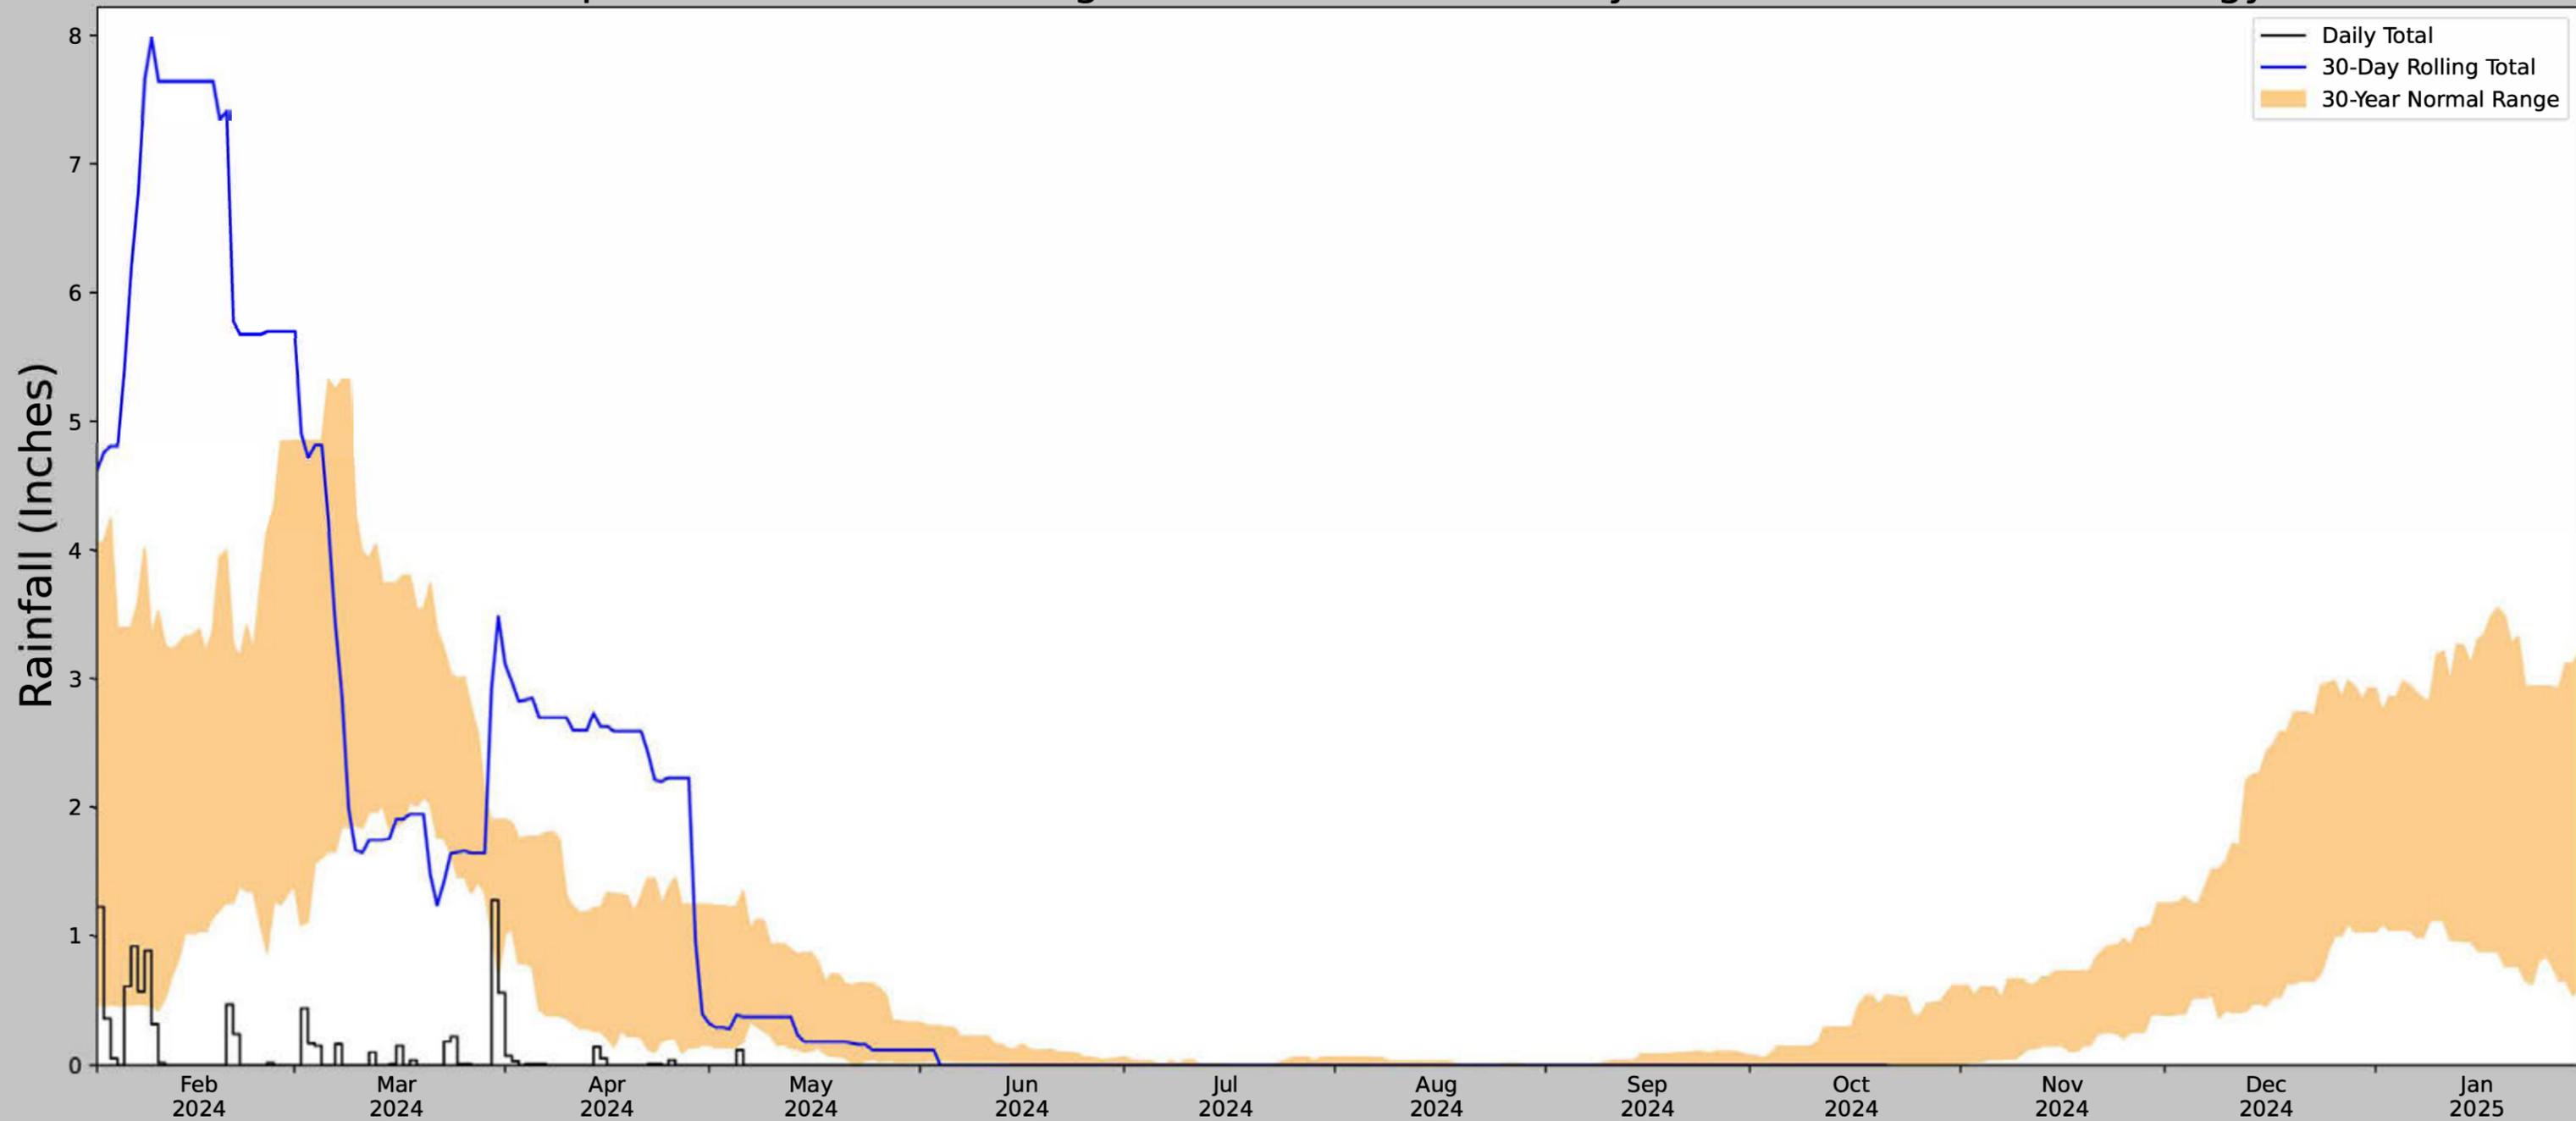
Coordinates	33.210632, -117.091881
Observation Date	2024-09-18
Elevation (ft)	1088.542723
Drought Index (PDSI)	Mild wetness (2024-08)
WebWIMP H ₂ O Balance	Dry Season

30 Days Ending	30 th %ile (in)	70 th %ile (in)	Observed (in)	Wetness Condition	Condition Value	Month Weight	Product
2024-09-18	0.0	0.079921	0.0	Normal	2	3	6
2024-08-19	0.0	0.005906	0.0	Normal	2	2	4
2024-07-20	0.0	0.003543	0.0	Normal	2	1	2
Result							Normal Conditions - 12

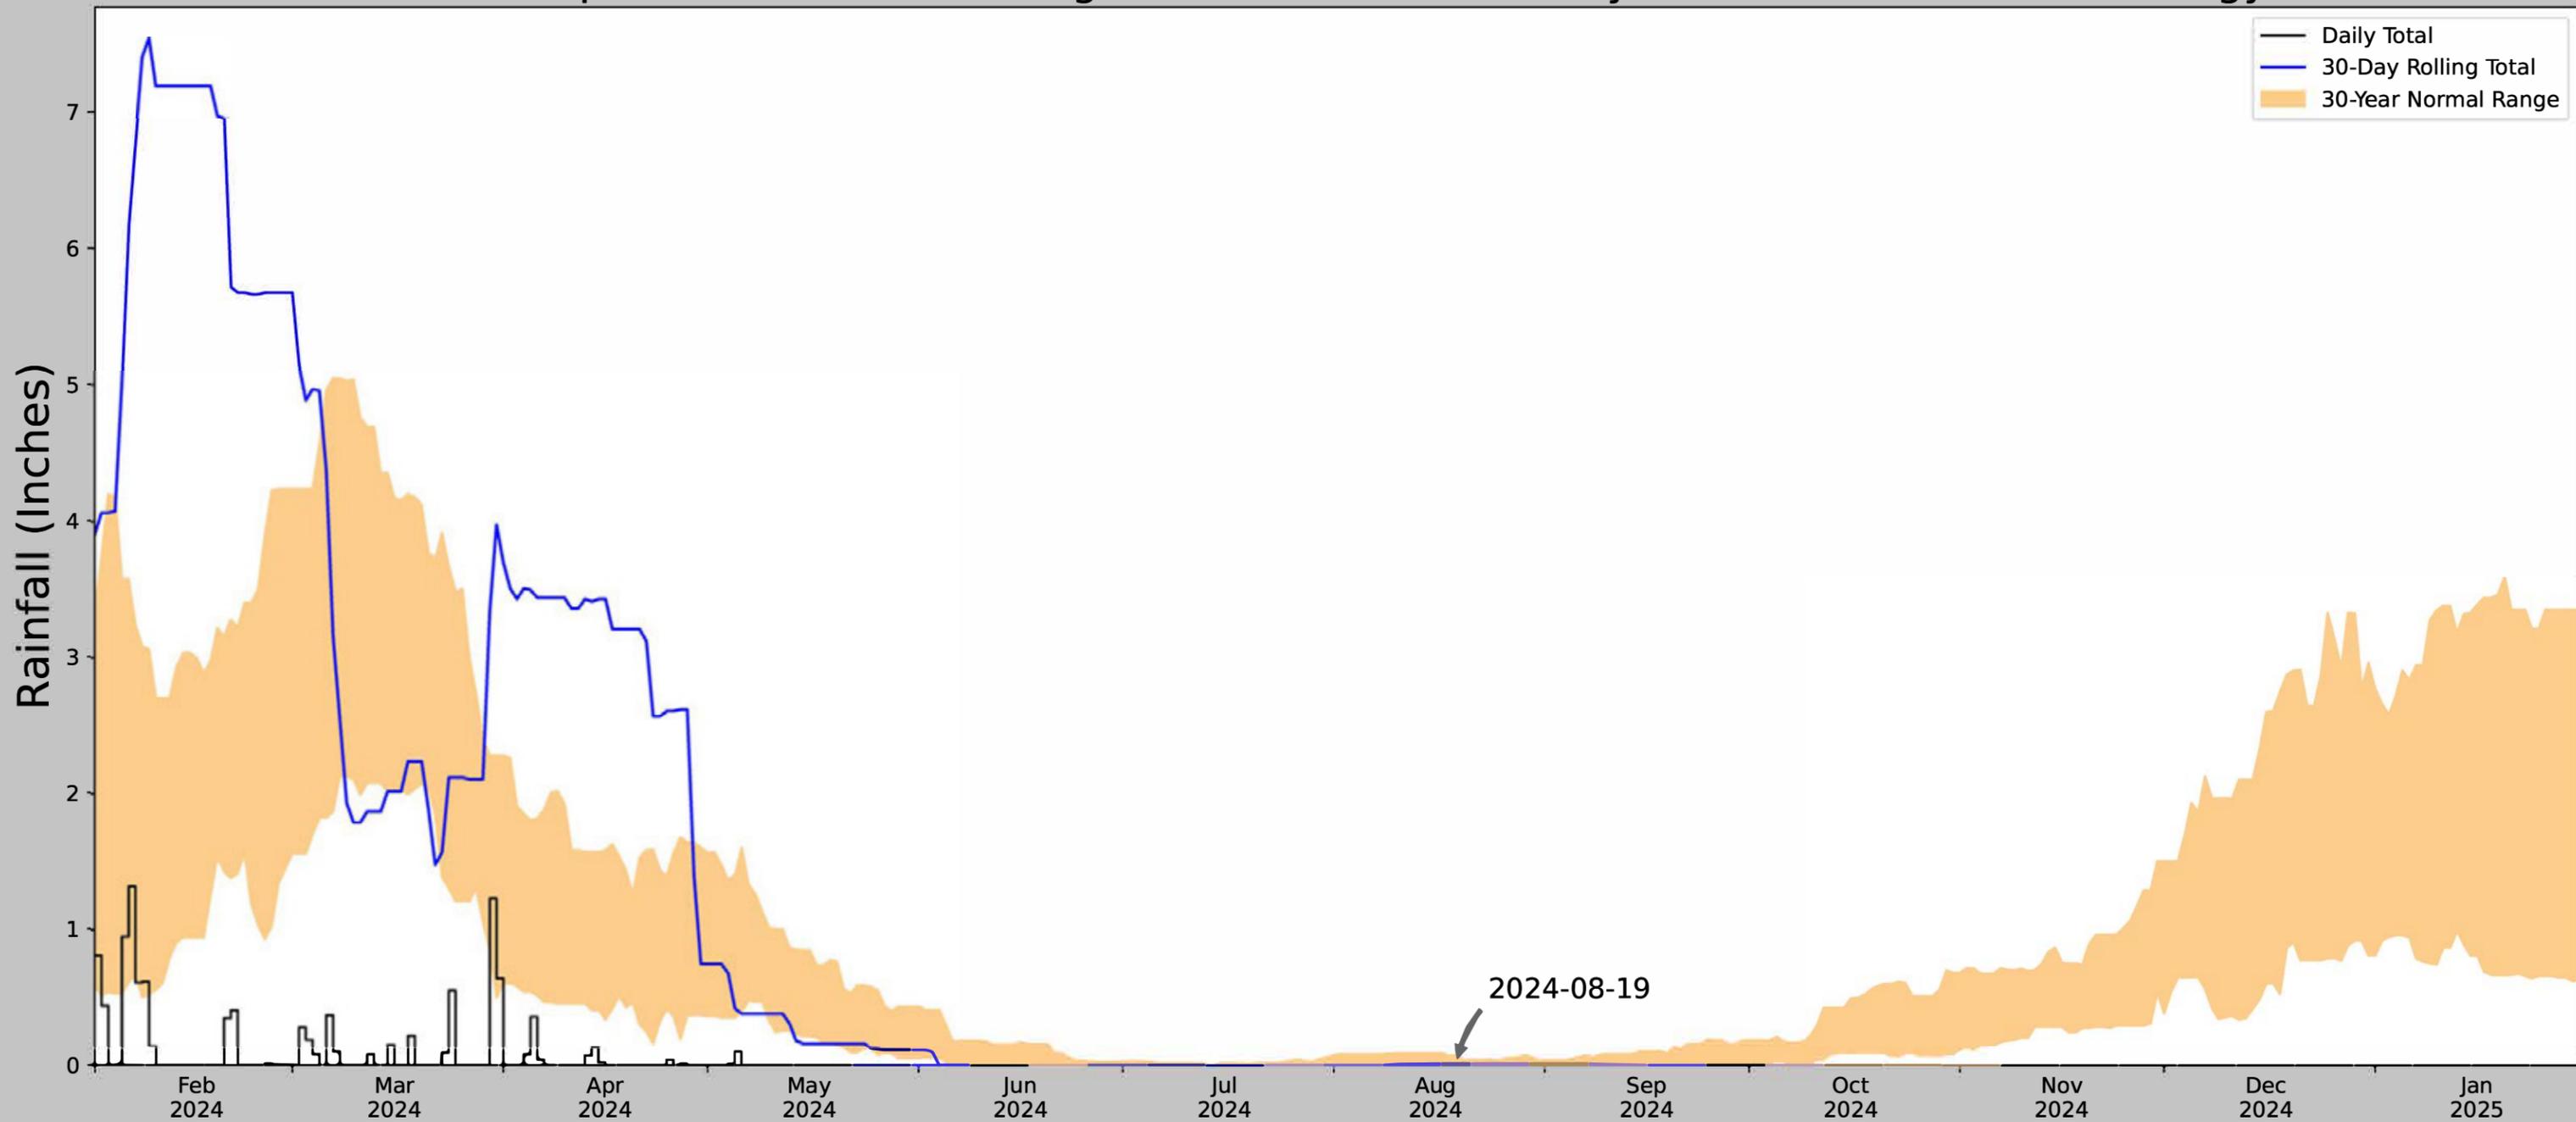
Coordinates	33.187149, -116.98962
Observation Date	2024-09-18
Elevation (ft)	1773.856713
Drought Index (PDSI)	Mild wetness (2024-08)
WebWIMP H ₂ O Balance	Dry Season

30 Days Ending	30 th %ile (in)	70 th %ile (in)	Observed (in)	Wetness Condition	Condition Value	Month Weight	Product
2024-09-18	0.011811	0.101969	0.0	Dry	1	3	3
2024-08-19	0.0	0.073228	0.011811	Normal	2	2	4
2024-07-20	0.0	0.011811	0.0	Normal	2	1	2
Result							Drier than Normal - 9

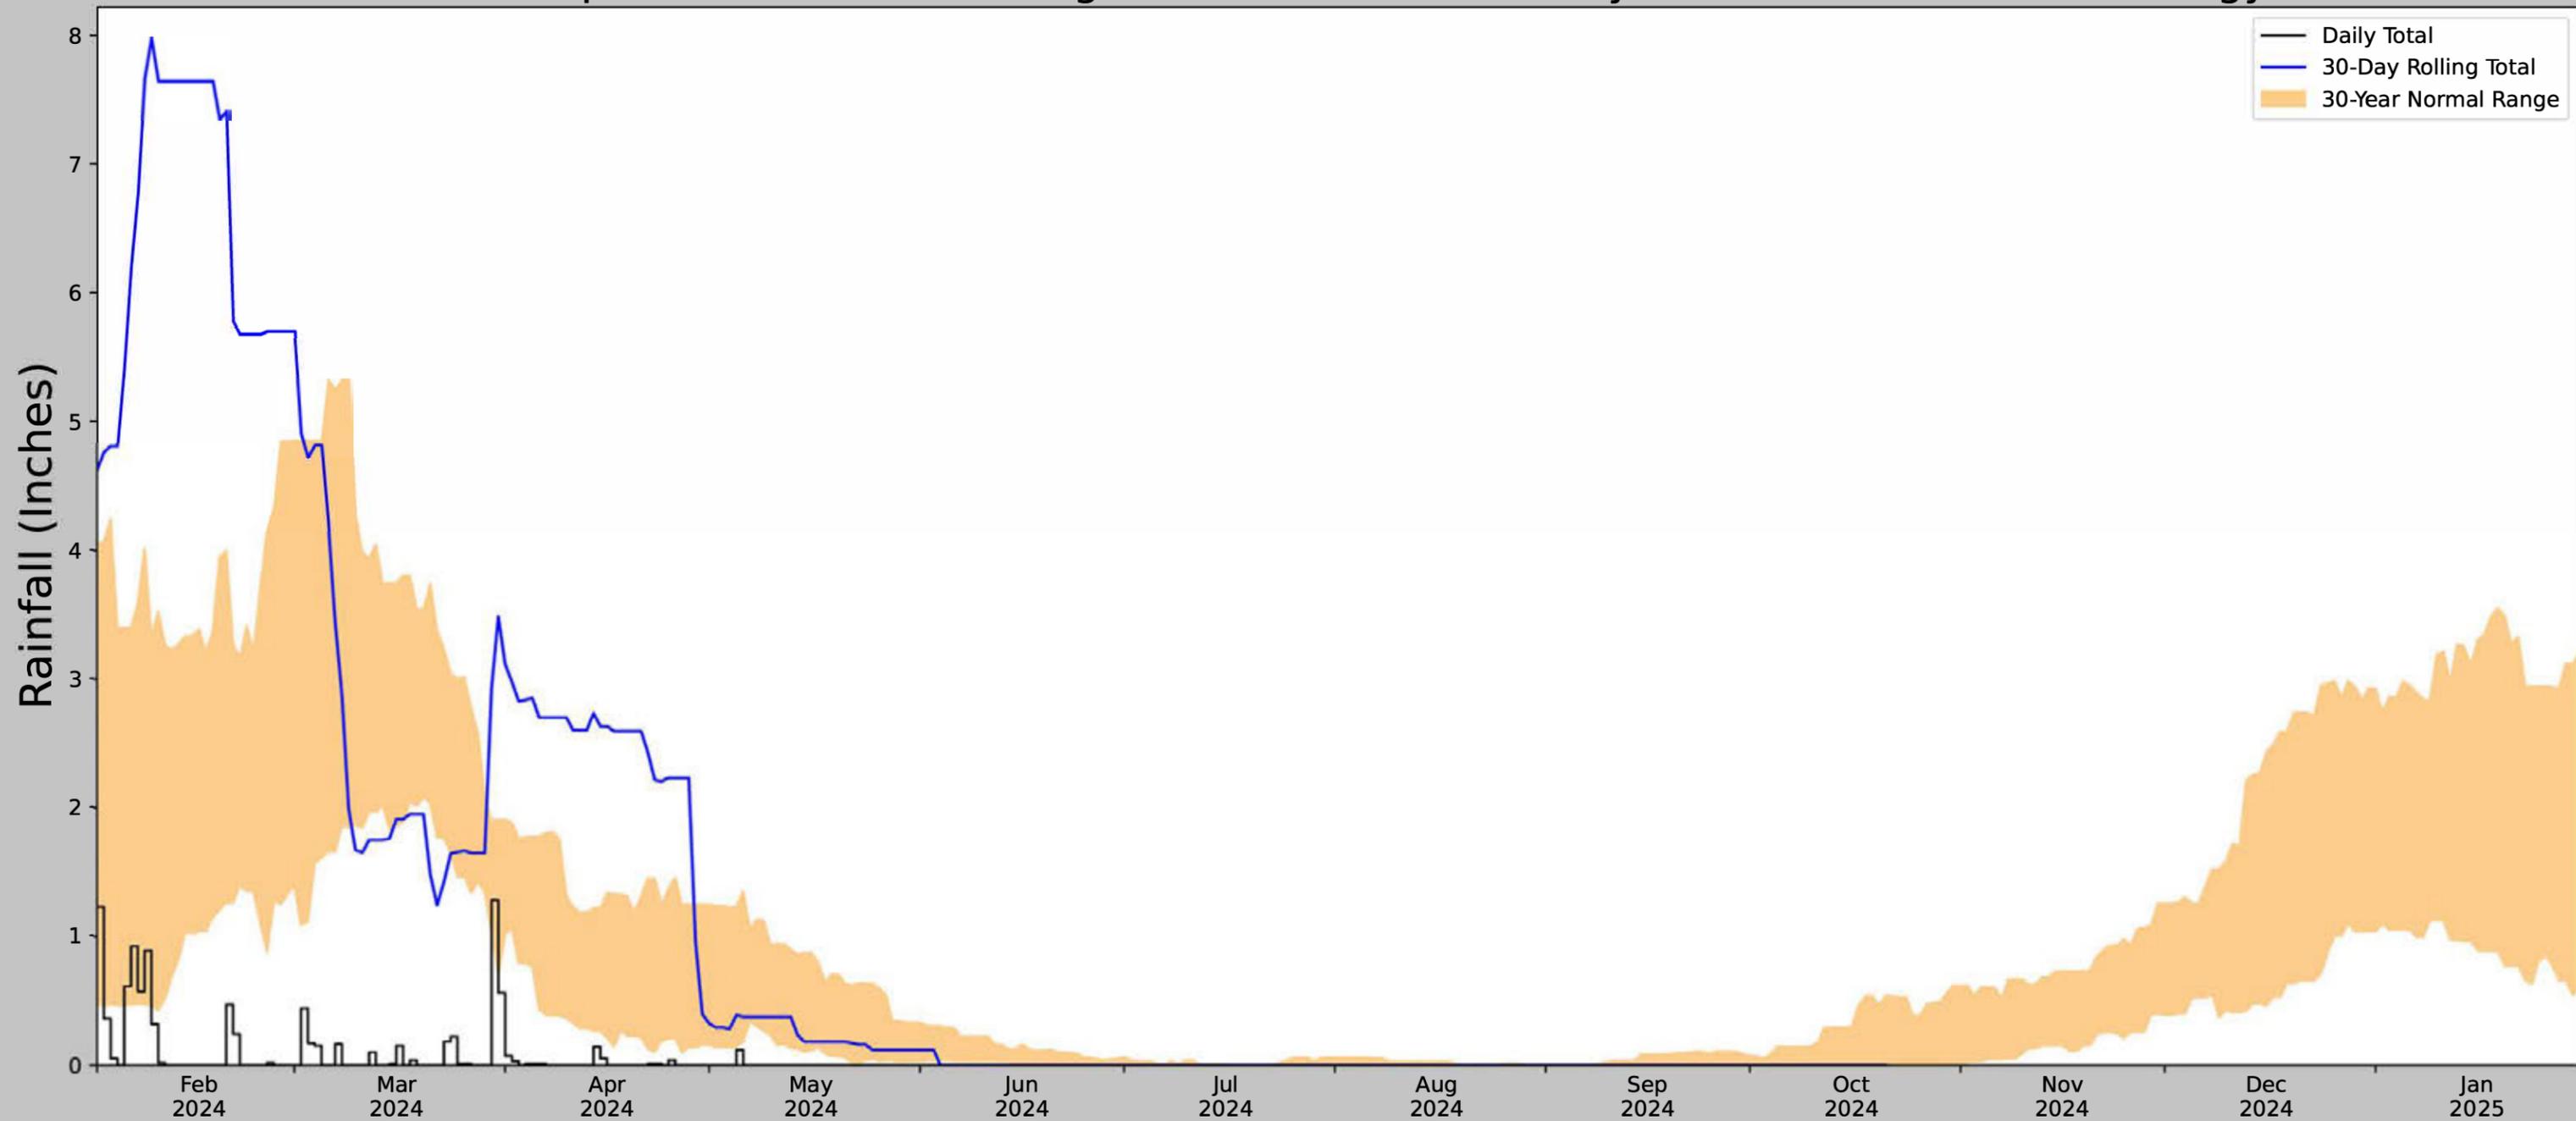
Coordinates	33.146548, -117.10266
Observation Date	2024-09-18
Elevation (ft)	706.066595
Drought Index (PDSI)	Mild wetness (2024-08)
WebWIMP H ₂ O Balance	Dry Season

30 Days Ending	30 th %ile (in)	70 th %ile (in)	Observed (in)	Wetness Condition	Condition Value	Month Weight	Product
2024-09-18	0.0	0.079921	0.0	Normal	2	3	6
2024-08-19	0.0	0.005906	0.0	Normal	2	2	4
2024-07-20	0.0	0.003543	0.0	Normal	2	1	2
Result							Normal Conditions - 12
