**Subject: PRELIMINARY EVALUATION  
ESCONDIDO EAST VALLEY PARKWAY &  
MIDWAY DRIVE DRAINAGE PROJECT  
CITY OF ESCONDIDO  
AGE Project No. 252 GS-24**

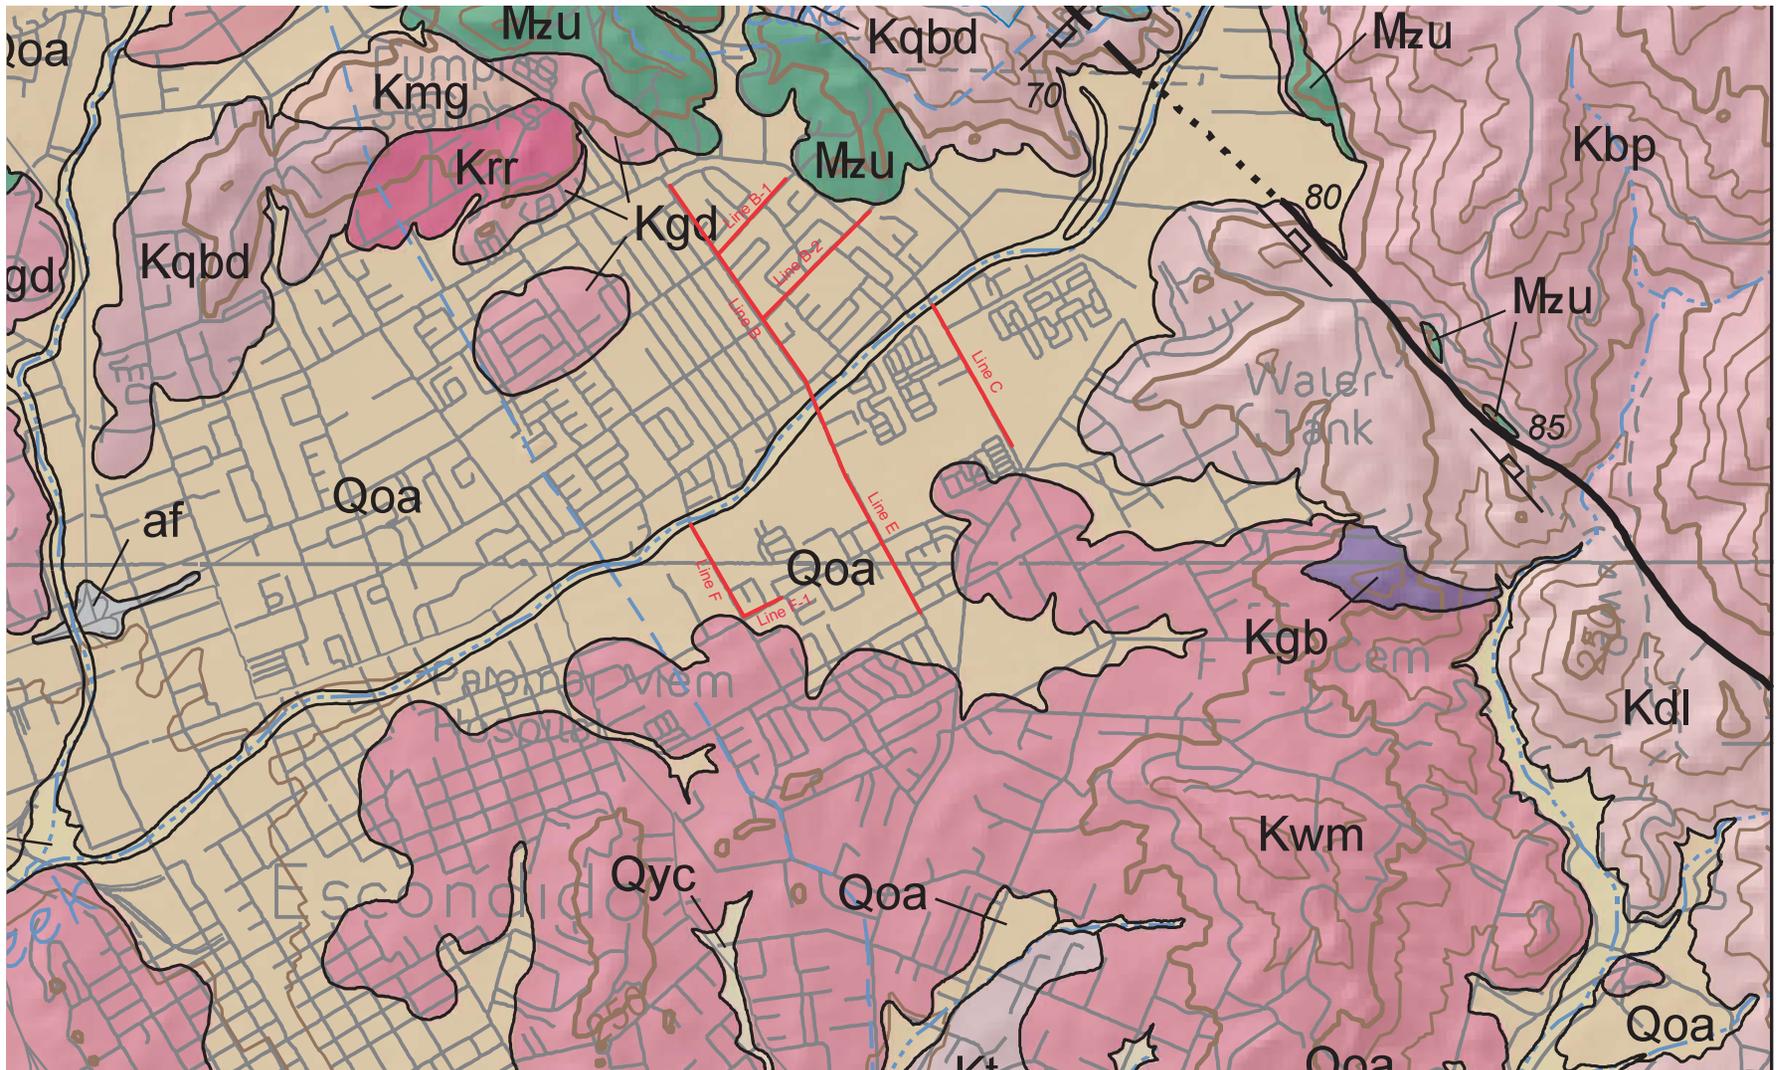
GENERALIZED GEOLOGIC MAP  
FIGURE 1

- Af - artificial fill
- Qyc - young colluvia deposits
- Qoa - old alluvial plain deposits

In accordance with your request, we have performed preliminary geologic evaluation along the proposed project alignments labeled as Lines B, B-1, B-2, C, E, F and F-1. The alignments are underlain by old alluvial deposits which in general are considered capable of providing support for the proposed storm drain culverts. A generalized geologic map of the project alignments is shown on Figure 1. The soil materials within the anticipated depths of the excavation along the project alignments consists primarily of shallow man-made fills and old alluvial deposits which are generally can be readily excavated with conventional heavy-duty construction equipment. The majority of the soil materials anticipated to be encountered during construction are considered suitable for use as compacted fill materials.

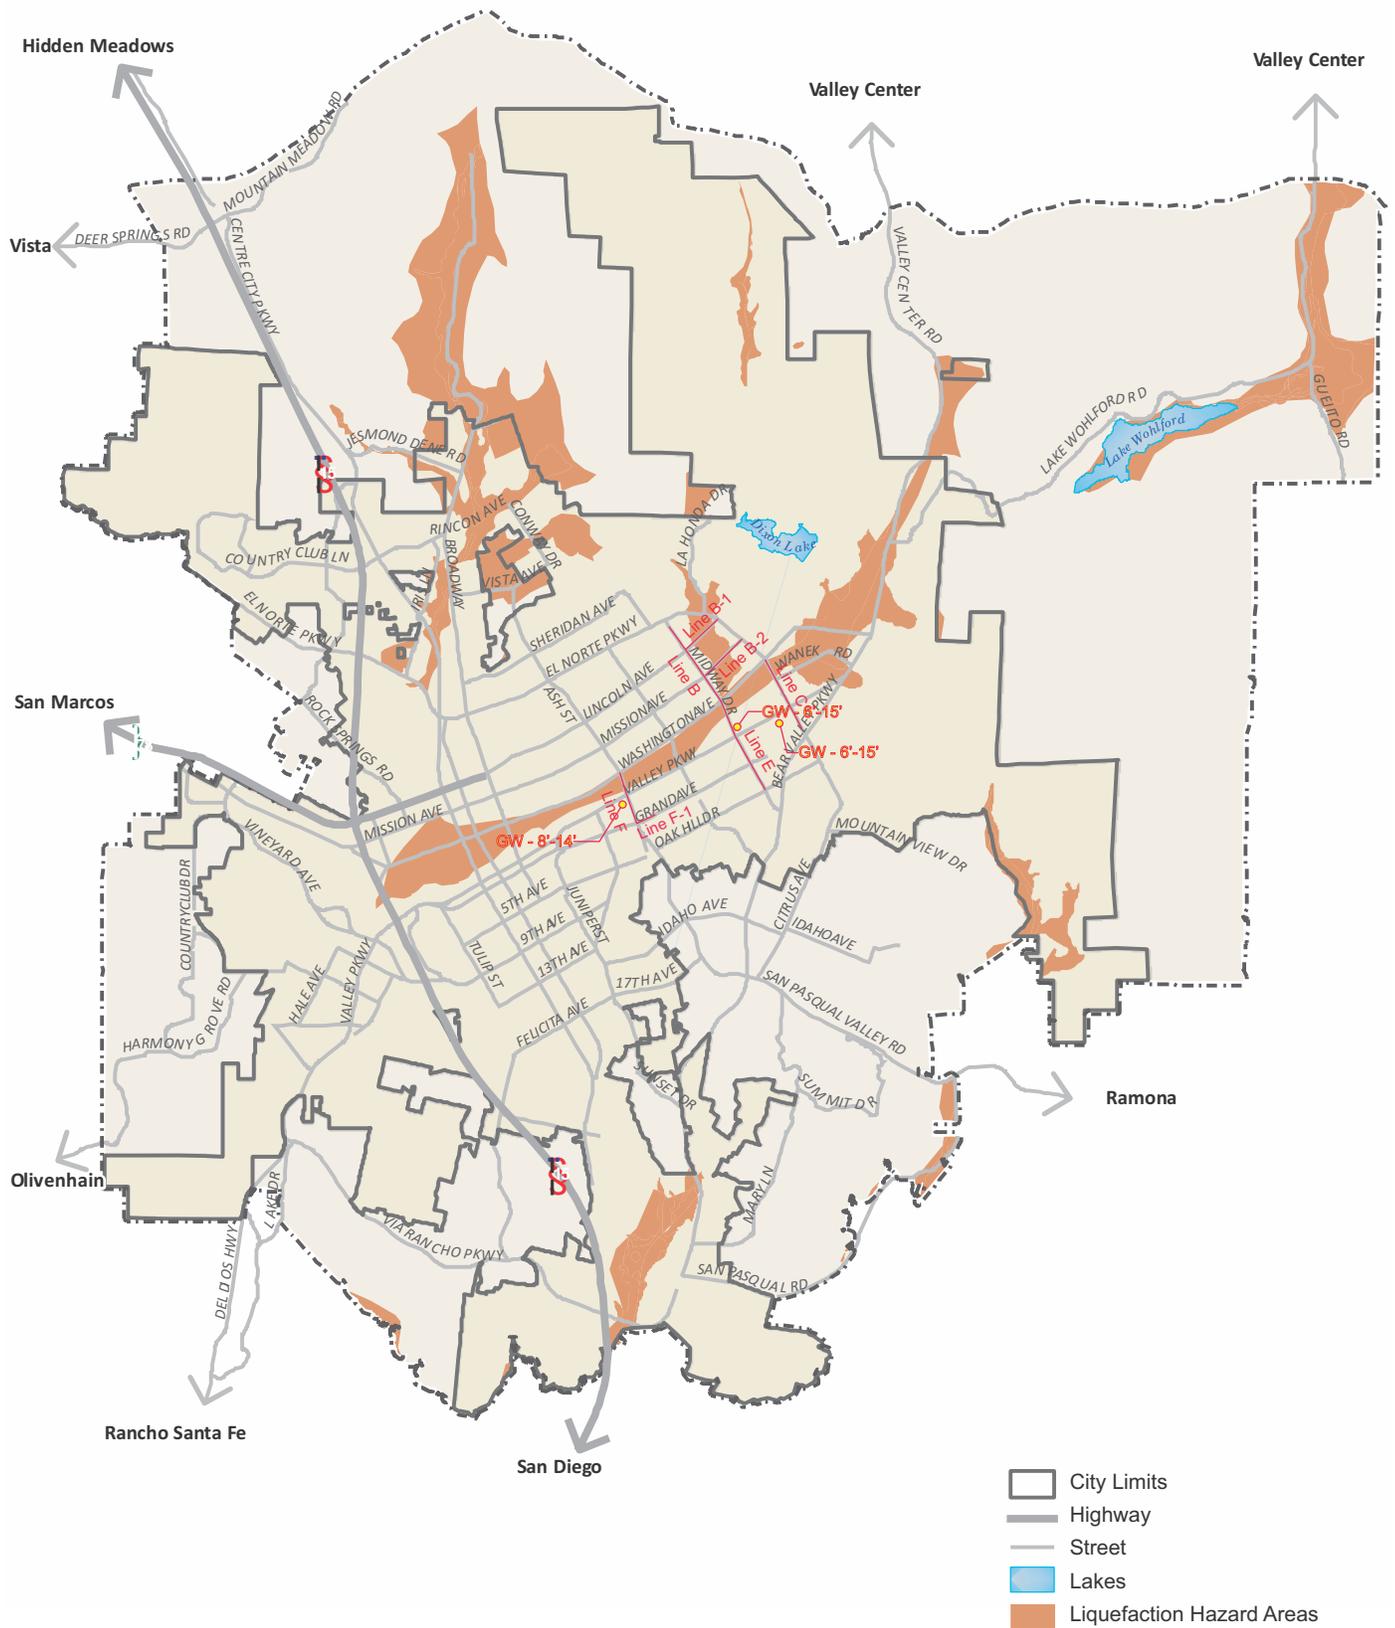
**LIQUEFACTION HAZARD AREAS  
FIGURE 2**

Source: City of Escondido 2011

Seismically-induced soil liquefaction is a phenomenon in which loose to medium dense, saturated granular materials undergo matrix rearrangement, develop high pore water pressure, and lose shear strength due to cyclic ground vibrations induced by earthquakes or other means. Segments of the project alignments are located in areas identified to have liquefaction potential which are shown on Figure 2. The liquefiable zones are deepest in the vicinity of Escondido River and are estimated to be on the order of 20 feet maximum.
