# Draft Biological Technical Report for the East Valley Parkway and Midway Drive Drainage Improvement Project, City of Escondido, California

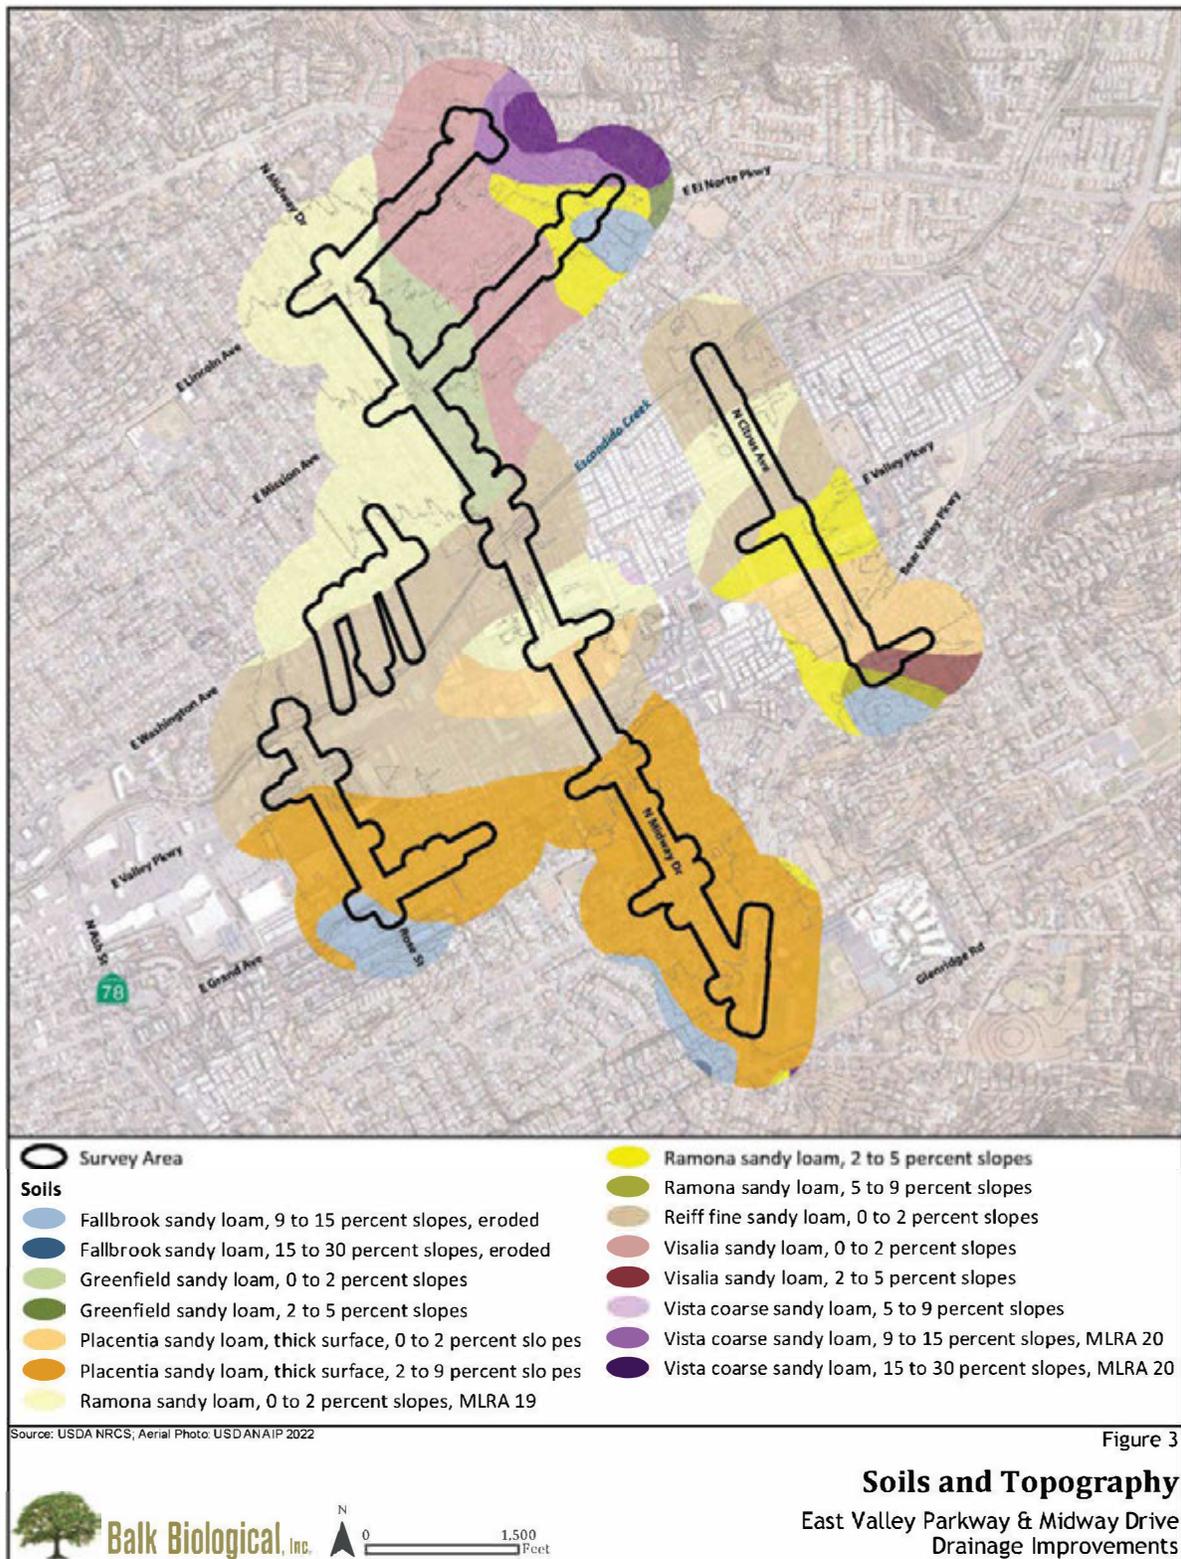
According to the San Diego County Soil Survey and digital soil maps from the NRCS 2.2 Database, 15 soil types are present in the Project study area as shown in Table 2 below and as depicted on the Soils and Topography map (Figure 3).

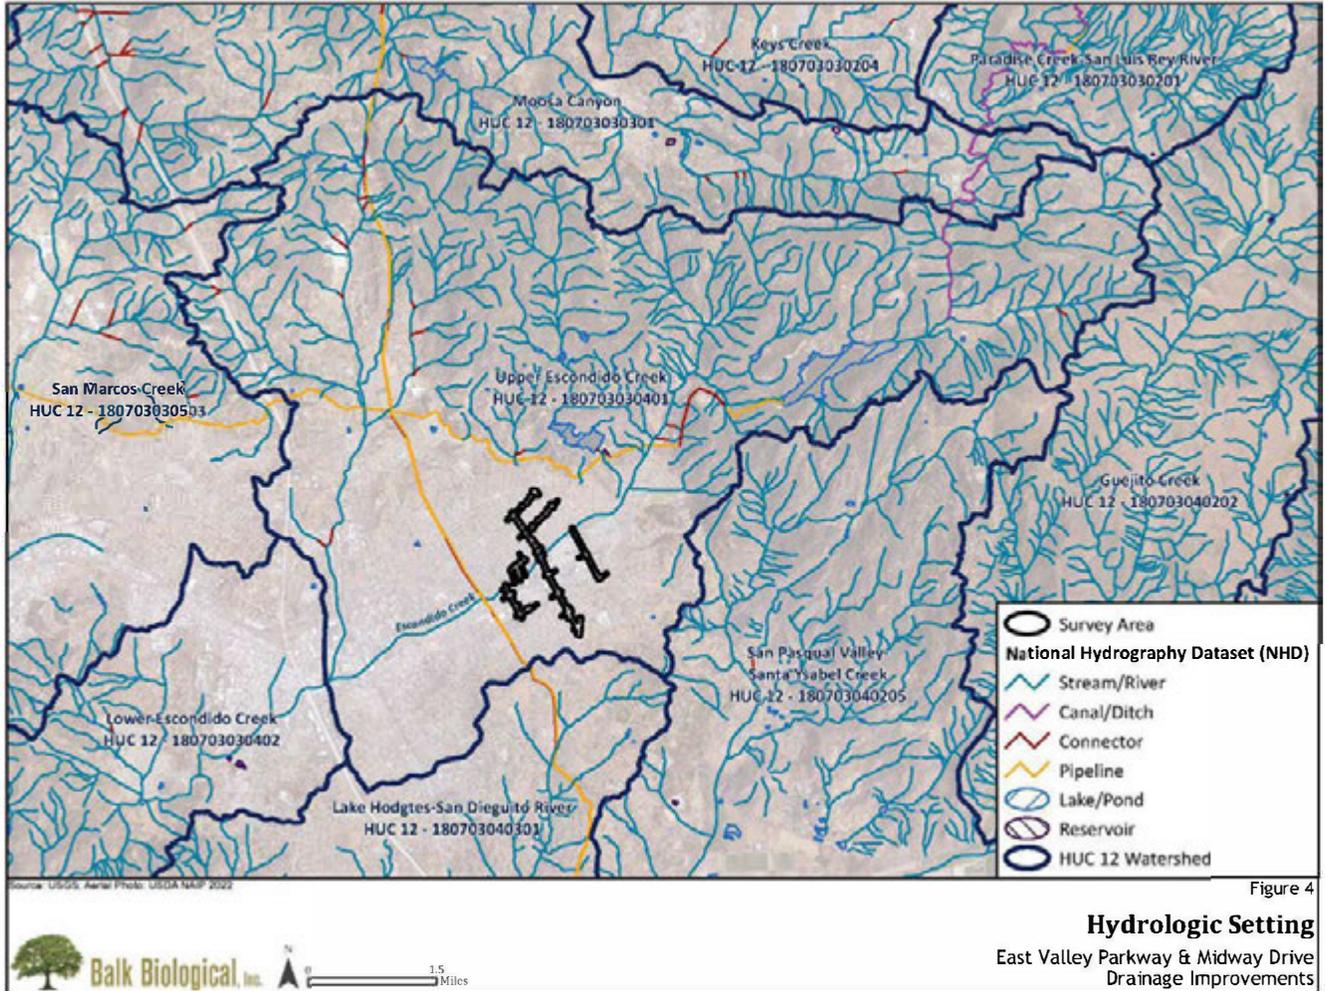
The Carlsbad Hydrologic Unit includes one small coastal lagoon (Loma Alta Slough) and four major coastal lagoons, including Buena Vista, Agua Hedionda, Batiqitos, and San Elijo (SDRWQCB 2002). Water flow through the Project site occurs exclusively through Escondido Creek (Figure 4).

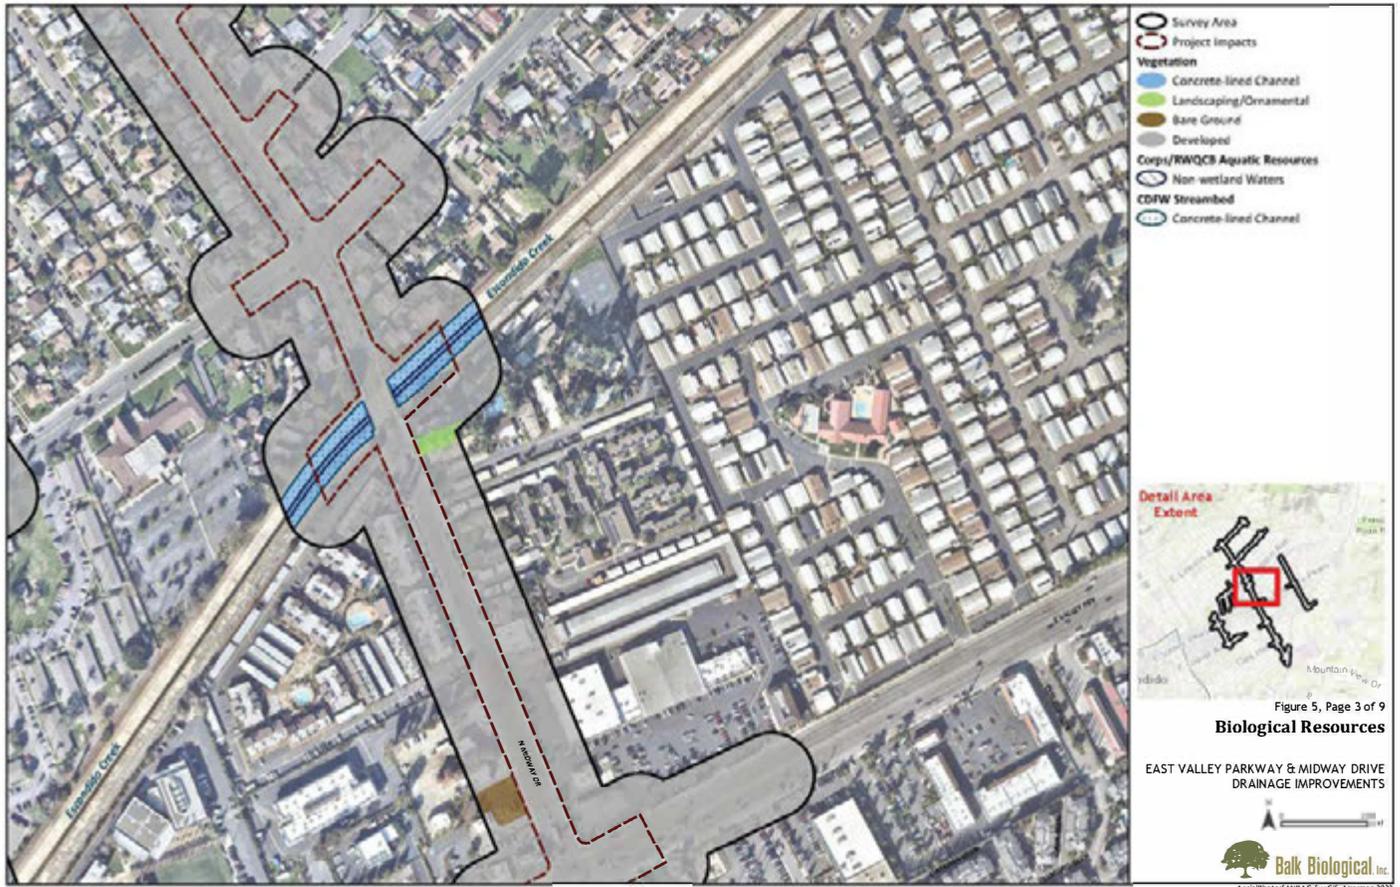
Figure 5, Page 3 of 9

The vegetation communities and land cover types recorded in the study area are described in detail below, their acreages are presented in Table 3, and their spatial distributions are presented on the Biological Resources and Impacts map (Figure 5).

**Biological Resources**

An aquatic resources delineation was conducted onsite to determine the type and extent of potential aquatic resources jurisdictional to the ACOE, RWQCB, and CDFW. Within the Project study area, potential aquatic resources were observed along the Escondido Creek channel and along a minor tributary to the Creek located in the southwestern portion of the Project study area near East Grand Avenue (see Figure 5). These potential aquatic resources are described below, according to agency jurisdiction.
