Alexan Escondido Project

Historic Resource Evaluation Report

July 2024 | 00876.00006.001

Report Title: Historic Resource Evaluation Report for the Alexan Escondido Project, Escondido, California

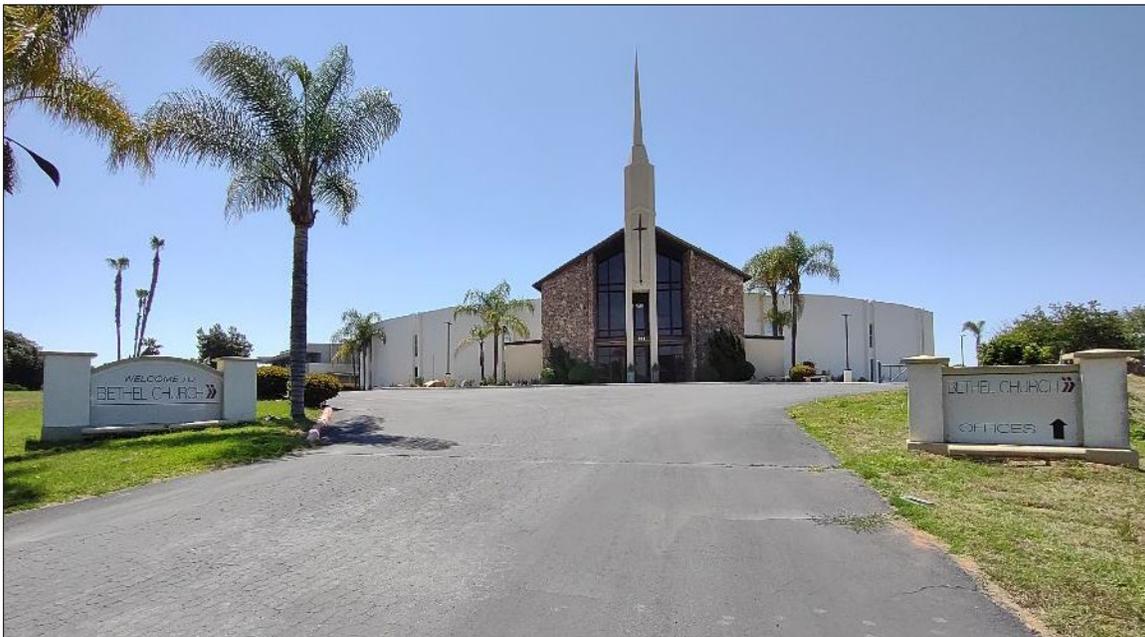
Photo 1. Overview of Bethel Baptist Church from entry driveway, facing southeast.

Bethel Baptist Church is a one- and two-story building constructed primarily of reinforced precast concrete on a concrete slab with some cast-in-place elements. The building plan is wedge-shaped, oriented on a northwest to southeast axis. A single-story L-shaped element occurs along the south and east facades that converge to a point at the southeast corner. The north and west facades curve toward the entry element and essentially comprise the front elevation of the church. A main entry projection and steeple occur at the northwest corner, and the facades of the main portion of the church are two stories in height (Photo 1). The roofs are primarily flat, with only the entry element consisting of a gabled roof covered in non-original concrete S-tiles that is punctuated by the steeple at the gable end. This gabled element tapers and recedes in height as it extends on the northwest-to-southeast axis toward the southeast corner of the church's two-story volume. The parapets surrounding the flat roofs are capped with metal flashing. The following sections describe the exterior elevations of the building, followed by descriptions of the interior that focus primarily on the main, publicly-accessible lobby and sanctuary with additional representative photos of secondary spaces.

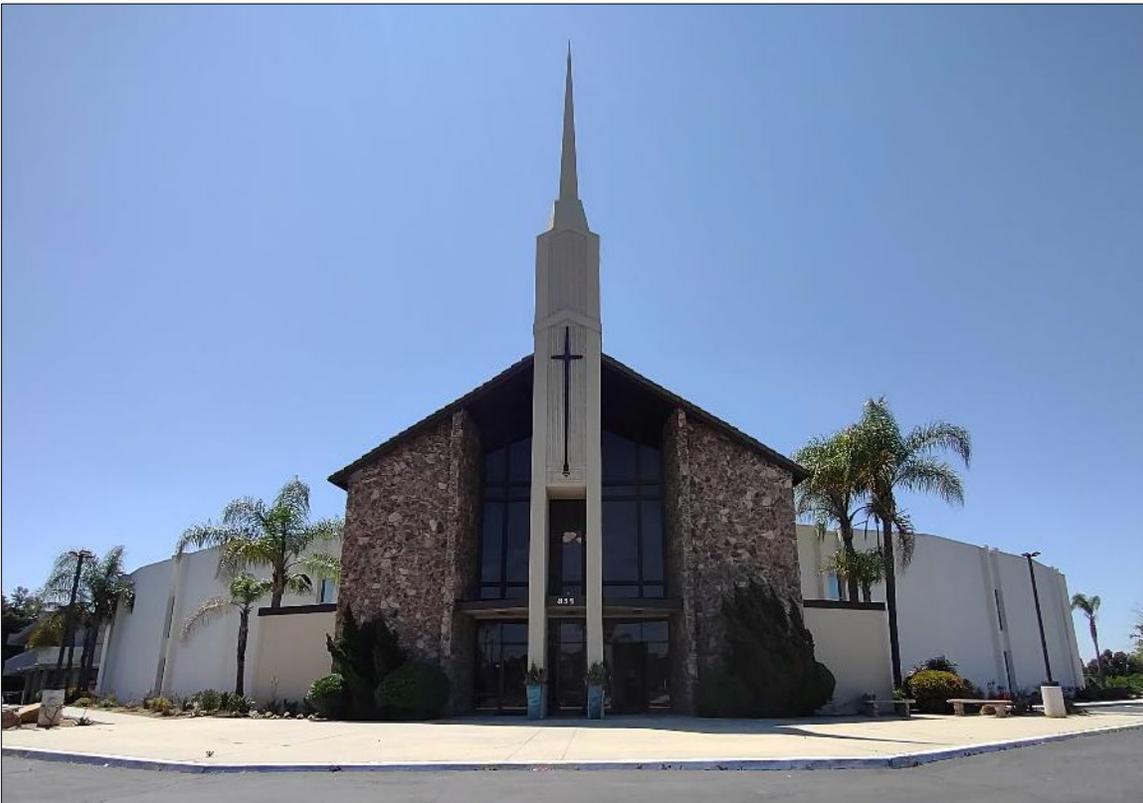
Photo 2. Front Elevation, facing southeast.

The north elevation is symmetrically arranged and is dominated by the reconstructed steeple tower topped by the original spire that rises to an overall height of approximately 82 feet above the gabled roof entry element in the center of the elevation. The tower is white in contrast with the recessed full height windows behind the tower and the brown, cultured stone walls that flank the windows on both sides. The main building façades are recessed back and flank the entry element (Photo 2). The original glass entry doors are covered by an integral flat ledge, with a tall multi-paned set of windows above that evoke a cross (Photo 3 and Photo 4).

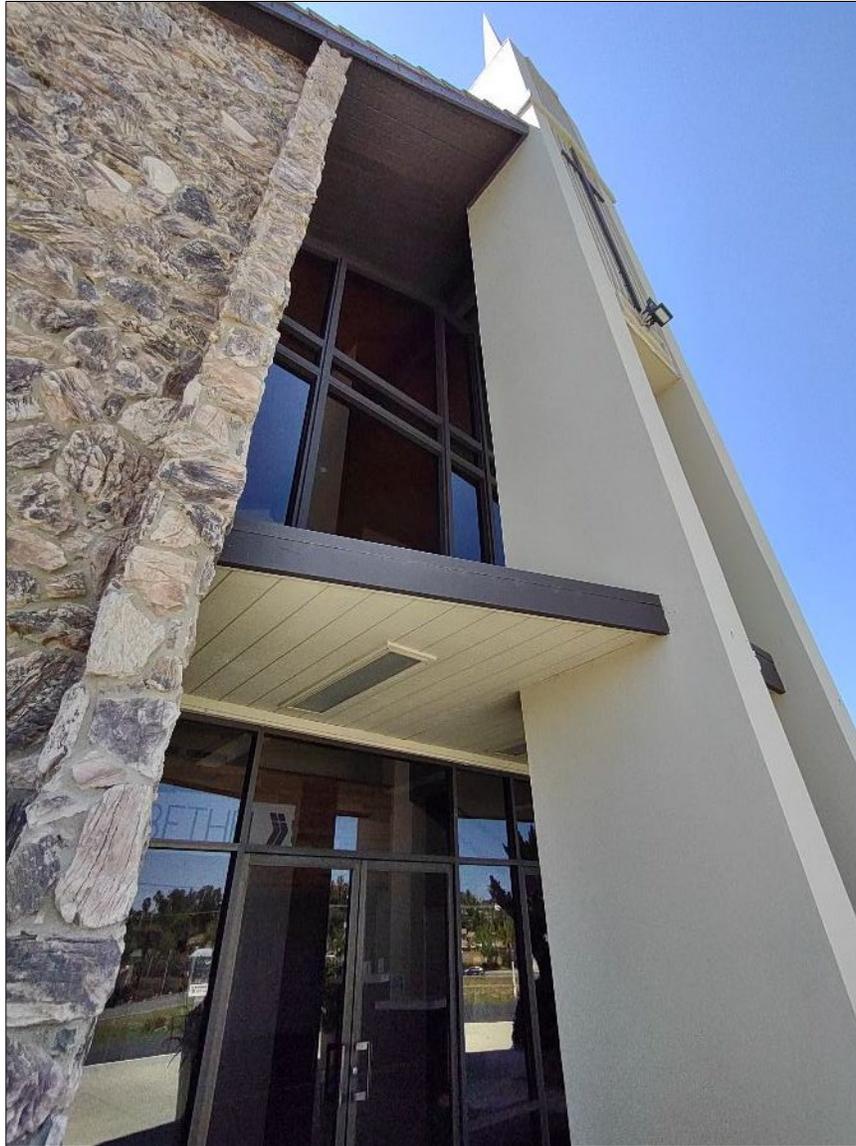
Photo 3. Closeup of entry element, covered entrance doors, and clerestory window above, left side.

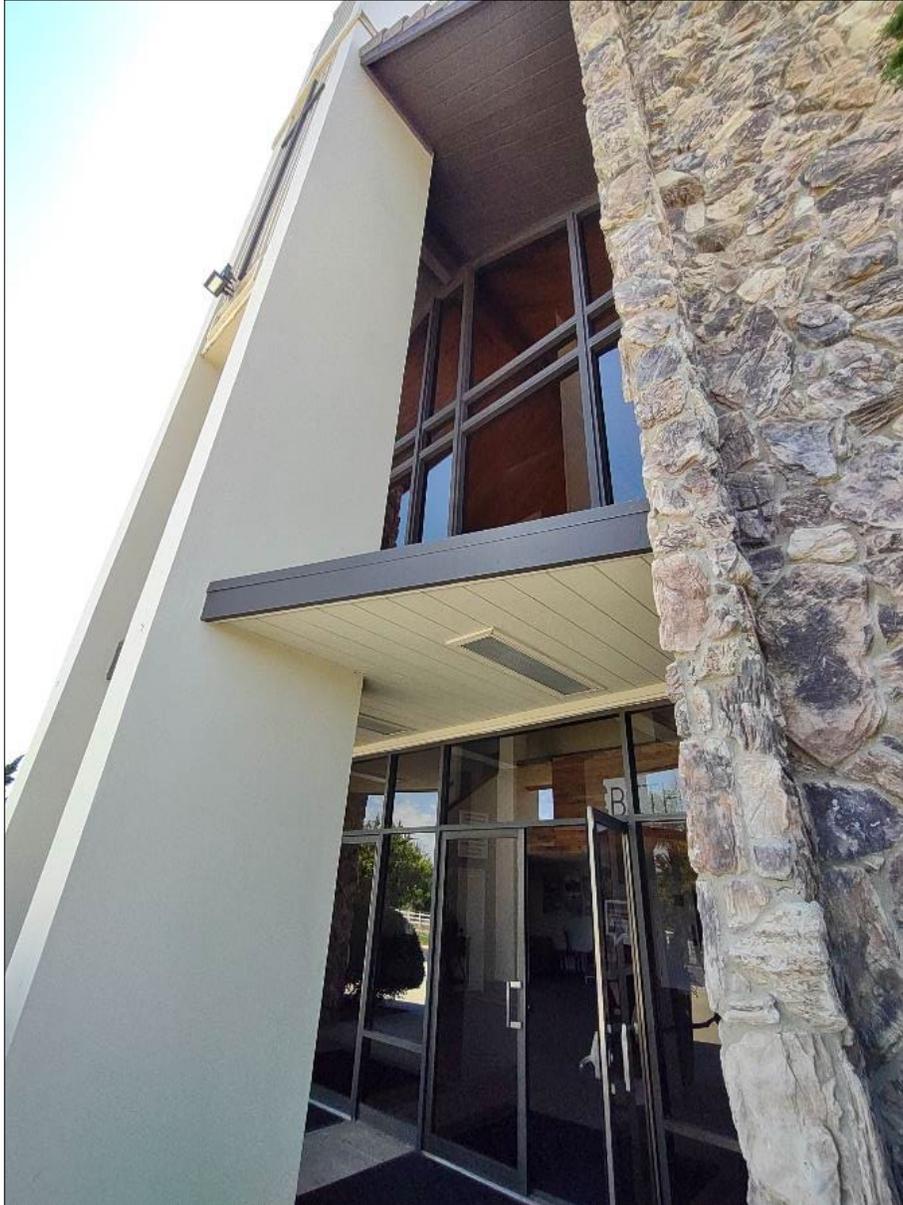
Photo 4. Closeup of entry element, covered entrance doors, and clerestory window above, right side.

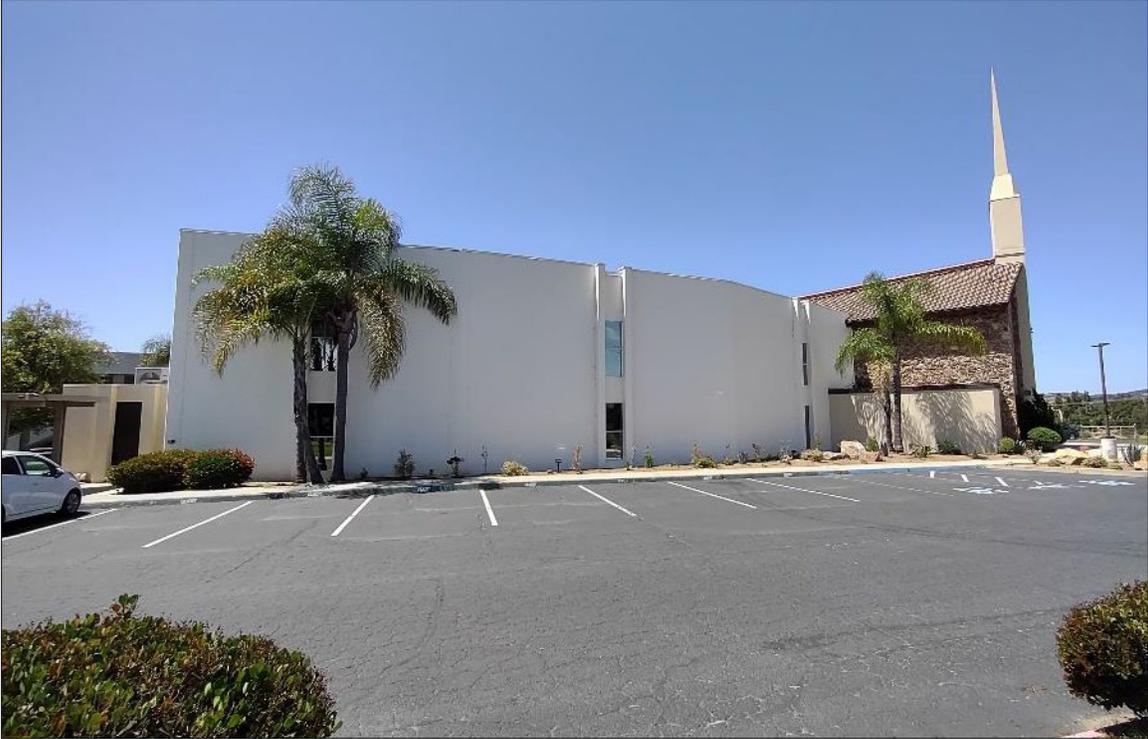
To both sides of the entry element’s stone walls are original, single-story, flat-roofed building projections that are connected to the main building façade. The cultured stone walls wrap both sides of the entry element under the gabled roof. The electrical service feeding the steeple’s wireless antennas can be seen within a metal duct that climbs the east slope of the gabled roof. The main building walls on the north and west elevations are painted precast concrete walls with V-groove joints forming very slight angles to create the overall curved appearance of the façade. The walls end in parapets above the roof, with metal flashing along the parapet edge. Within each of the three main wall panels are framed, vertical recessed sections with aluminum windows at the first and second floors; the parapets at the recesses are lower than the main parapet, creating a varied roof edge along the front elevation. The main walls and the recessed sections are painted white. The west end of the single-story classroom addition is recessed and visible at the south end of the west façade. Photo 7 and Photo 8 show the north and west facades of the front elevation, respectively.

Photo 7. Front elevation, north facade, facing south.

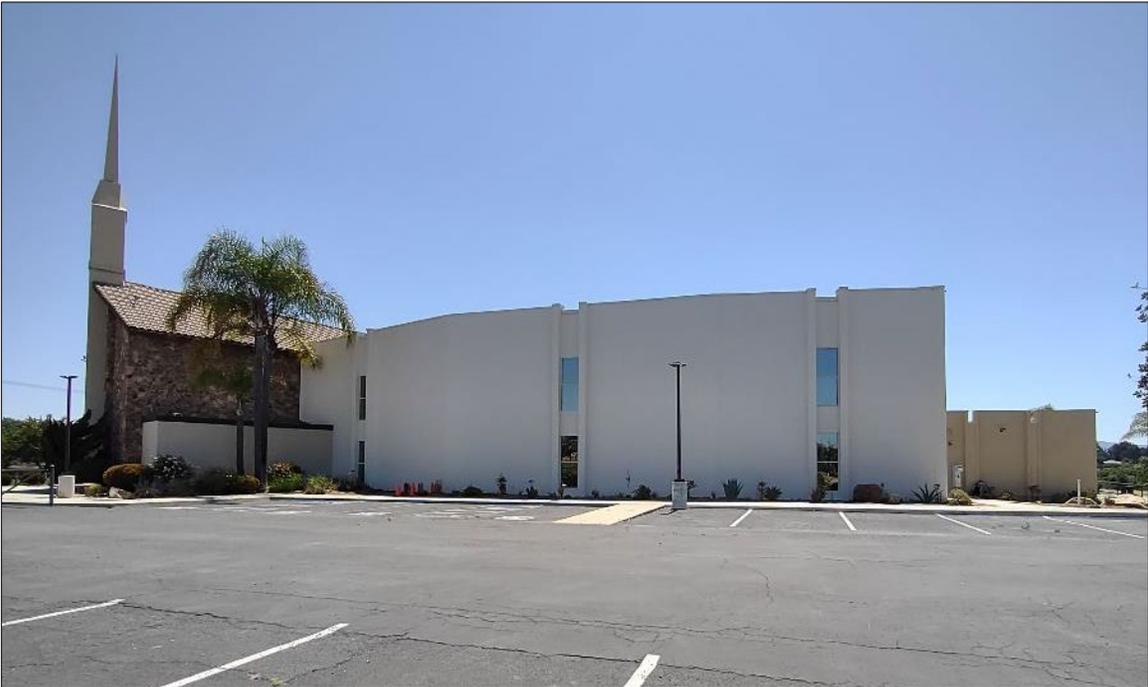
Photo 8. Front elevation, west facade, facing east.

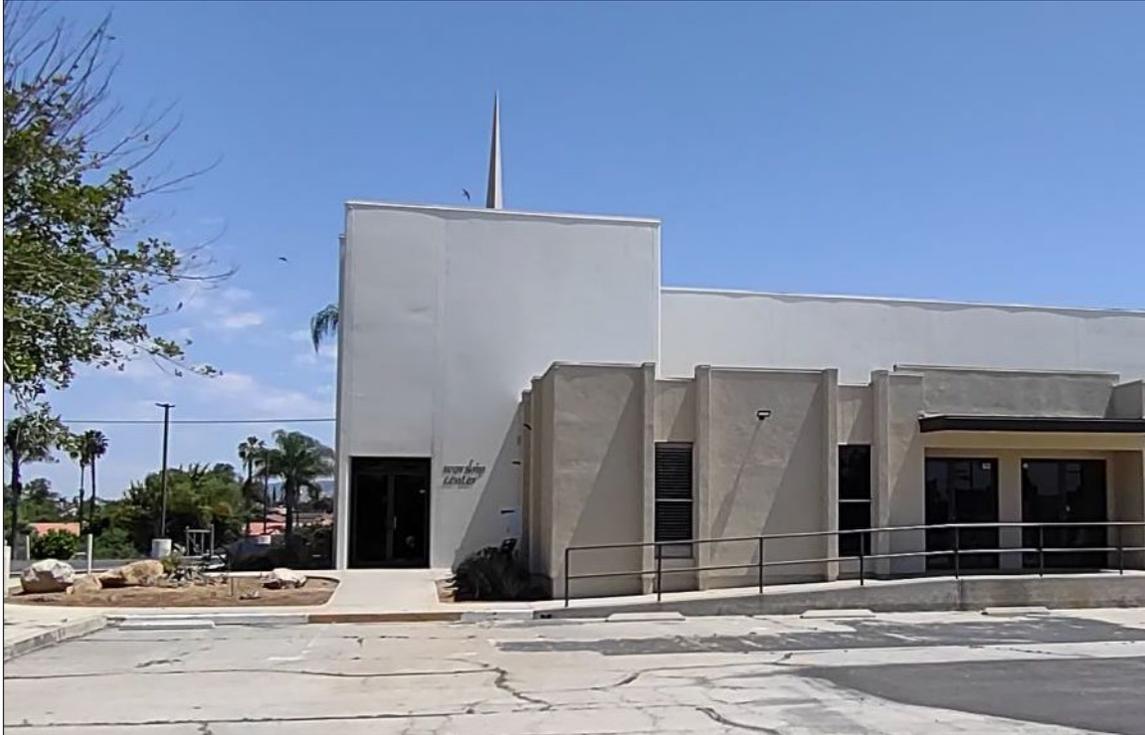
own entrance built circa 1981, and storage additions to the kitchen and the fellowship hall built circa 2000. The additions obscure much of the original building elevation on this side. The additions are single-story with flat roofs and parapets with metal flashing. The church walls on this side are unadorned but feature score joints at appropriate locations. The parapet walls are the same height along the elevation. The westerly end of the elevation features a building projection that houses the interior stairwell to the second floor, along with a pair of secondary entrance doors. A sign to the right of the doors reads “Worship Center” (Photo 9).

Photo 9. Side elevation, west end facing north.

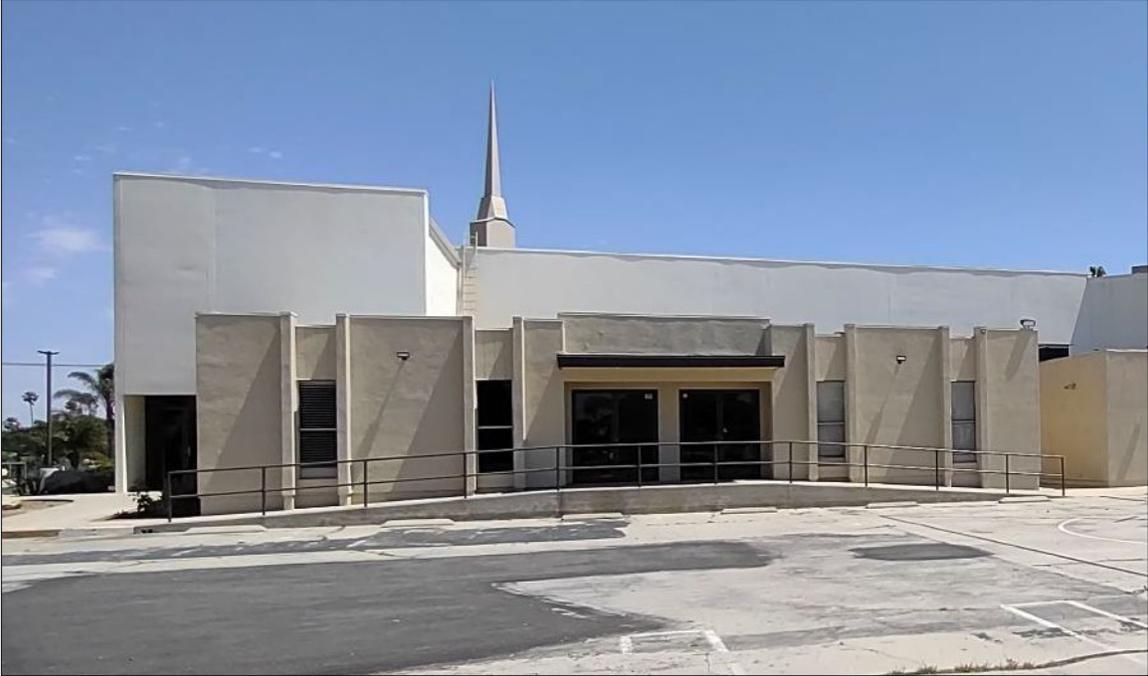
To the right of the secondary entrance doors is the projecting classroom addition. It is symmetrically arranged and mimics the front elevation’s main walls. Two pairs of entry doors are located in the center of the addition’s facade, elevated above the level of the parking lot. The entrance is covered by a flat concrete ledge and is accessed from both ends of the addition by a concrete ramp with a pipe railing. On the main walls at both sides of the entrance are two framed, vertical recesses with windows; the wall sections above the windows are clad in T1-11 siding. The parapets at the recessed sections are lower than the main walls, while the parapet above the entry ledge is slightly elevated, creating a varied roof line for the addition. The addition appears to be wood framed rather than precast concrete (Photo 10).

Photo 10. Side elevation classroom addition, facing north.

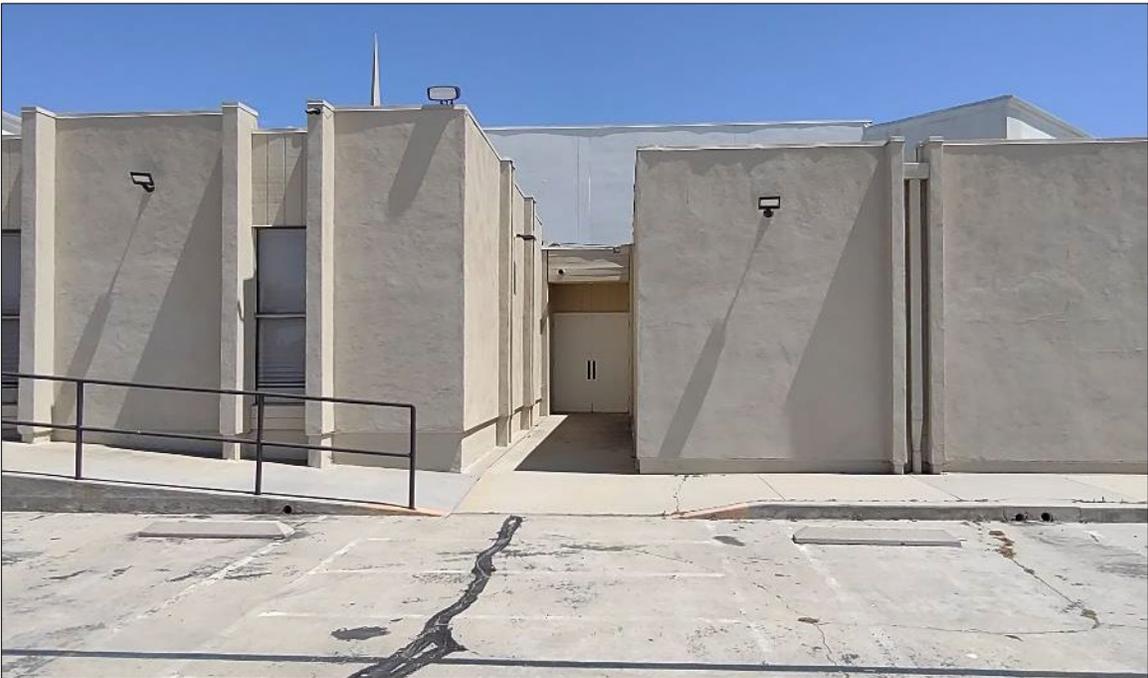
A narrow break occurs to the east of the classroom addition to provide access to a pair of church exit doors. The projecting kitchen addition frames the other side of the narrow break and also appears to be of wood frame construction with no windows. A very narrow vertical recess in the center of the addition’s blank wall echoes others on the church but has no window and appears to house a scupper and roof drain (Photo 11).

Photo 11. Closeup of break between additions, facing north.

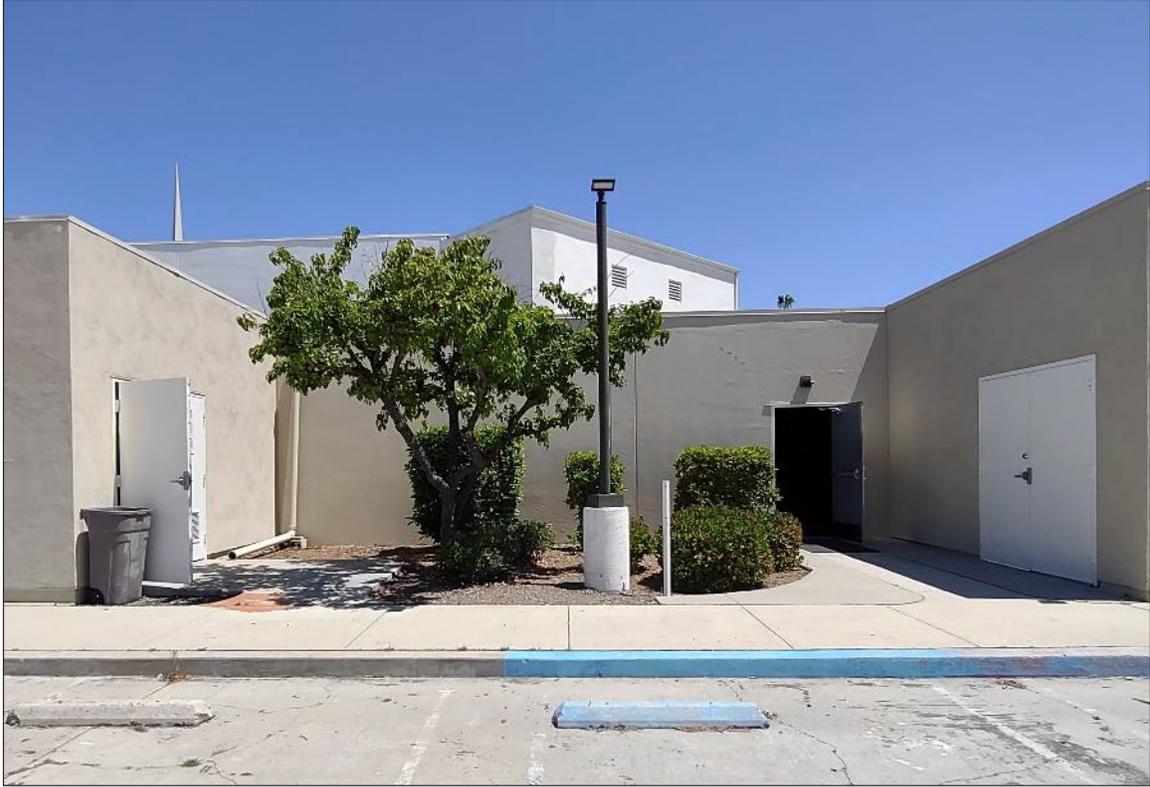
A pair of doors occurs on the east side of the kitchen addition. A recessed, landscaped courtyard provides a view of the original church wall, which features an exterior entrance to the fellowship hall. To the right of the entrance is the final projecting storage addition, which also features blank walls, punctuated only on the west side by a pair of doors. The south façade has a sign reading “Fellowship Center” at the west end, and two narrow vertical projections whose purpose could not be discerned (Photo 12 and Photo 13).

Photo 12. Closeup of courtyard between kitchen and fellowship hall additions, facing north.

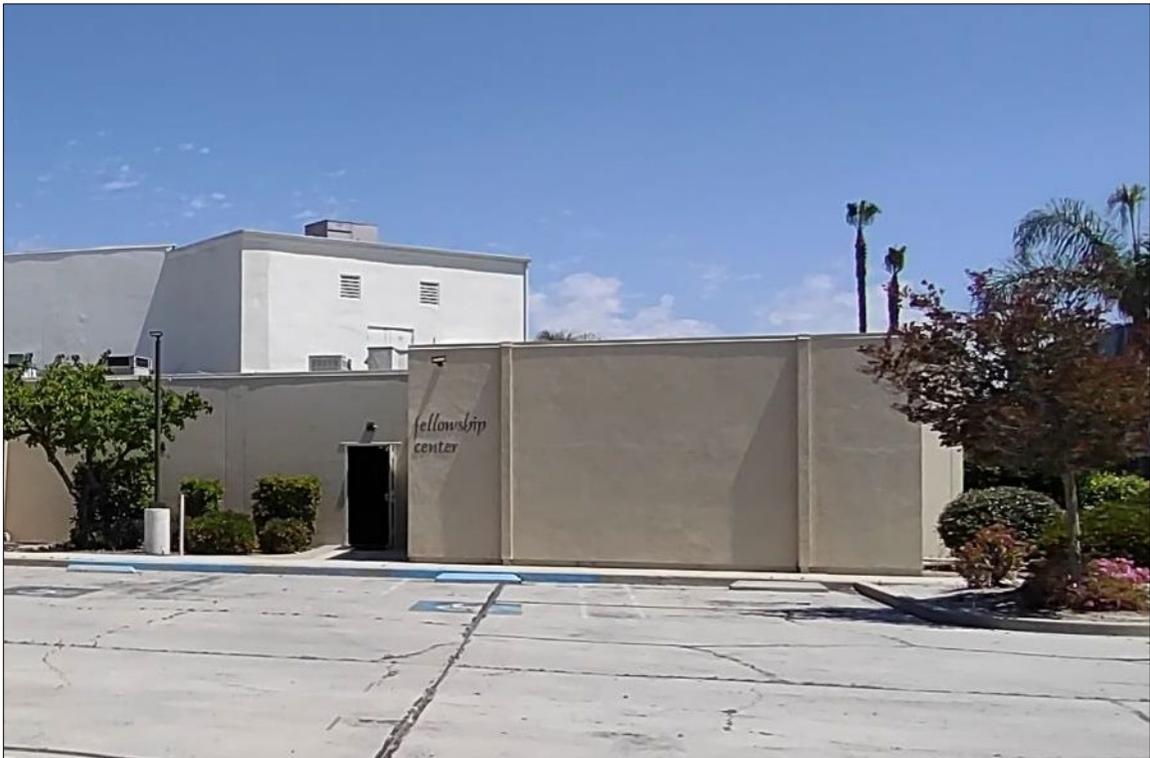
Photo 13. South elevation, east end, facing northwest.

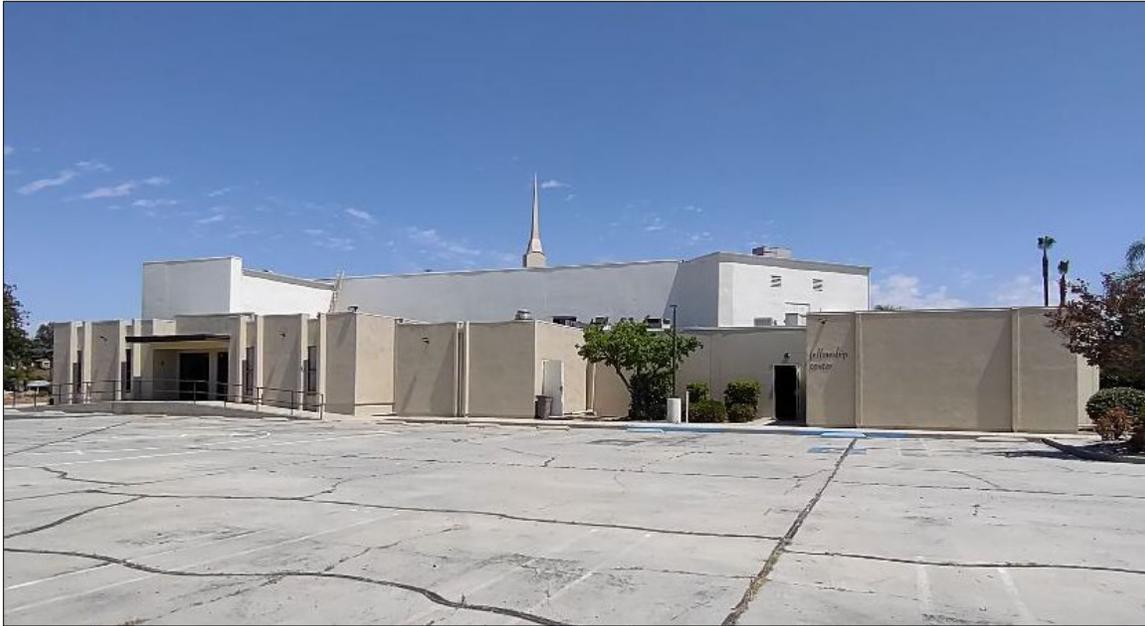
The church walls are visible above the roofs of the additions and include the angled element at the southeast corner and a long intervening wall between it and the stairwell projection to the west. The angled element exhibits two louvered vents and a pair of roof access doors. Roof-mounted equipment is located in various areas of the flat roofs. The spire is visible from the parking lot, rising above and beyond church parapet walls (Photo 14).

Photo 14. South elevation, facing northwest.

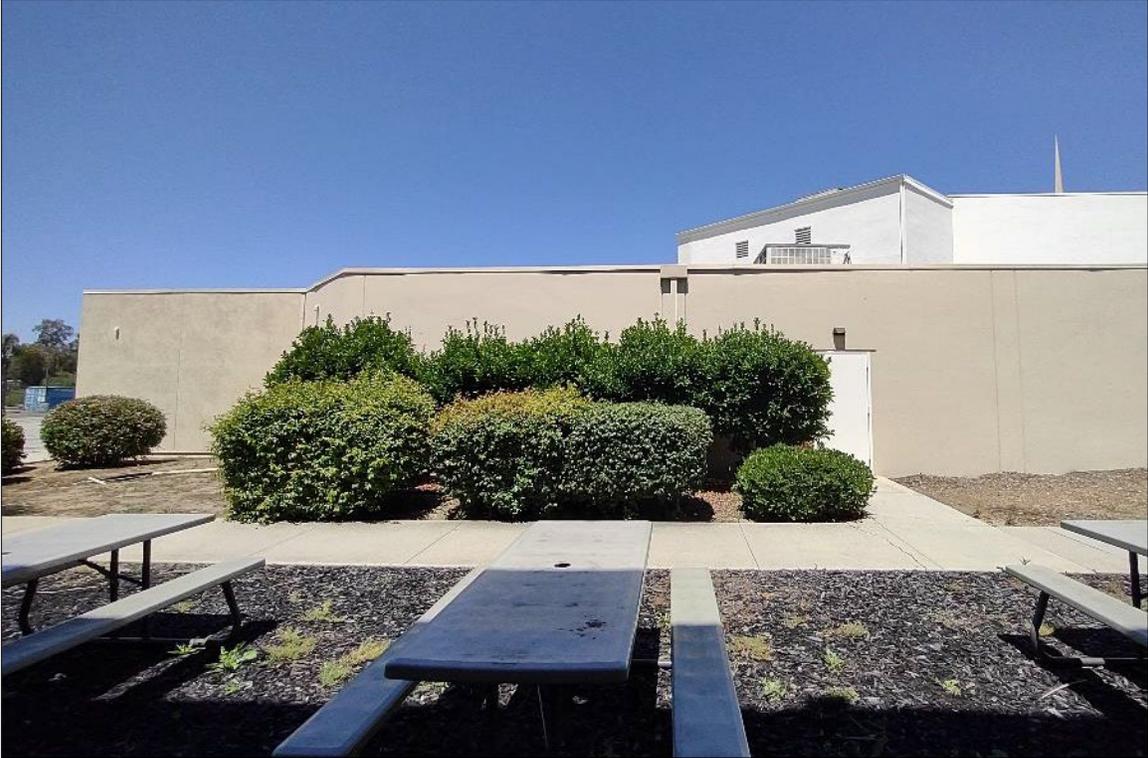
The rear elevation faces east toward the two modern education buildings. The east side of the single-story fellowship hall storage addition is located at the southerly end. Directly north of the addition are the original angled southeast corners of the church above and the fellowship hall below that angle to the east elevation. The fellowship hall's east elevation features a chimney rising above the roof near the corner of the building projection (Photo 15 and Photo 16).

Photo 15. South end of east elevation, facing west.

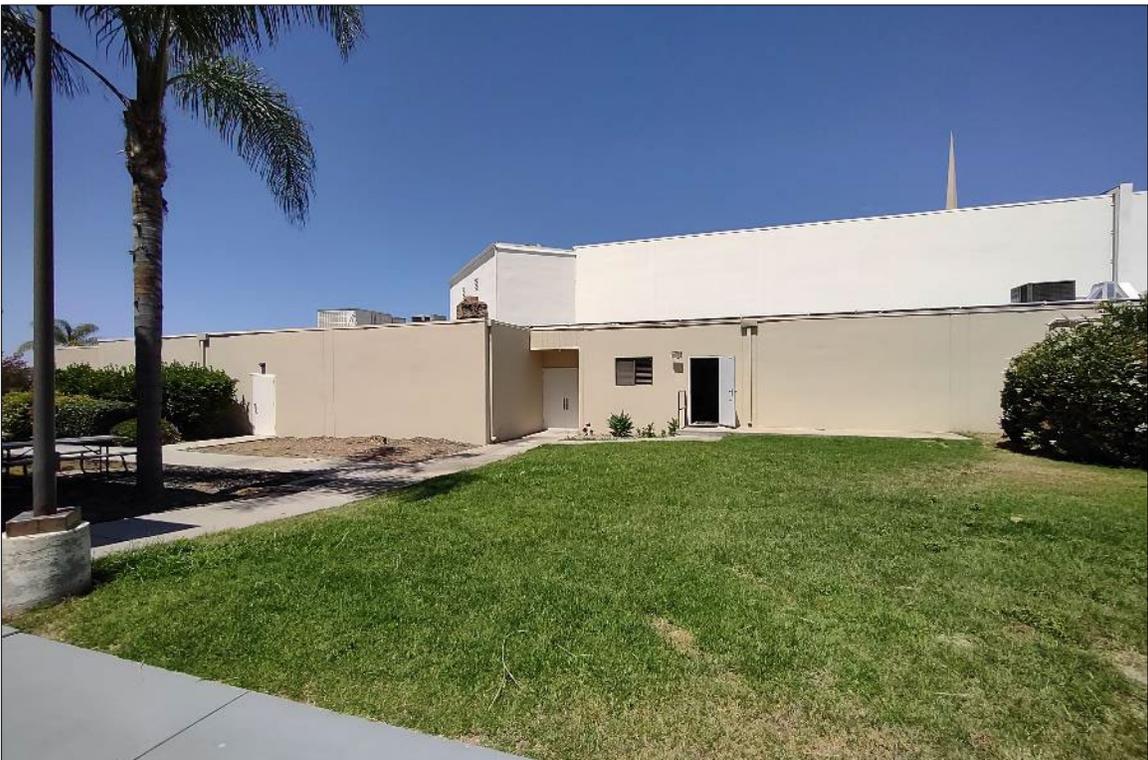
The recessed intervening middle section that is single story contains a recessed pair of entrance doors, a window, and a single entry door at the south end. A blank wall extends north of the single entry door, with wall-mounted wireless equipment and conduit attached to the wall behind a screening tree. The main church wall rises above the single-story element and is a blank wall, with the exception of the vertical duct for the wireless electrical service (Photo 16 and Photo 17).

Photo 16. East elevation fellowship hall with chimney and south end of middle section, facing southwest.

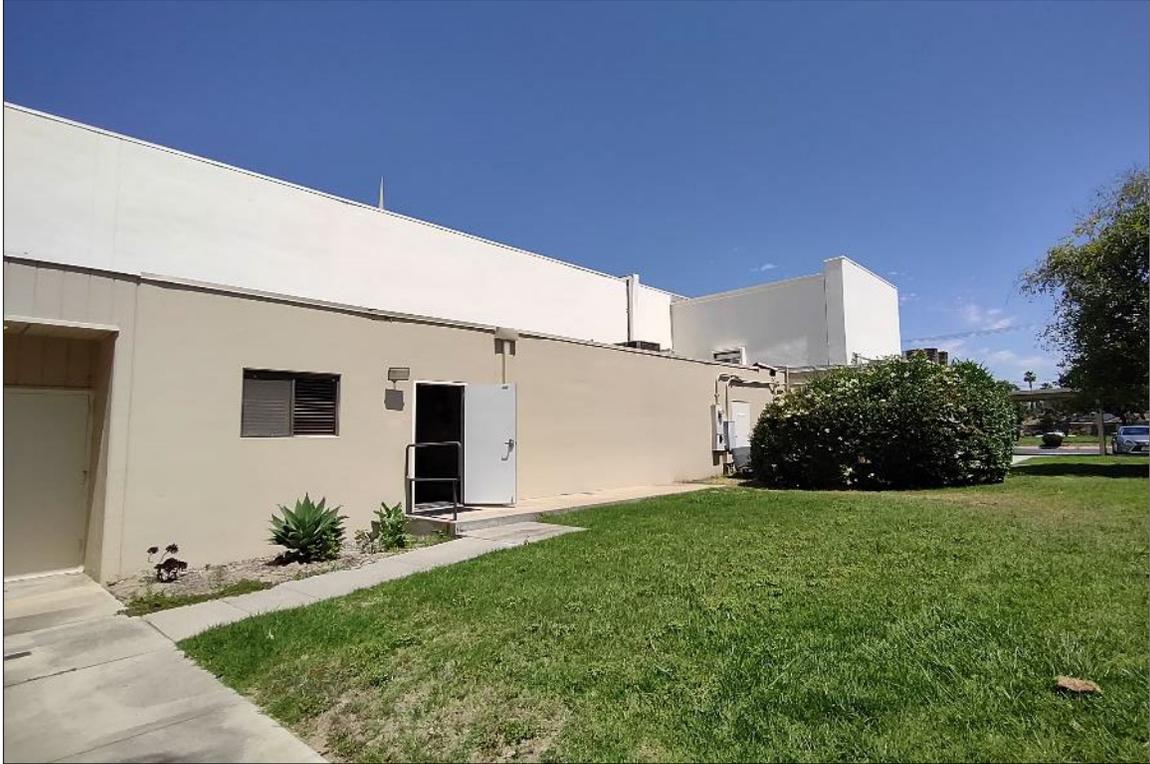
Photo 17. East elevation middle section, facing northwest.

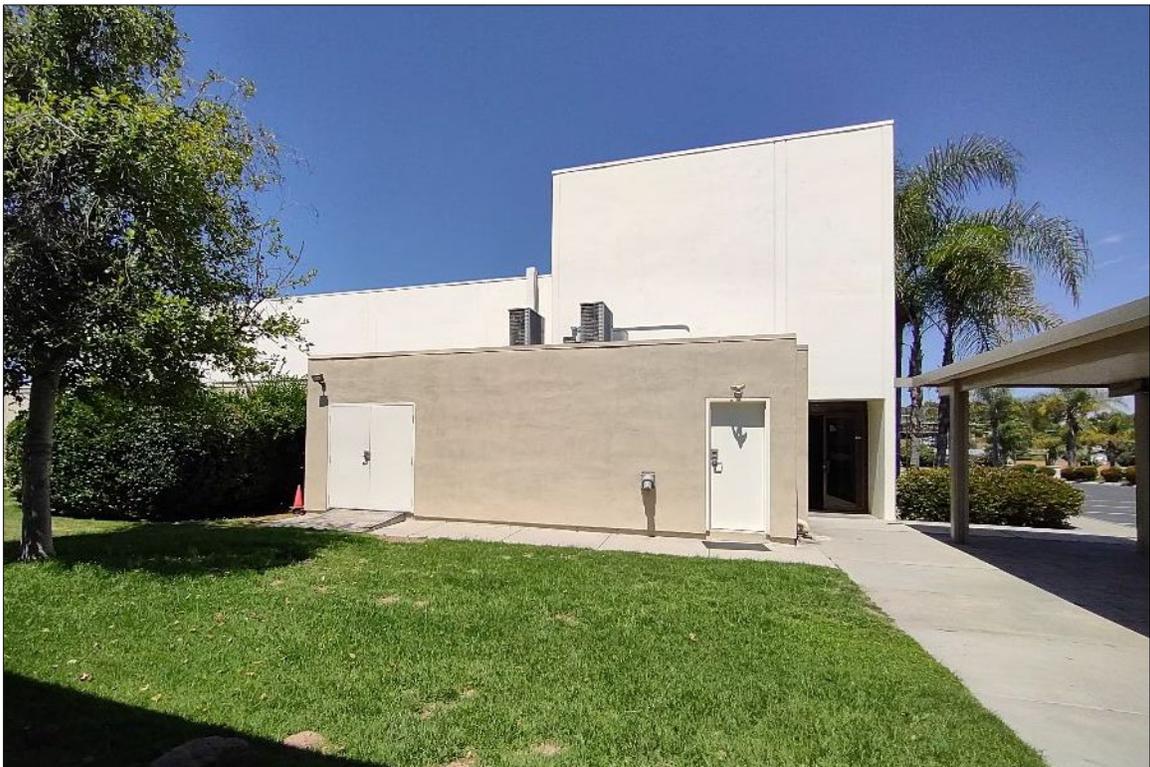
In the north section, the wireless communications equipment and storage addition projects from the original church wall. The northerly end of the elevation features the church's original building projection behind the addition, which houses another interior stairwell to the second floor with a pair of secondary glass entrance doors. A modern covered walkway attached to the education building extends toward, but does not physically connect with, the church (Photo 18).

Photo 18. East elevation north section with single story addition and original secondary entrance, facing west.

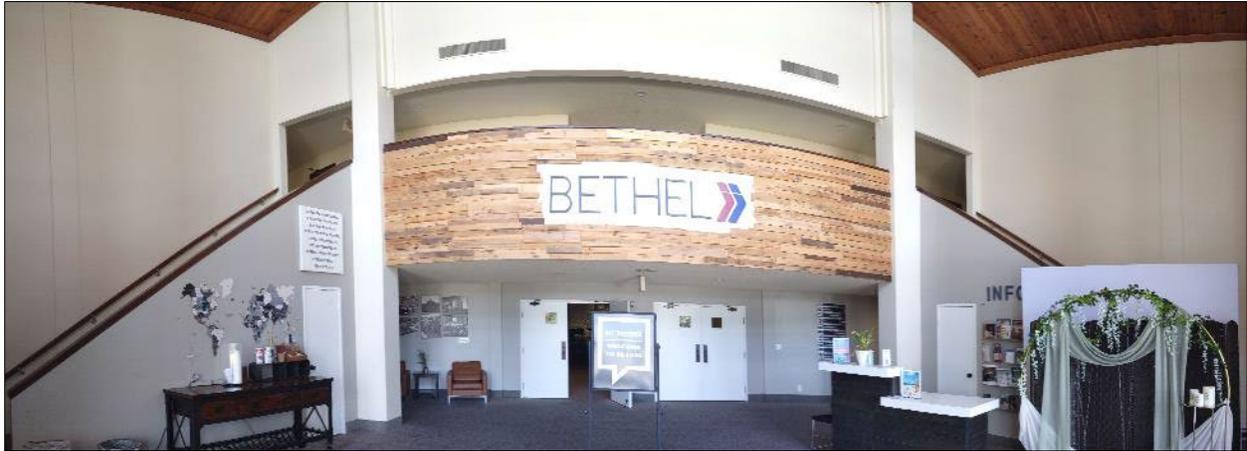
Accessing the building through the glass entry doors at the northwest corner of the building leads to the public lobby of the church. The layout of the lobby, windows, and ceiling appear to be original. Stairs to the right and left lead to a second-floor hallway; the finish material on the hallway railing may not be original. Continuing straight under the overhead hallway leads to doors entering the sanctuary. The lobby ceiling consists of stained wood planks and laminated wood beams that reflect the beginning of the tapered and gabled roof plan (Photo 19, Photo 20, and Photo 21).

Photo 19. Entrance lobby.

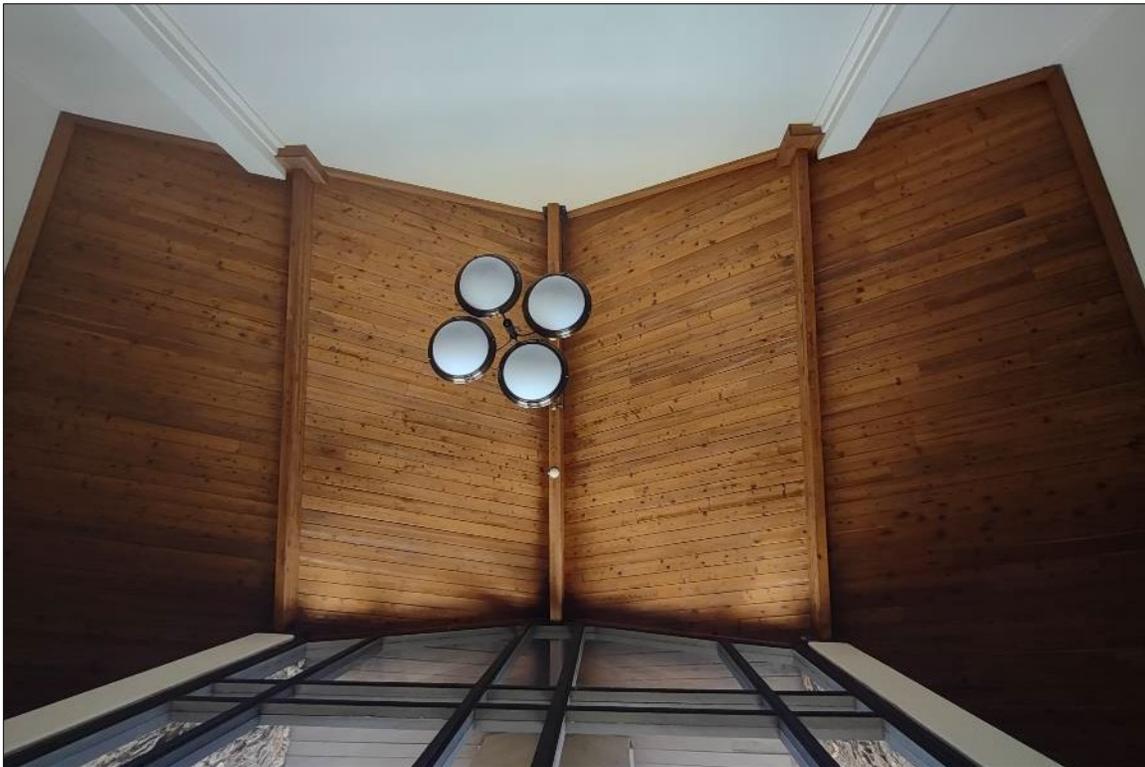
Photo 20. Lobby ceiling.

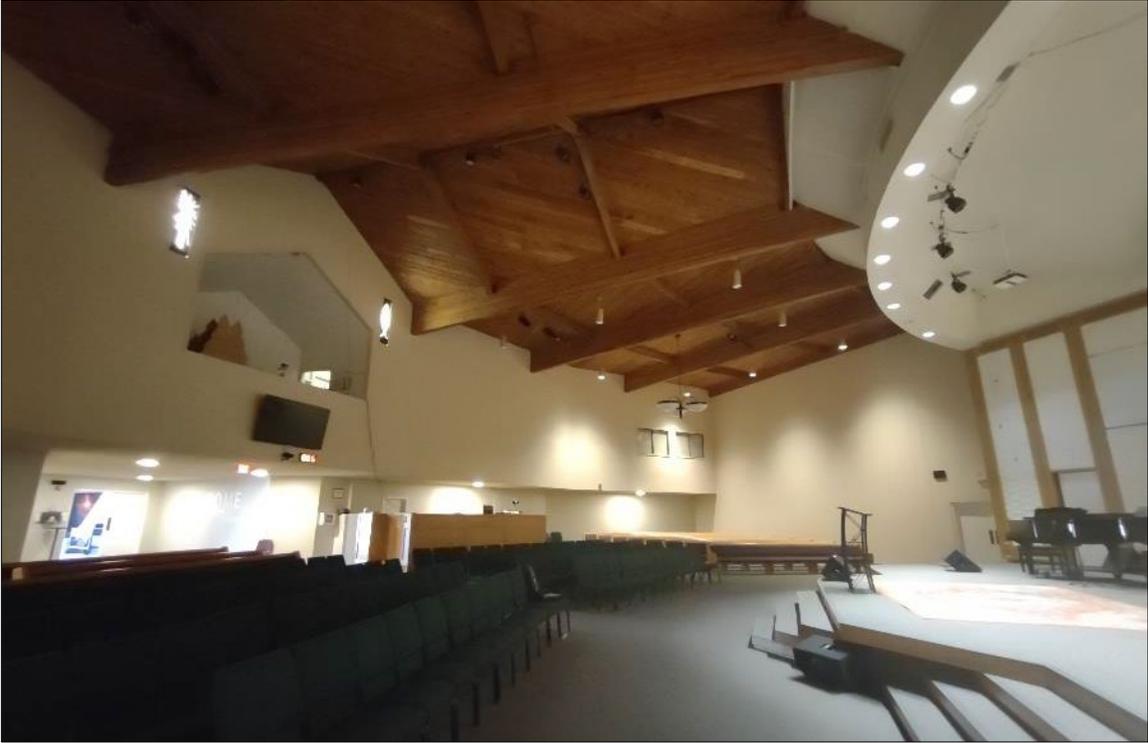
The sanctuary space and ceiling appear to be original. Changes have been made to finish materials, and some of the original pews have been removed in favor of individual chairs (Photo 22 and Photo 23).

Photo 22. Interior sanctuary space, facing north.

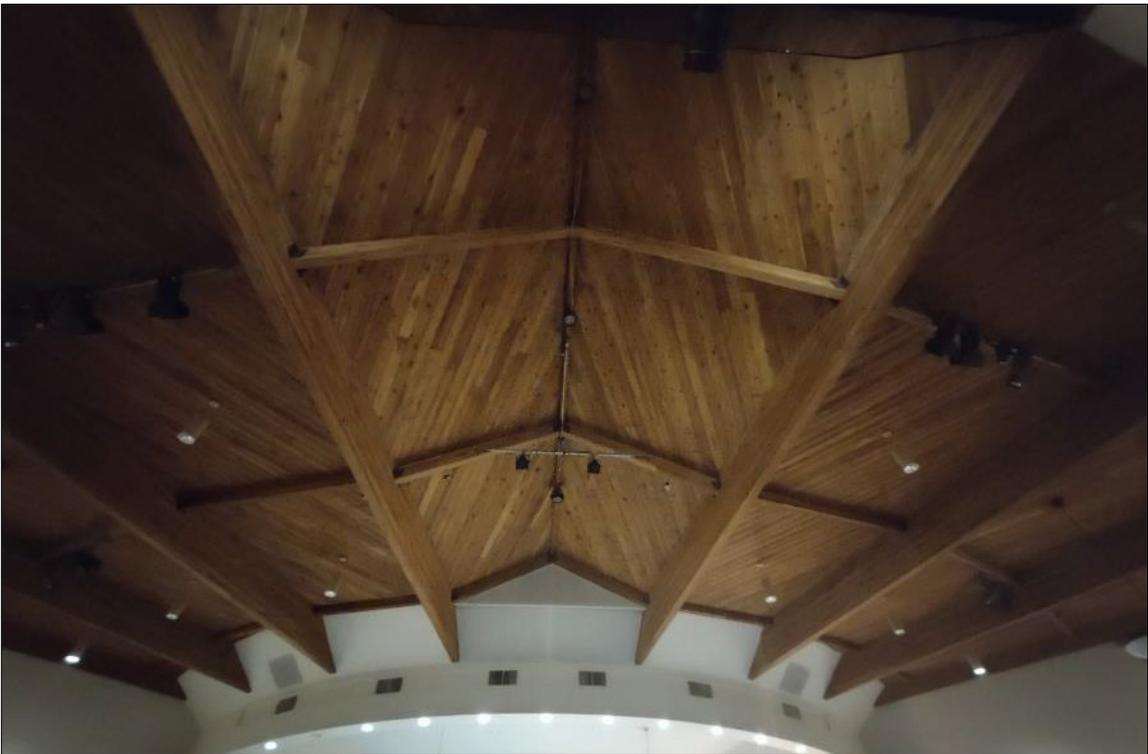
Photo 23. Detail of sanctuary ceiling facing southeast.

The church was constructed of precast concrete panels and some cast-in-place elements. The sanctuary and second floor ceilings were either stained or painted wood planks with laminated wood beams. The gabled roof portion behind the steeple was covered in asphalt composition shingles. The cultured stone on the front of the church flanking the steeple and entrance was replicated on the interior feature wall

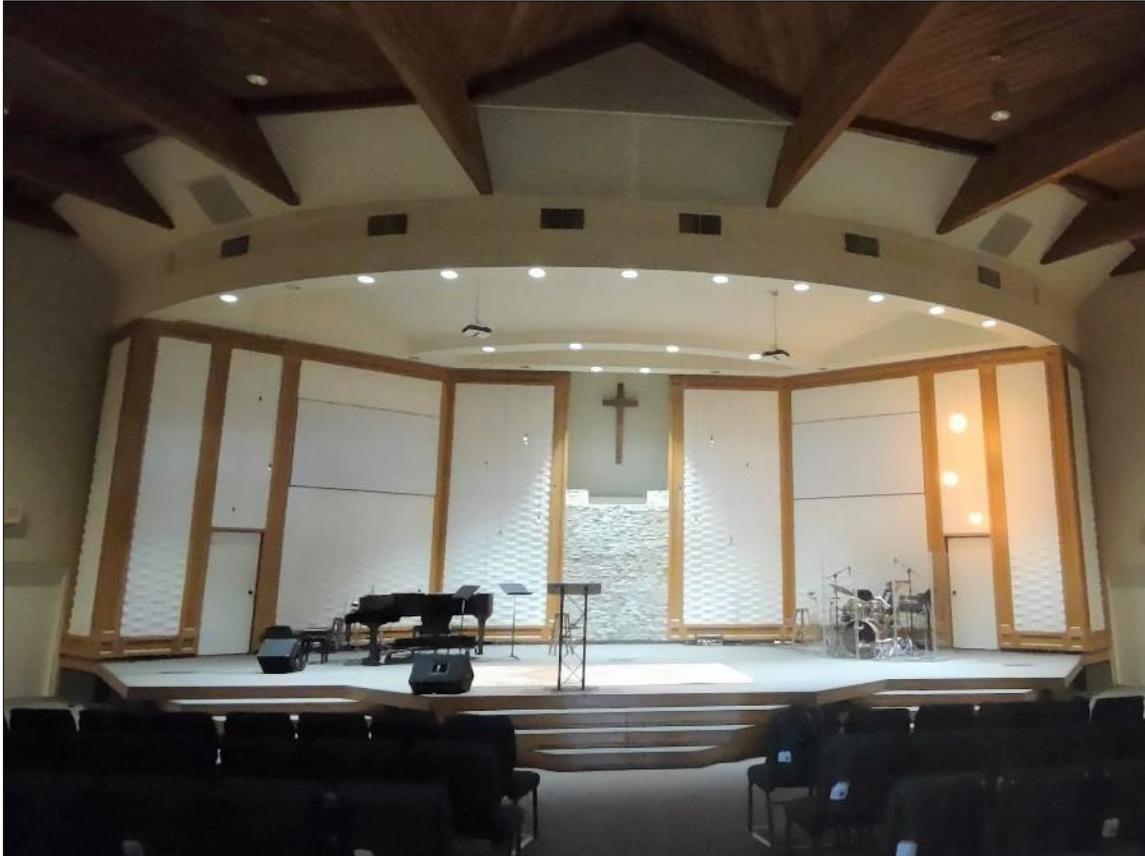
The most significant changes are to the main chancel feature wall and platform area. The wall, originally veneered in cultured stone to match the exterior entry element and featured two-tone chambers (see Section 5.2.1 below), has been removed (or covered). The wall now features modern wood-trimmed sections filled with plastic panels featuring a faux basketweave detail, and a section clad in linear stacked stone at the center below the baptistry and cross. Screen monitors have been added on both sides, and doors are located where the tone chambers were (which originally extended to the floor based on a review of the church archives and historic photos on the lobby wall). The baptistry is reached through the single doors, as well as doors from the hallway behind the sanctuary (Photo 24, Photo 25, and Photo 26).

Photo 24. Interior of sanctuary feature wall, facing southeast.

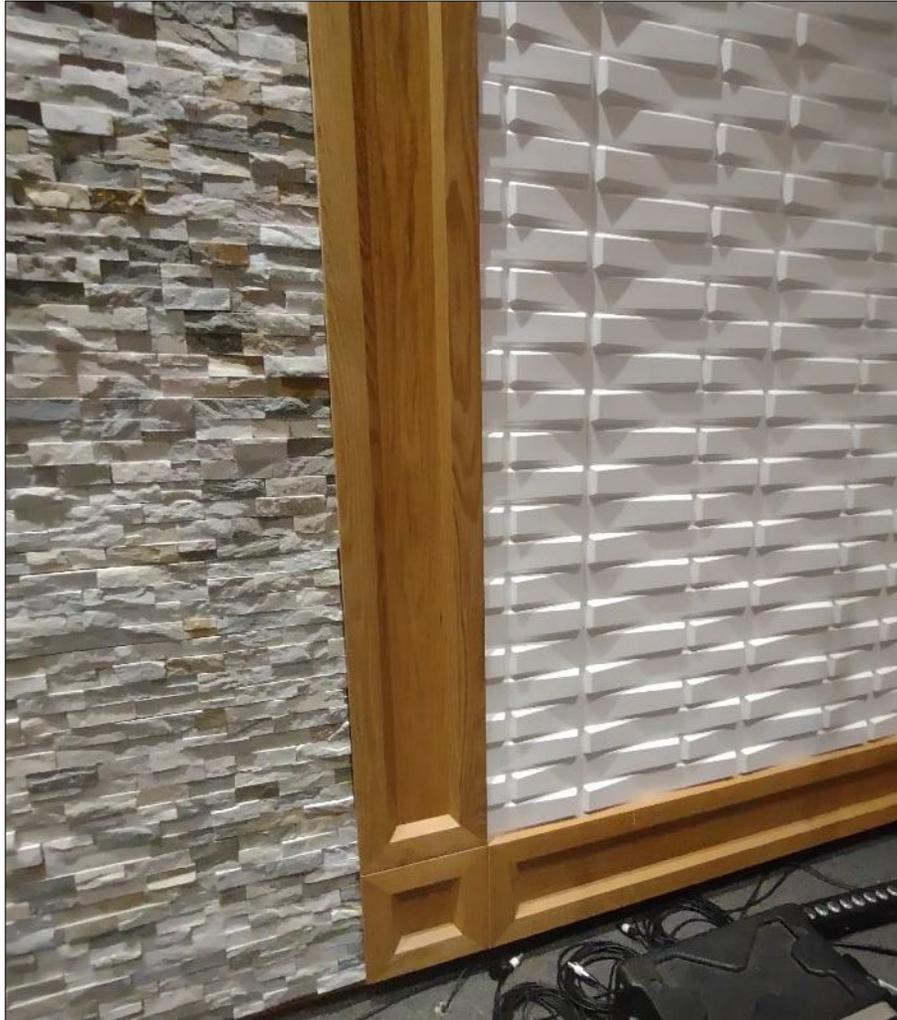
Photo 25. Closeup of wood trim, stacked stone, and plastic, faux basketweave panels.
