Alexan Escondido Project

Historic Resource Evaluation Report

July 2024 | 00876.00006.001

Report Title: Historic Resource Evaluation Report for the Alexan Escondido Project, Escondido, California

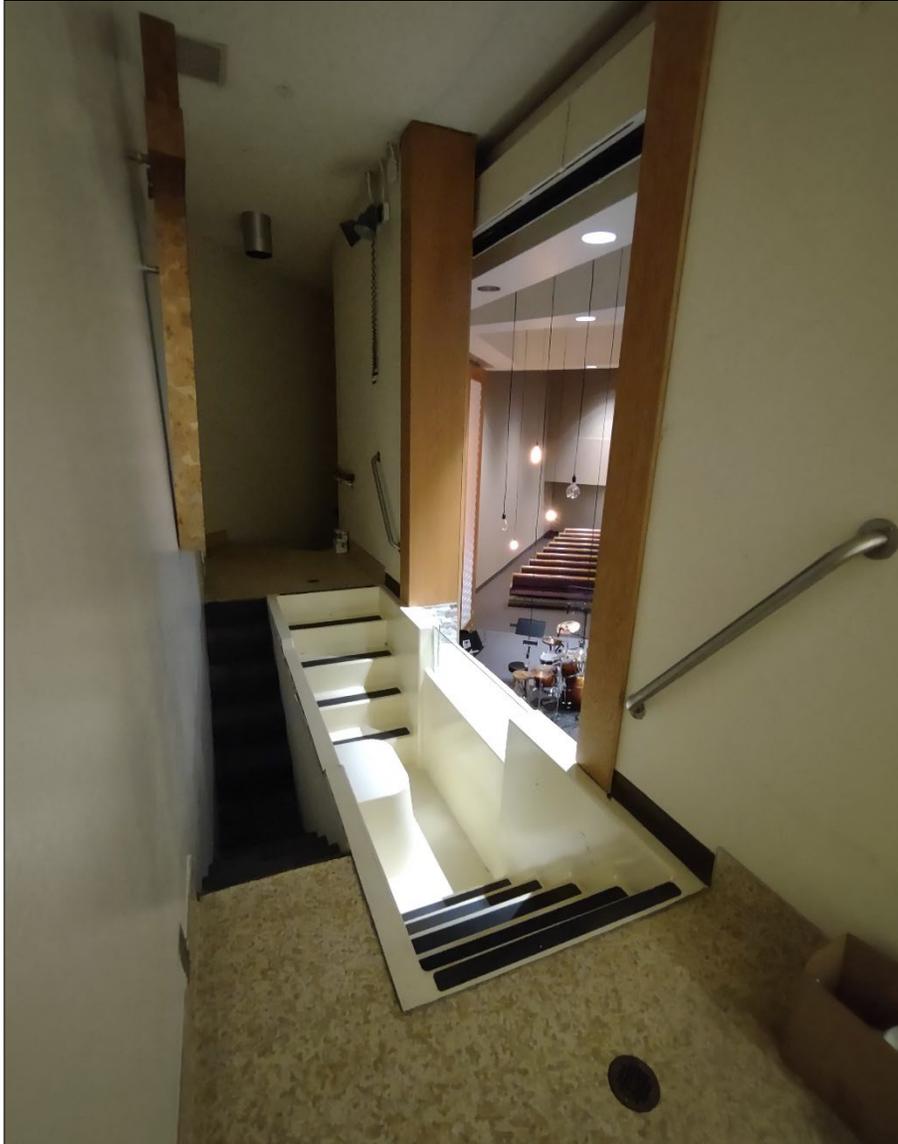
The most significant changes are to the main chancel feature wall and platform area. The wall, originally veneered in cultured stone to match the exterior entry element and featured two-tone chambers (see Section 5.2.1 below), has been removed (or covered). The wall now features modern wood-trimmed sections filled with plastic panels featuring a faux basketweave detail, and a section clad in linear stacked stone at the center below the baptistry and cross. Screen monitors have been added on both sides, and doors are located where the tone chambers were (which originally extended to the floor based on a review of the church archives and historic photos on the lobby wall). The baptistry is reached through the single doors, as well as doors from the hallway behind the sanctuary (Photo 24, Photo 25, and Photo 26).

Photo 26. Baptistry behind feature wall with opening to sanctuary below, cross on wall at left.

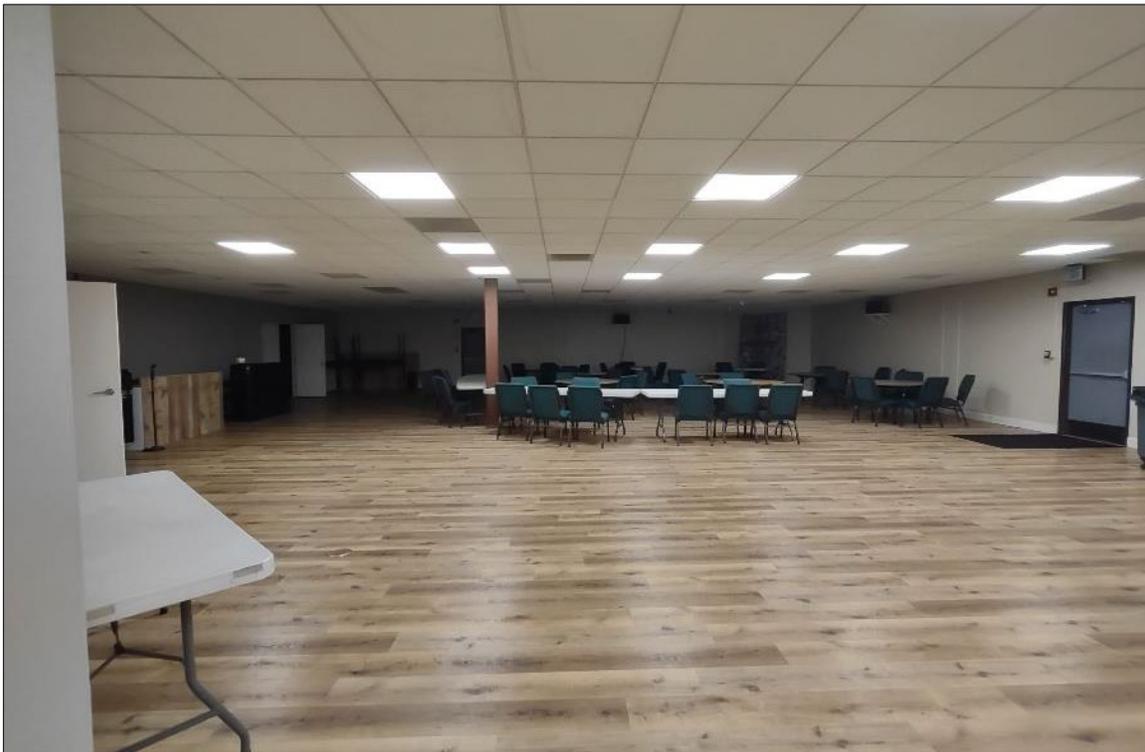
Photo 28. First floor original fellowship hall with dropped acoustical ceiling and modern laminate flooring.

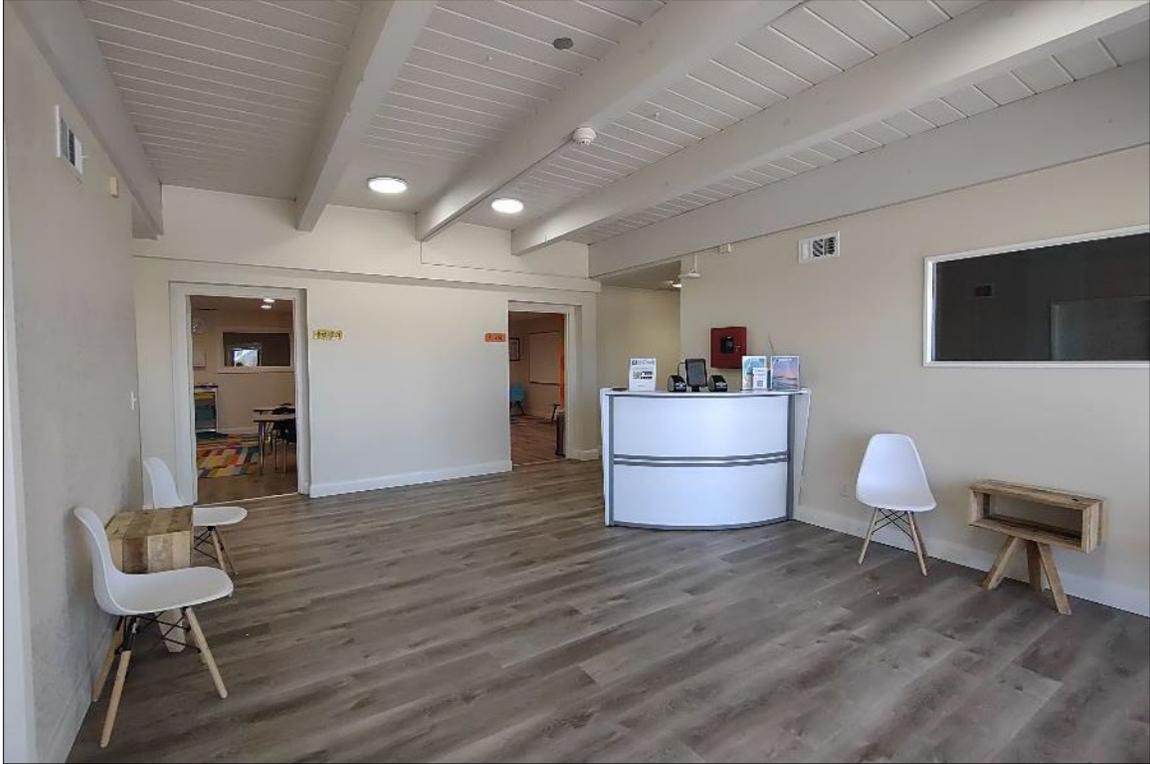
Photo 32. Lobby of classroom addition built circa 1981 with typical finishes. Note similar ceiling materials to original church second floor rooms and two-story volume spaces.

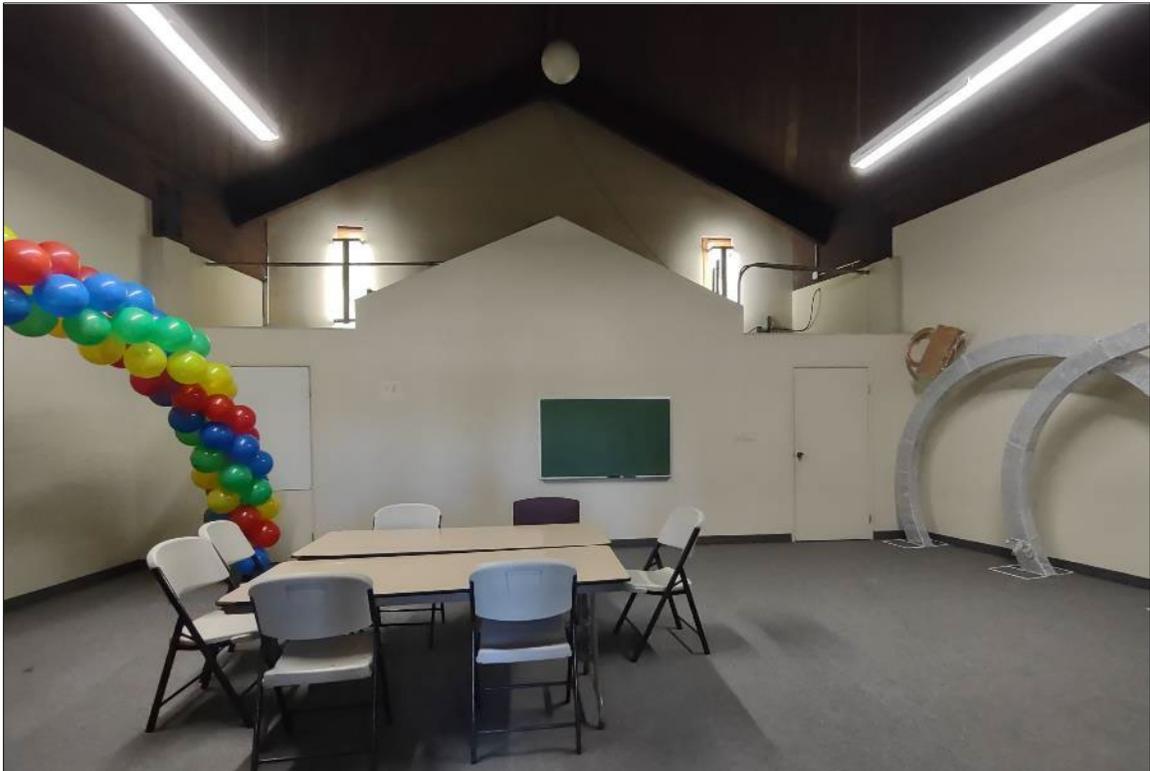
Photo 36. Second floor central room with narrow windows and opening behind partition visible from sanctuary below, with typical finishes and stained wood and beam ceiling.

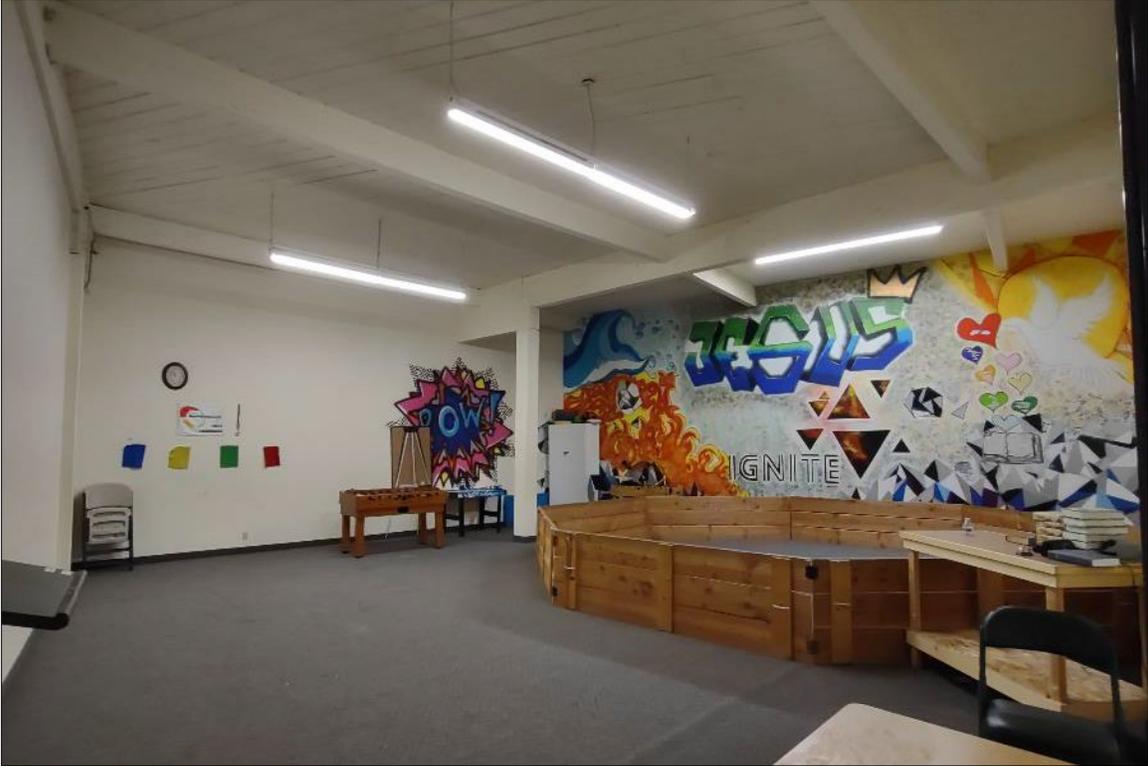
Photo 37. Representative second floor classroom with typical finishes including painted wood and beam ceiling.

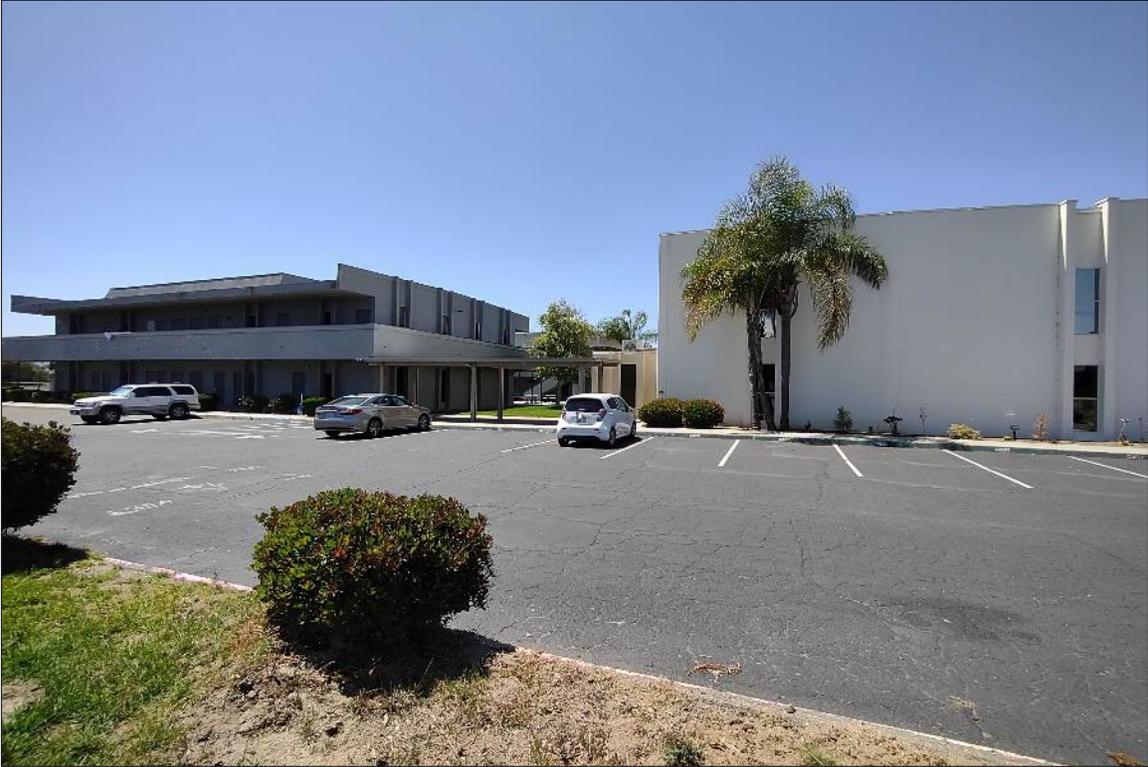
Photo 38. Overview of Building A, church building and partial Building B in center background, facing southeast.

As described in the Historic Context section below, two education buildings are located east of the church building, separated by a landscaped area. The buildings are rectangular in shape, parallel to Brotherton Road and to each other, and are separated by a courtyard. The northerly building, Building A, was built in 1982 and is 10,451 SF in size. The southerly building, Building B, was built in 1993 and is 10,044 SF in size. Although not evaluated due to their modern construction dates, representative photographs of each building are provided below.

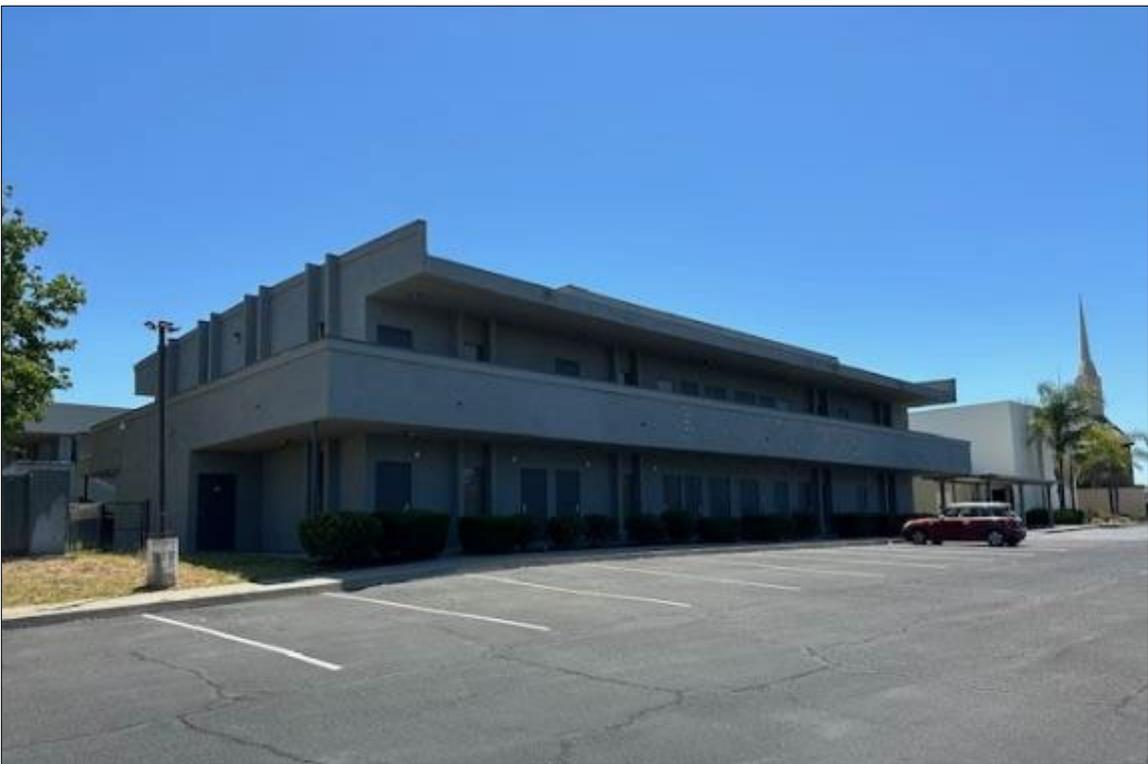
Photo 39. Overview of Building A, north elevation, facing southwest.

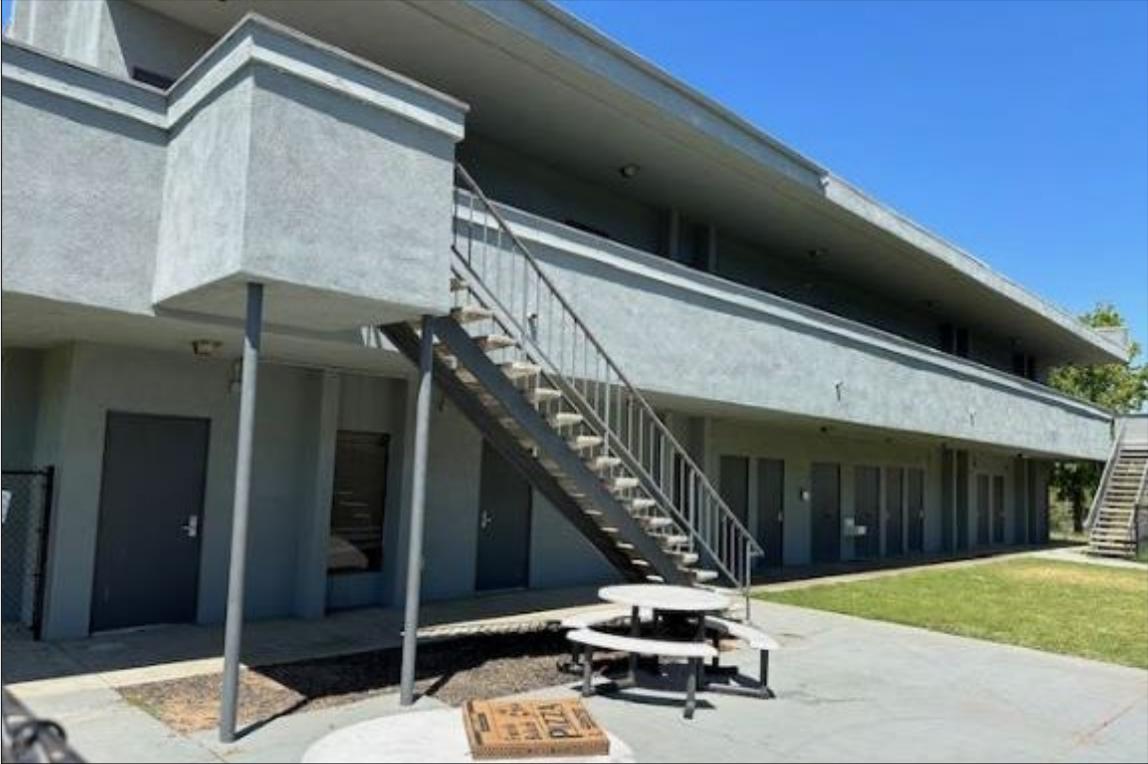
Photo 40. Overview of Building A, south elevation and partial courtyard, facing northeast.

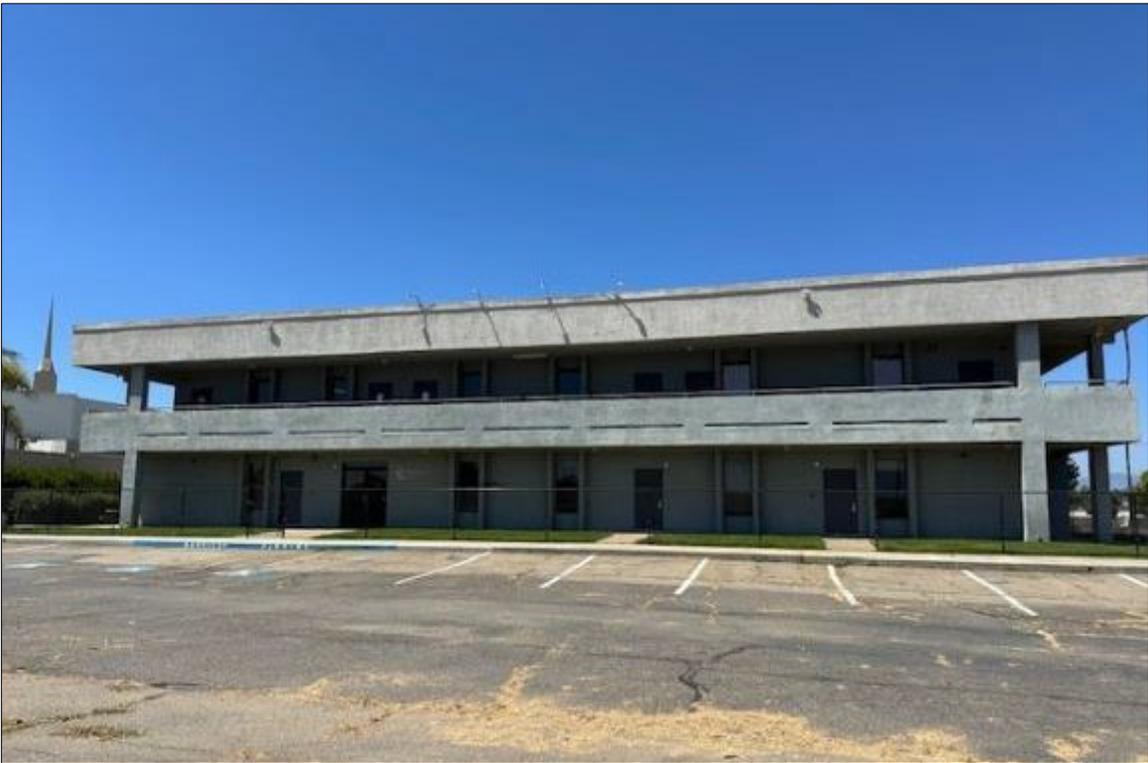
Photo 41. Overview of Building B, south elevation, facing north.

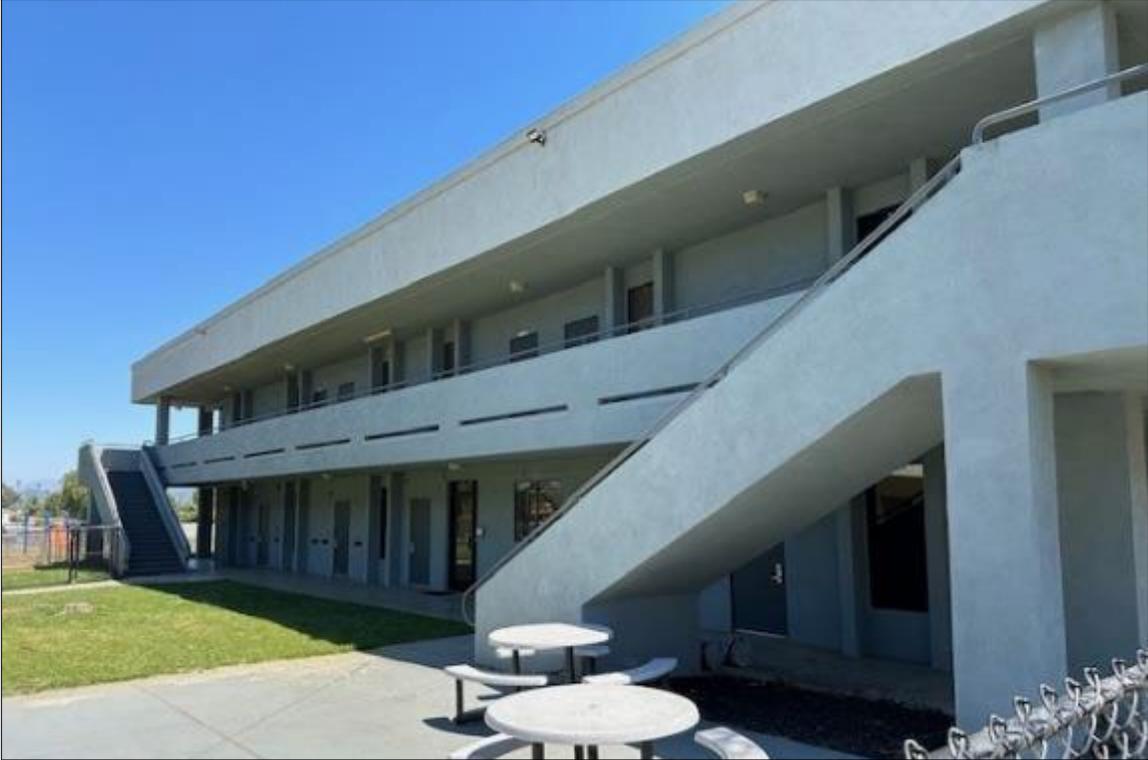
Photo 42. Overview of Building B, north elevation and partial courtyard, facing southeast.

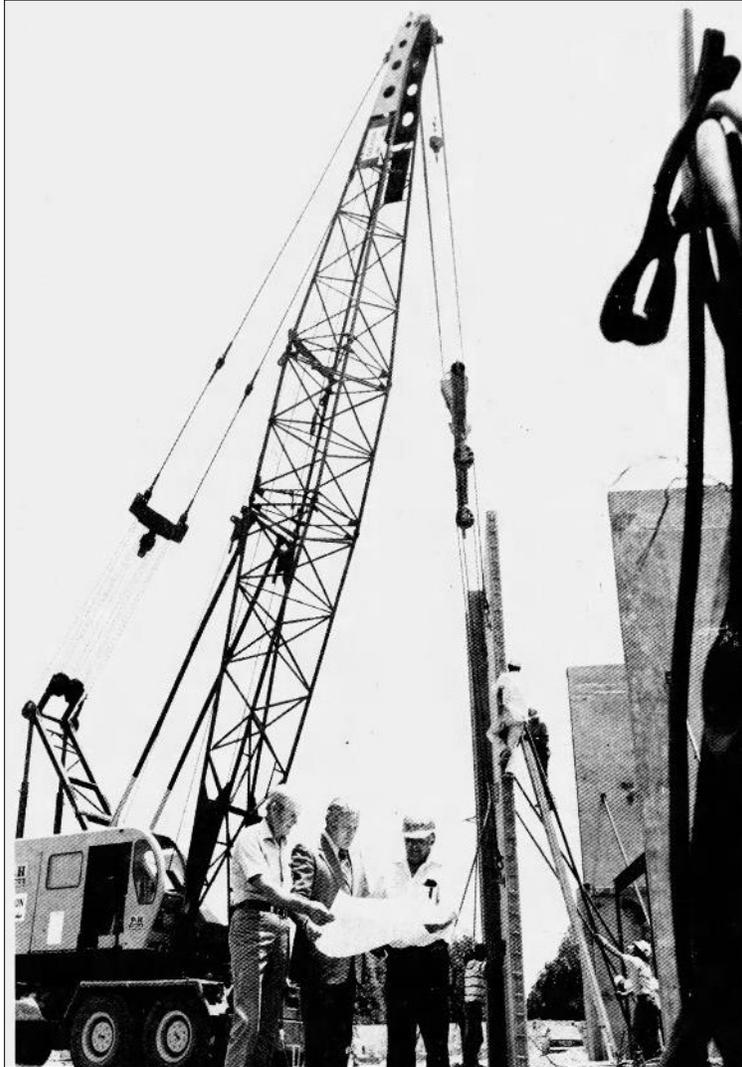
Plate 2. Church under construction, August 1975. Source: *Times-Advocate*, August 1, 1975.

facility will include a sanctuary, fellowship hall with kitchen facilities, five offices, church library and 26 classrooms.”¹ Pews were installed in the sanctuary to provide seating for 572. Plate 2 shows the church under construction in August 1975.

The church was constructed of precast concrete panels and some cast-in-place elements. The sanctuary and second floor ceilings were either stained or painted wood planks with laminated wood beams. The gabled roof portion behind the steeple was covered in asphalt composition shingles. The cultured stone on the front of the church flanking the steeple and entrance was replicated on the interior feature wall

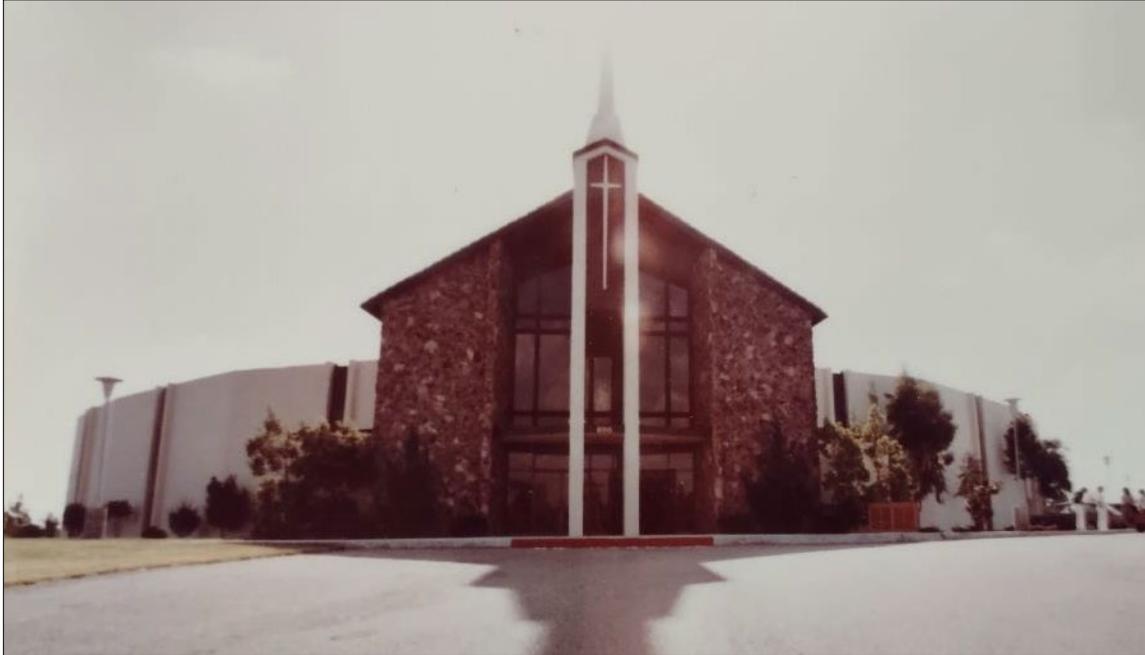
Plate 3. Bethel Baptist Church, 1978. Source: Bethel Baptist Church archives.

of the church sanctuary, with what was referred to on the construction drawings as “tone chambers” with “grill cloth” covering them to both sides of the central baptistry (City of Escondido 2023). Plate 3 shows the exterior appearance of the church in 1978, and Plate 4 shows the original stone veneer wall, baptistry, and flanking tone chambers within the sanctuary.

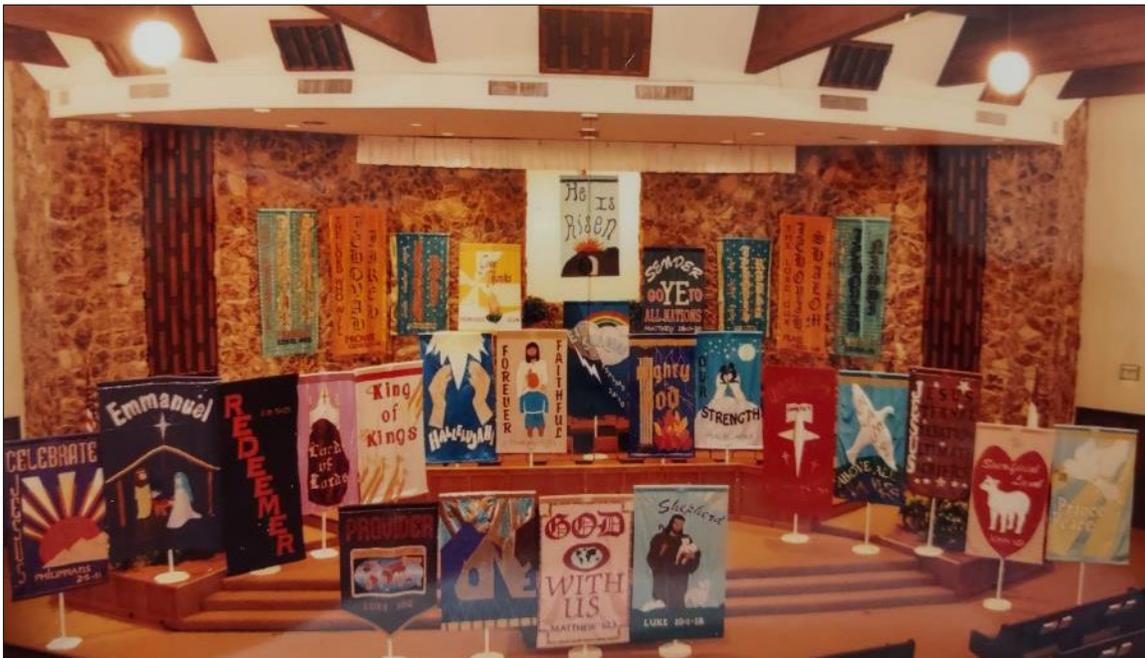
Plate 4. Bethel Baptist Church sanctuary interior, circa 1994. Source: Bethel Baptist Church archives.

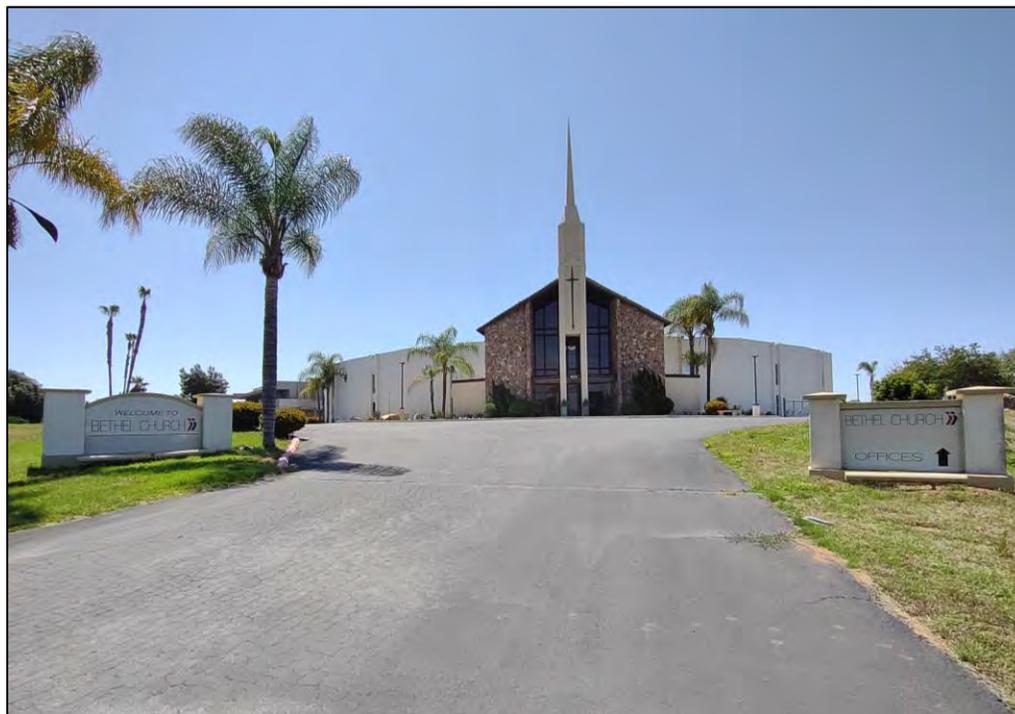
Overview of Bethel Baptist Church from entryway driveway, facing southeast.

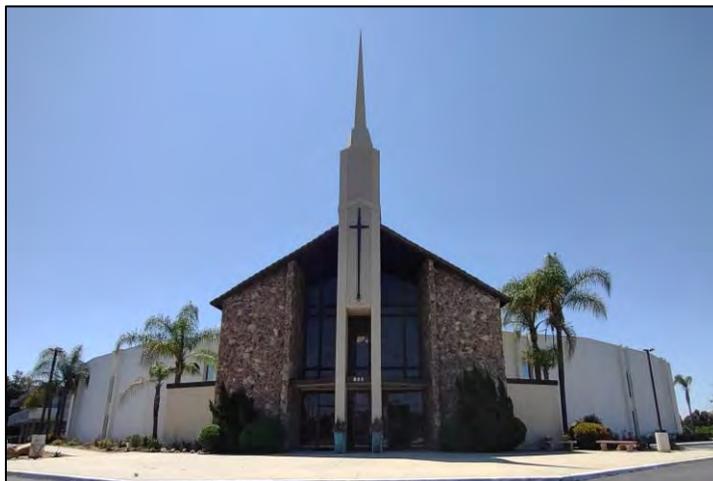
Photo 1. Front Elevation, facing southeast.

The roofs are primarily flat, with only the entry element consisting of a gabled roof covered in non-original concrete S-tiles that is punctuated by the steeple at the gable end. This gabled element tapers and recedes in height as it extends on the northwest-to-southeast axis toward the southeast corner of the church's two-story volume. The parapets surrounding the flat roofs are capped with metal flashing. The following sections describe the exterior elevations of the building, followed by descriptions of the interior that focus primarily on the main, publicly-accessible lobby and sanctuary with additional representative photos of secondary spaces.

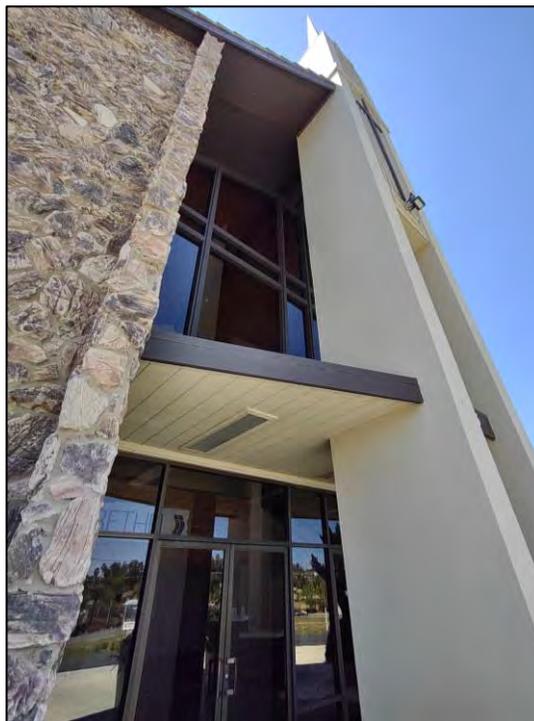
Photo 2. Closeup of entry element covered entrance doors and clerestory window above, left side.

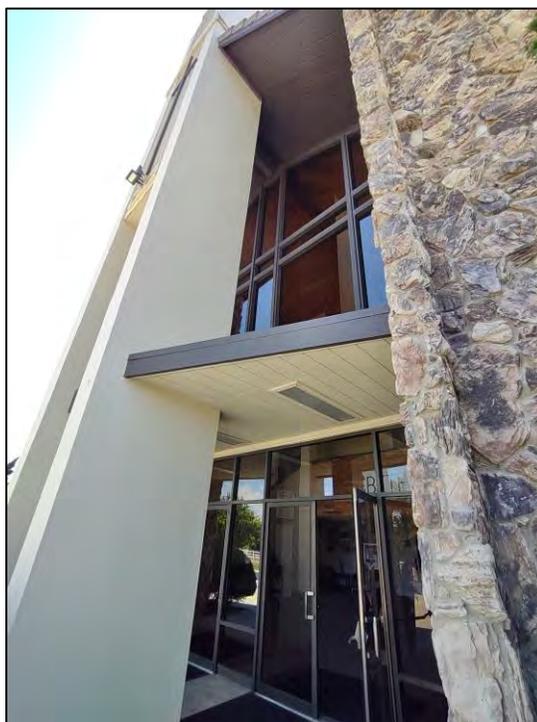
Photo 3. Closeup of entry element covered entrance doors and clerestory window above, right side.

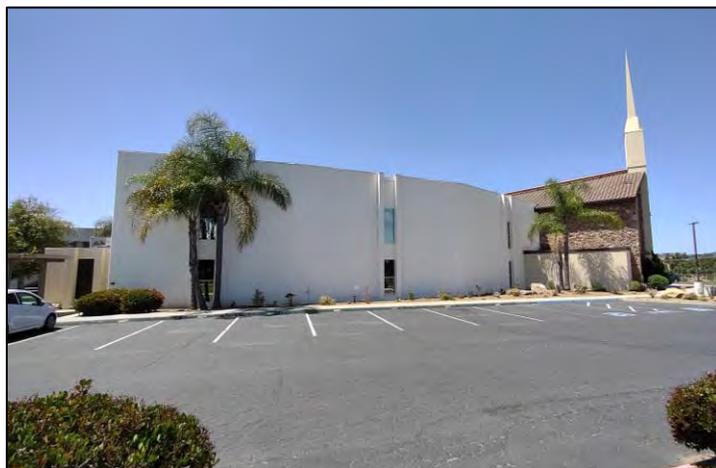
Photo 6. Front Elevation, north facade, facing south.

To both sides of the entry element's stone walls are original, single-story, flat-roofed building projections that are connected to the main building façade. The cultured stone walls wrap both sides of the entry element under the gabled roof. The electrical service feeding the steeple's wireless antennas can be seen within a metal duct that climbs the east slope of the gabled roof. The main building walls on the north and west elevations are painted precast concrete walls with V-groove joints forming very slight angles to create the overall curved appearance of the façade. The walls end in parapets above the roof with metal flashing along the parapet edge. Within each of the three main wall panels are framed, vertical recessed sections with aluminum windows at the first and second floors; the parapets at the recesses are lower than the main parapet, creating a varied roof edge along the front elevation. The main walls and the recessed sections are painted white. The west end of the single-story classroom addition is recessed and visible at the south end of the west façade. Photo 6 and Photo 7 show the north and west facades of the front elevation, respectively.

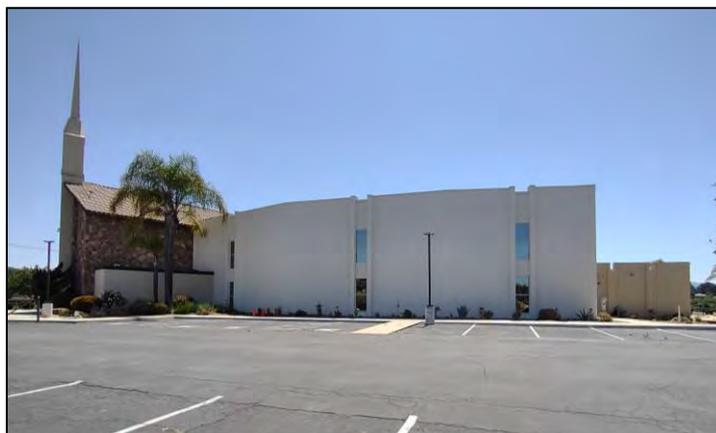
Photo 7. Front Elevation, west facade, facing east.

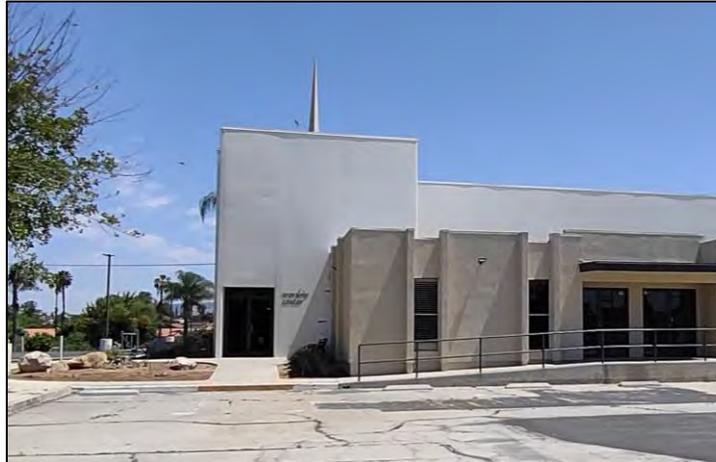
Photo 8. Side Elevation, west end facing north.

The south side elevation is the single side elevation and exhibits the original side of the church that is visible above and between three addition areas including a Sunday School classroom addition with its own entrance built circa 1981, and storage additions to the kitchen and the fellowship hall built circa 2000. The additions obscure much of the original building elevation on this side. The additions are single story with flat roofs and parapets with metal flashing. The church walls on this side are unadorned but feature score joints at appropriate locations. The parapet walls are the same height along the elevation. The westerly end of the elevation features a building projection that houses the interior stairwell to the second floor, along with a pair of secondary entrance doors. A sign to the right of the doors reads "Worship Center" (Photo 8).

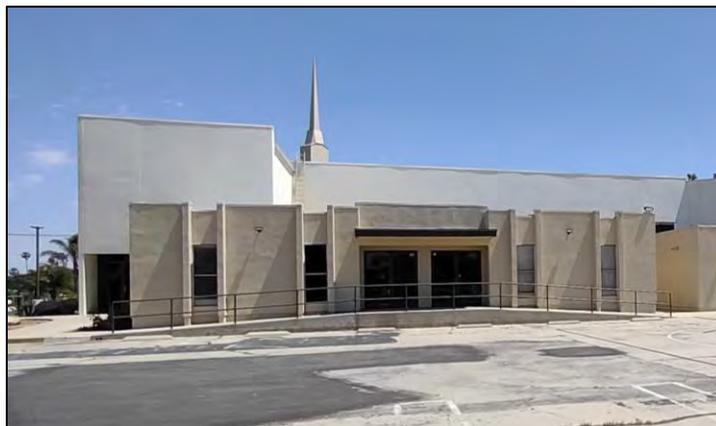
Photo 9. Side Elevation classroom addition, facing north.

To the right of the secondary entrance doors is the projecting classroom addition. It is symmetrically arranged and mimics the front elevation's main walls. Two pairs of entry doors are located in the center of the addition's facade, elevated above the level of the parking lot. The entrance is covered by a flat concrete ledge and is accessed from both ends of the addition by a concrete ramp with a pipe railing. On the main walls at both sides of the entrance are two framed, vertical recesses with windows; the wall sections above the windows are clad in T1-11 siding. The parapets at the recessed sections are lower than the main walls, while the parapet above the entry ledge is slightly elevated, creating a varied roof line for the addition. The addition appears to be wood framed rather than precast concrete (Photo 9).

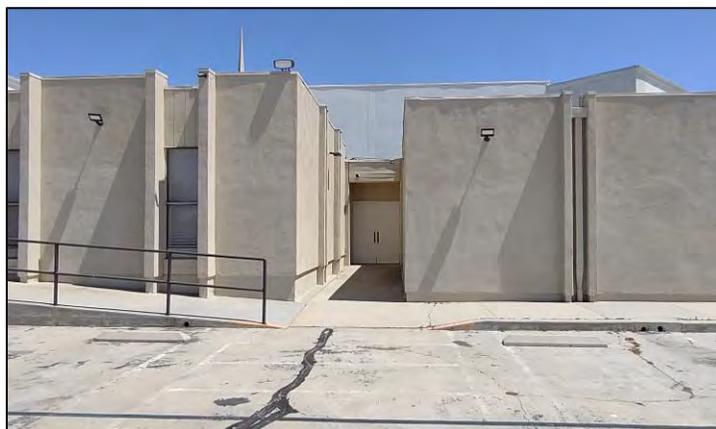
Photo 10. Closeup of break between additions, facing north.

A narrow break occurs to the east of the classroom addition to provide access to a pair of church exit doors. The projecting kitchen addition frames the other side of the narrow break and also appears to be of wood frame construction with no windows. A very narrow vertical recess in the center of the addition's blank wall echoes others on the church but has no window and appears to house a scupper and roof drain (Photo 10).

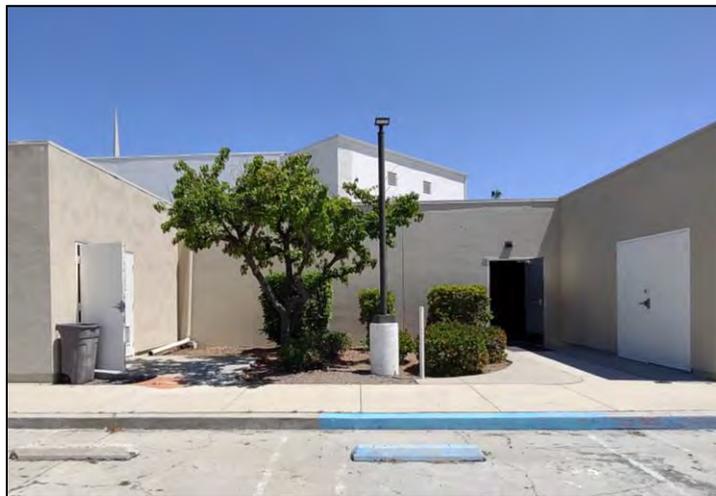
Photo 11. Closeup of courtyard between kitchen and fellowship hall additions, facing north.

A pair of doors occurs on the east side of the kitchen addition. A recessed, landscaped courtyard provides a view to the original church wall which features an exterior entrance to the fellowship hall. To the right of the entrance is the final projecting storage addition, which also features blank walls, punctuated only on the west side by a pair of doors. The south façade has a sign reading "Fellowship Center" at the west end, and two, narrow vertical projections whose purpose could not be discerned (Photo 11 and Photo 12).

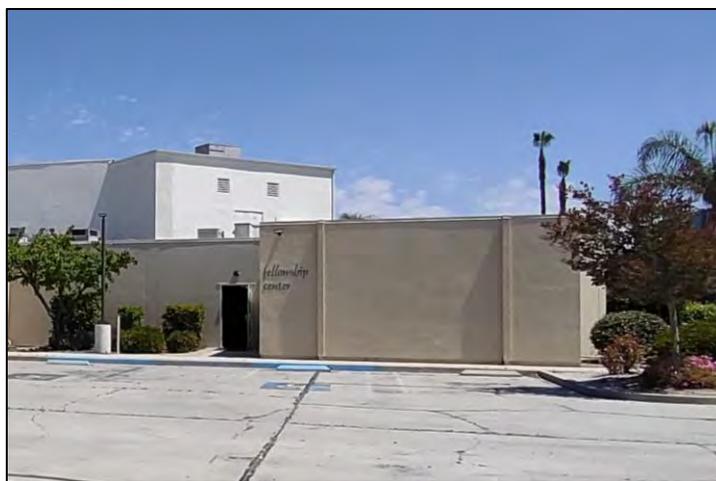
Photo 12. South elevation, east end, facing northwest.

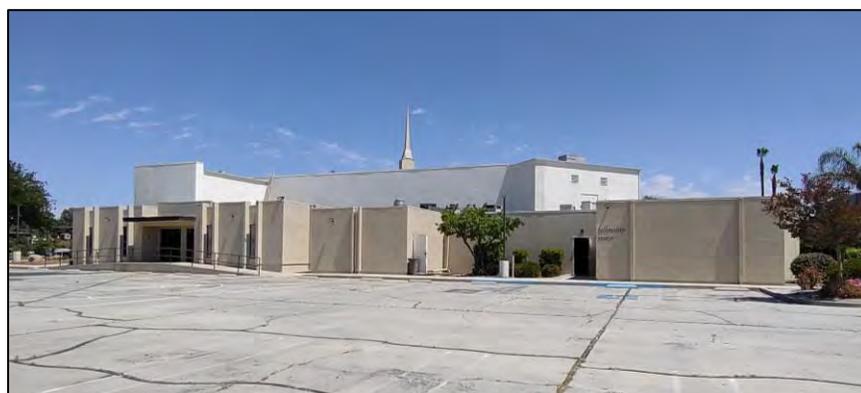
Photo 13. South elevation, facing northwest.

louvred vents and a pair of roof access doors. Roof mounted equipment is located in various areas of the flat roofs. The spire is visible from the parking lot rising above and beyond church parapet walls (Photo 13).

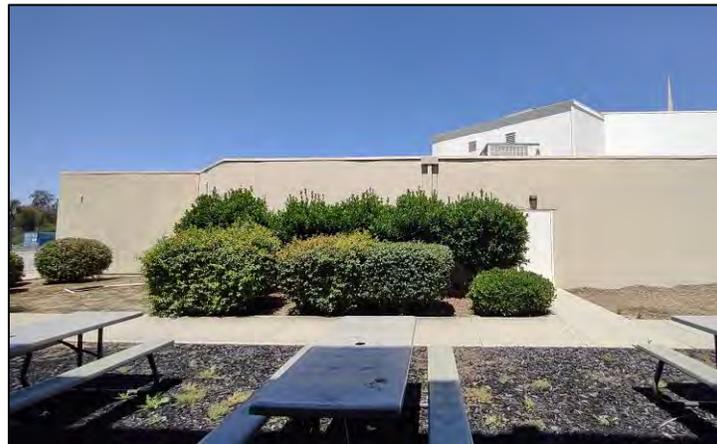
Photo 14. South end of east elevation, facing west.

The rear elevation faces east toward the two modern education buildings. The east side of the single-story fellowship hall storage addition is located at the southerly end. Directly north of the addition are the original angled southeast corners of the church above and fellowship hall below that angle to the east elevation. The fellowship hall east elevation features a chimney rising above the roof near the corner of the building projection (Photo 14 and Photo 15).

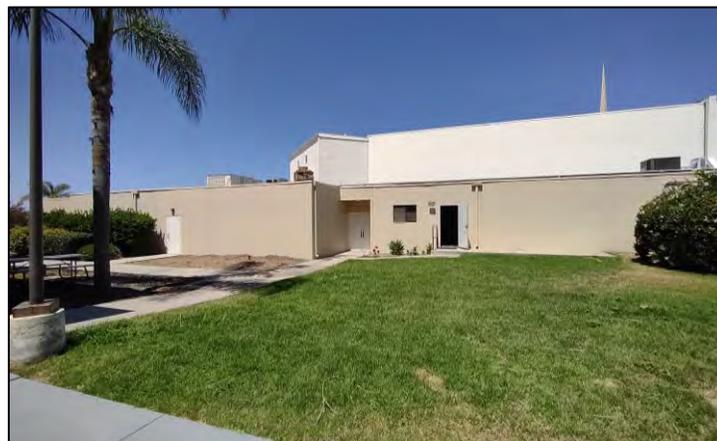
Photo 15. East elevation fellowship hall with chimney and south end of middle section, facing southwest.

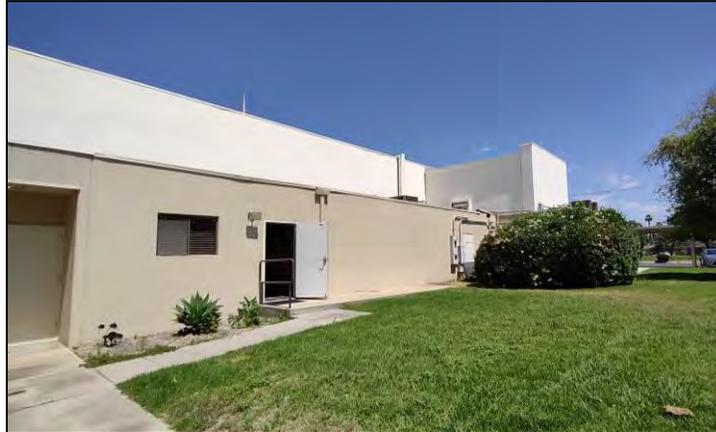
Photo 16. East elevation middle section, facing northwest.

The recessed intervening middle section that is single story contains a recessed pair of entrance doors, a window and a single entry door at the south end. A blank wall extends to the north of the single entry door, with wall-mounted wireless equipment and conduit attached to the wall behind a screening tree. The main church wall rises above the single-story element and is a blank wall with the exception of the vertical duct for the wireless electrical service (Photo 15 and Photo 16).

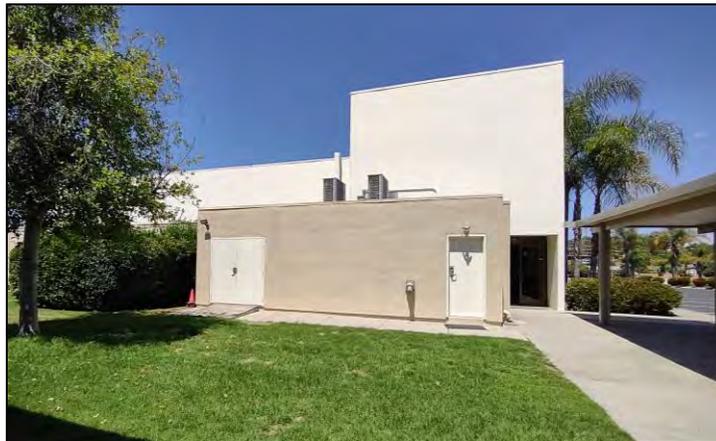
Photo 17. East elevation north section with single story addition and original secondary entrance, facing west.

At the north section, the wireless communications equipment and storage addition projects from the original church wall. The northerly end of the elevation features the church's original building projection behind the addition, which houses another interior stairwell to the second floor with a pair of secondary glass entrance doors. A modern covered walkway attached to the education building extends toward, but does not physically connect with, the church (Photo 17).

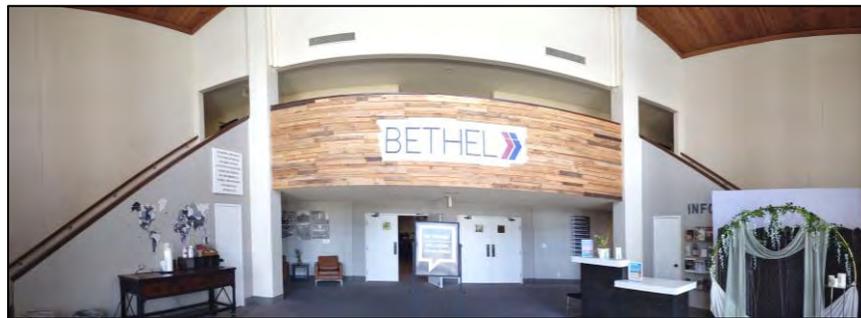
Photo 18. Entrance lobby.

Accessing the building through the glass entry doors at the northwest corner of the building leads to the public lobby of the church. The layout of the lobby, windows and ceiling appear to be original. Stairs to the right and left lead to a second-floor hallway; the finish material on the hallway railing may not be original. Continuing straight under the overhead hallway leads to doors entering the sanctuary. The lobby ceiling consists of stained wood planks and laminated wood beams that reflect the beginning of the tapered and gabled roof plan (Photo 18, Photo 19 and Photo 20). The sanctuary space and ceiling appear to be original. Changes have been made to finish materials, and some of the original pews have been removed in favor of individual chairs (Photo 21 and Photo 22).

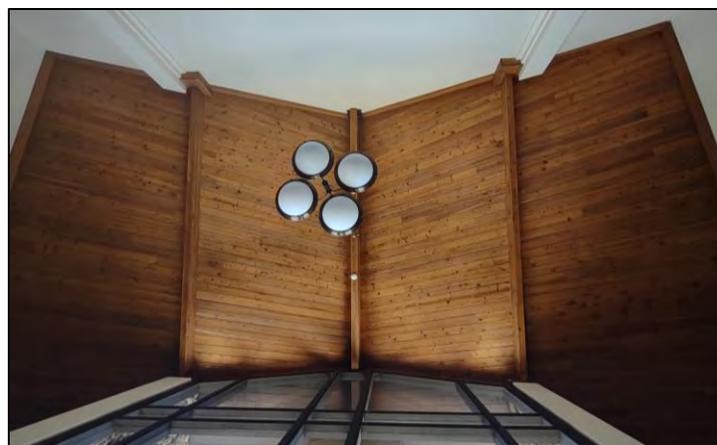
Photo 19. Lobby ceiling.

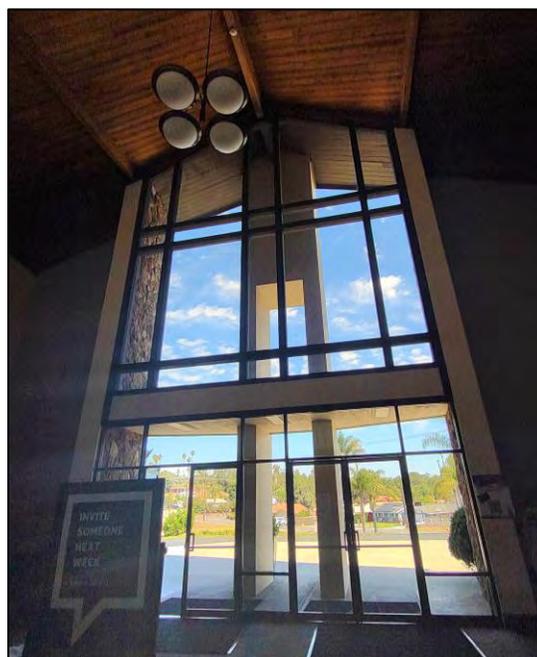
Photo 20. Closeup of entry element doors and clerestory window.

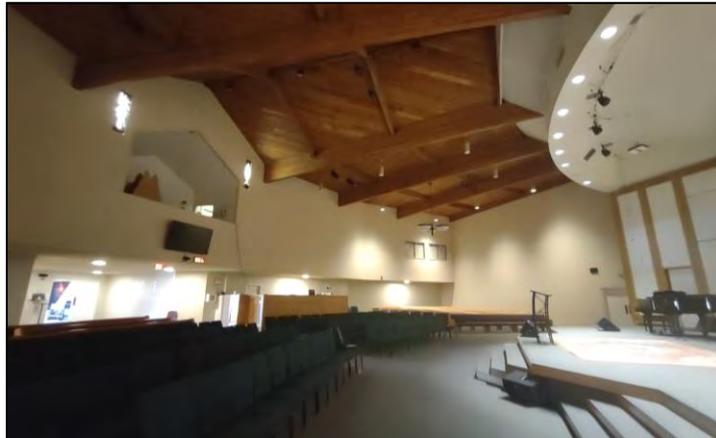
Photo 21. Interior sanctuary space, facing north.

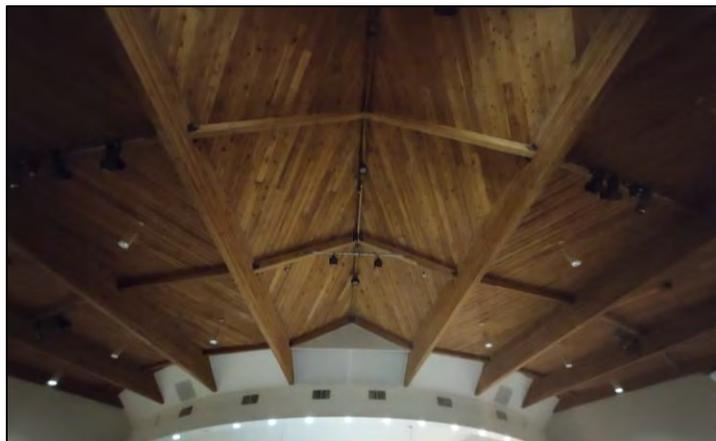
Photo 22. Detail of sanctuary ceiling facing southeast.

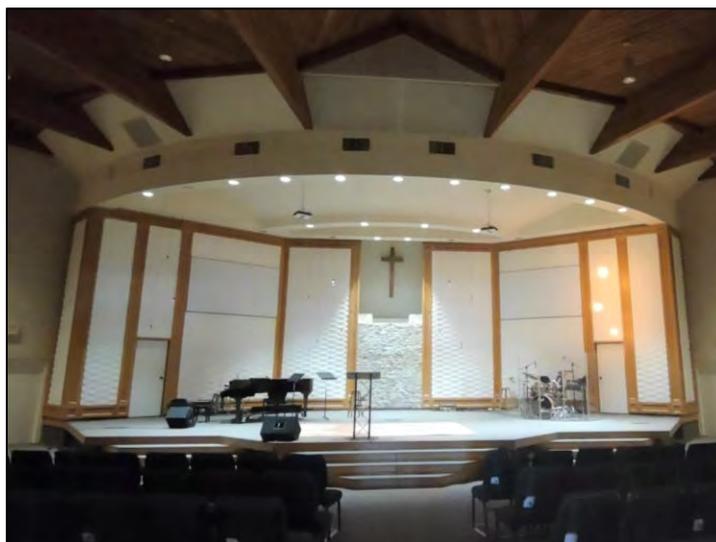
Photo 23. Interior of sanctuary feature wall, facing southeast.

The most significant changes are to the main chancel feature wall and platform area. The wall that was originally veneered in cultured stone to match the exterior entry element and featured two tone chambers (see Section 4.2.1 below) has been removed (or covered). The wall now features modern wood-trimmed sections filled with plastic panels featuring a faux basketweave detail, and a section clad in linear stacked stone at the center below the baptistry and cross. Screen monitors have been added on both sides, and doors are located where the tone chambers were (and which originally extended to the floor based on a review of the church archives and historic photos on the lobby wall). The baptistry is reached through the single doors, as well as doors from the hallway behind the sanctuary (Photo 23, Photo 24 and Photo 25).
