Alexan Escondido Project

Historic Resource Evaluation Report

July 2024 | 00876.00006.001

Report Title: Historic Resource Evaluation Report for the Alexan Escondido Project, Escondido, California

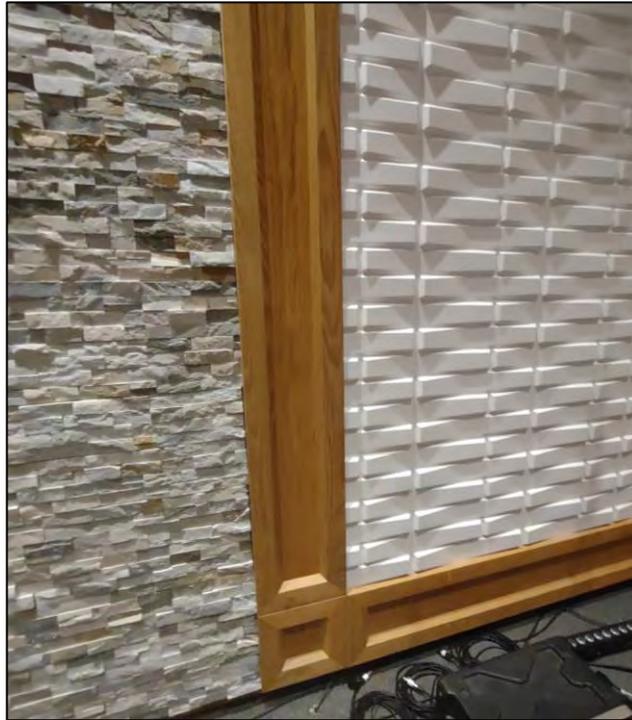
Photo 24. Closeup of wood trim, stacked stone and plastic faux basketweave panels.

The most significant changes are to the main chancel feature wall and platform area. The wall that was originally veneered in cultured stone to match the exterior entry element and featured two tone chambers (see Section 4.2.1 below) has been removed (or covered). The wall now features modern wood-trimmed sections filled with plastic panels featuring a faux basketweave detail, and a section clad in linear stacked stone at the center below the baptistry and cross. Screen monitors have been added on both sides, and doors are located where the tone chambers were (and which originally extended to the floor based on a review of the church archives and historic photos on the lobby wall). The baptistry is reached through the single doors, as well as doors from the hallway behind the sanctuary (Photo 23, Photo 24 and Photo 25).

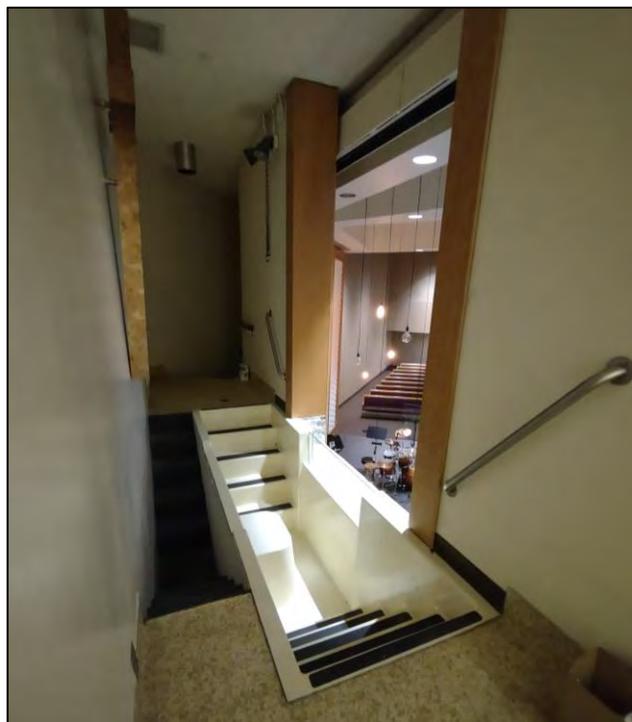
Photo 25. Baptistry behind feature wall with opening to sanctuary below, cross on wall at left.

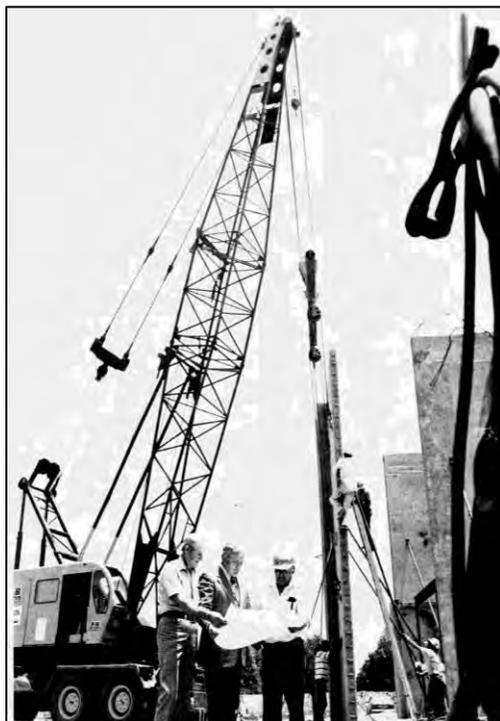
Plate 2. Church under construction, August 1975. Source: Times-Advocate, August 1, 1975.

include a sanctuary, fellowship hall with kitchen facilities, five offices, church library and 26 classrooms.”¹ Pews were installed in the sanctuary to provide seating for 572. Plate 2 shows the church under construction in August 1975.

The church was constructed of precast concrete panels and some cast-in-place elements. The sanctuary and second floor ceilings were either stained or painted wood planks with laminated wood beams. The gabled roof portion behind the steeple was covered in asphalt composition shingles. The cultured stone on the front of the church flanking the steeple and entrance was replicated on the interior feature wall of the church sanctuary, with what were referred to on the construction drawings as “tone chambers” with “grill cloth” covering them to both sides of the central baptistry (City of Escondido 2023). Plate 3 shows the exterior appearance of the church in 1978, and Plate 4 shows the original stone veneer wall, baptistry and flanking tone chambers within the sanctuary.

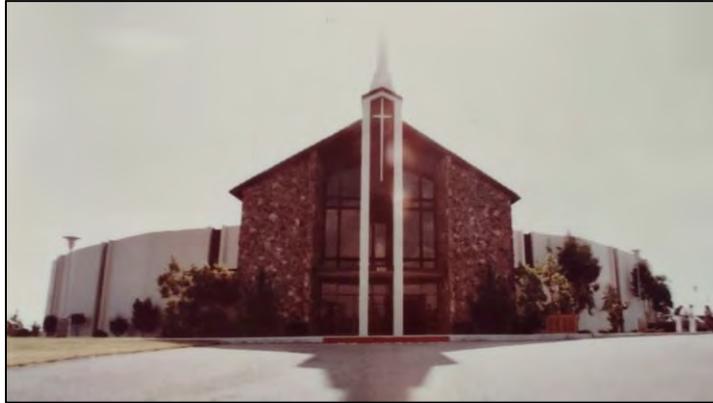
Plate 3. Bethel Baptist Church, 1978. *Source: Bethel Baptist Church archives.*

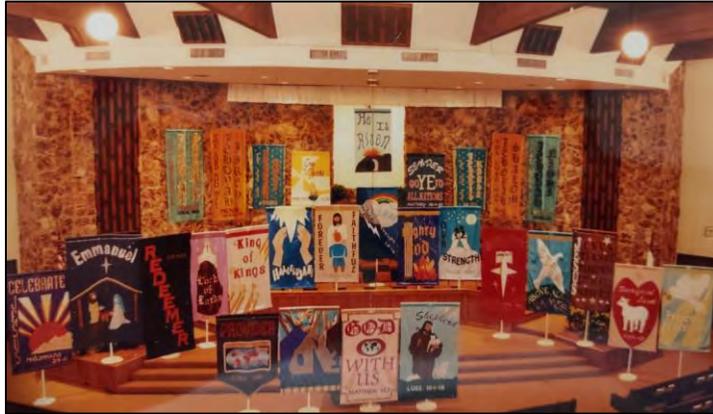
Plate 4. Bethel Baptist Church sanctuary interior, circa 1994. *Source: Bethel Baptist Church archives.*

of the church sanctuary, with what was referred to on the construction drawings as “tone chambers” with “grill cloth” covering them to both sides of the central baptistry (City of Escondido 2023). Plate 3 shows the exterior appearance of the church in 1978, and Plate 4 shows the original stone veneer wall, baptistry, and flanking tone chambers within the sanctuary.
